NATIONAL ARCHITECTURAL AND
ENGINEERING RECORD

CAPTAIN THOMAS MENDENHALL HOUSE
CAPTAIN THOMAS MENDENHALL TENANT HOUSES
217-219 EAST FRONT STREET

Prepared by
Bernard L. Herman
and
David L. Ames

December 1980

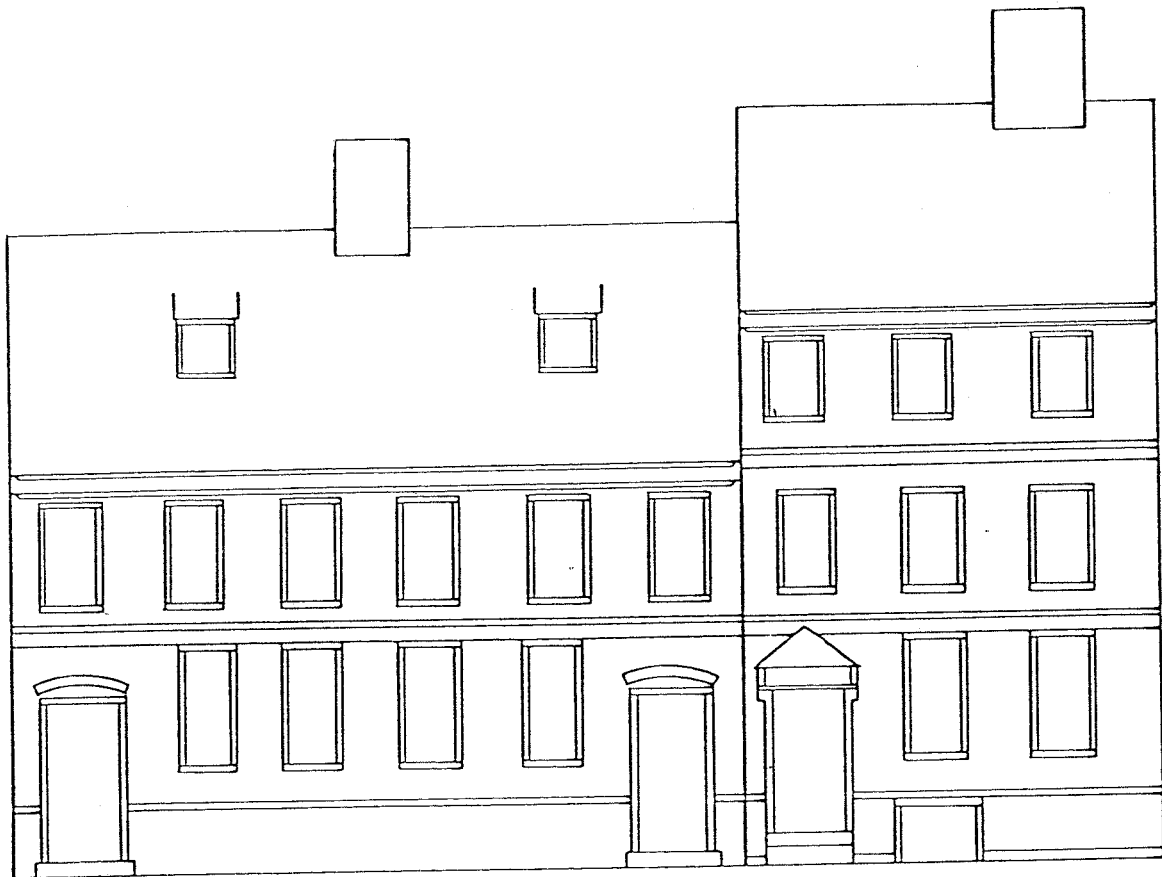
FIGURE 1

CAPTAIN THOMAS MENDENHALL HOUSE
AND MENDENHALL TENANT HOUSES:
RECONSTRUCTED FRONT STREET ELEVATION, ca. 1805

Figure 1: Captain Thomas Mendenhall House and Mendenhall Tenant Houses Reconstructed Front Street Elevation, ca. 1805. Evidence for all the second and third floor openings and their locations survived in unaltered bays found in the Mendenhall House and the tenant houses at 223 and 225 East Front Street. The second floor window openings for the tenant house at 221 East Front Street had been closed with brick infill to create narrower openings, but the presence of queen closers and the dimensions of the original windows piercing the second floor of 223 East Front Street provided both the location and size of the original openings and second floor fenestrations. The roof lines of 223 and 225 East Front Street also reflected the initial period of construction, and because 223 and 221 used to be a single structure that was later subdivided and altered, the roof for 223 East Front Street was reconstructed as a continuous elevation over its neighboring property. The more detailed information for this conclusion involved the presence of a bridled scarf joint in the Front Street facade false plate and the extension of chimney braces which had enframed the large central chimney pile shared by the two addresses. Finally, the first floor elevation and fenestration were extrapolated from the placement of openings in the upper floors, original door openings located in the Front Street facades of 221 and 225 East Front Street, and the scars for an infilled window opening positioned adjoining and above the present doorway for 223 East Front Street. With the dimensions known for all first floor openings and the positioning derived for known doors and windows, the lines of the second floor openings were extended downwards and the heavily altered street level facade of ca. 1805 reconstructed.

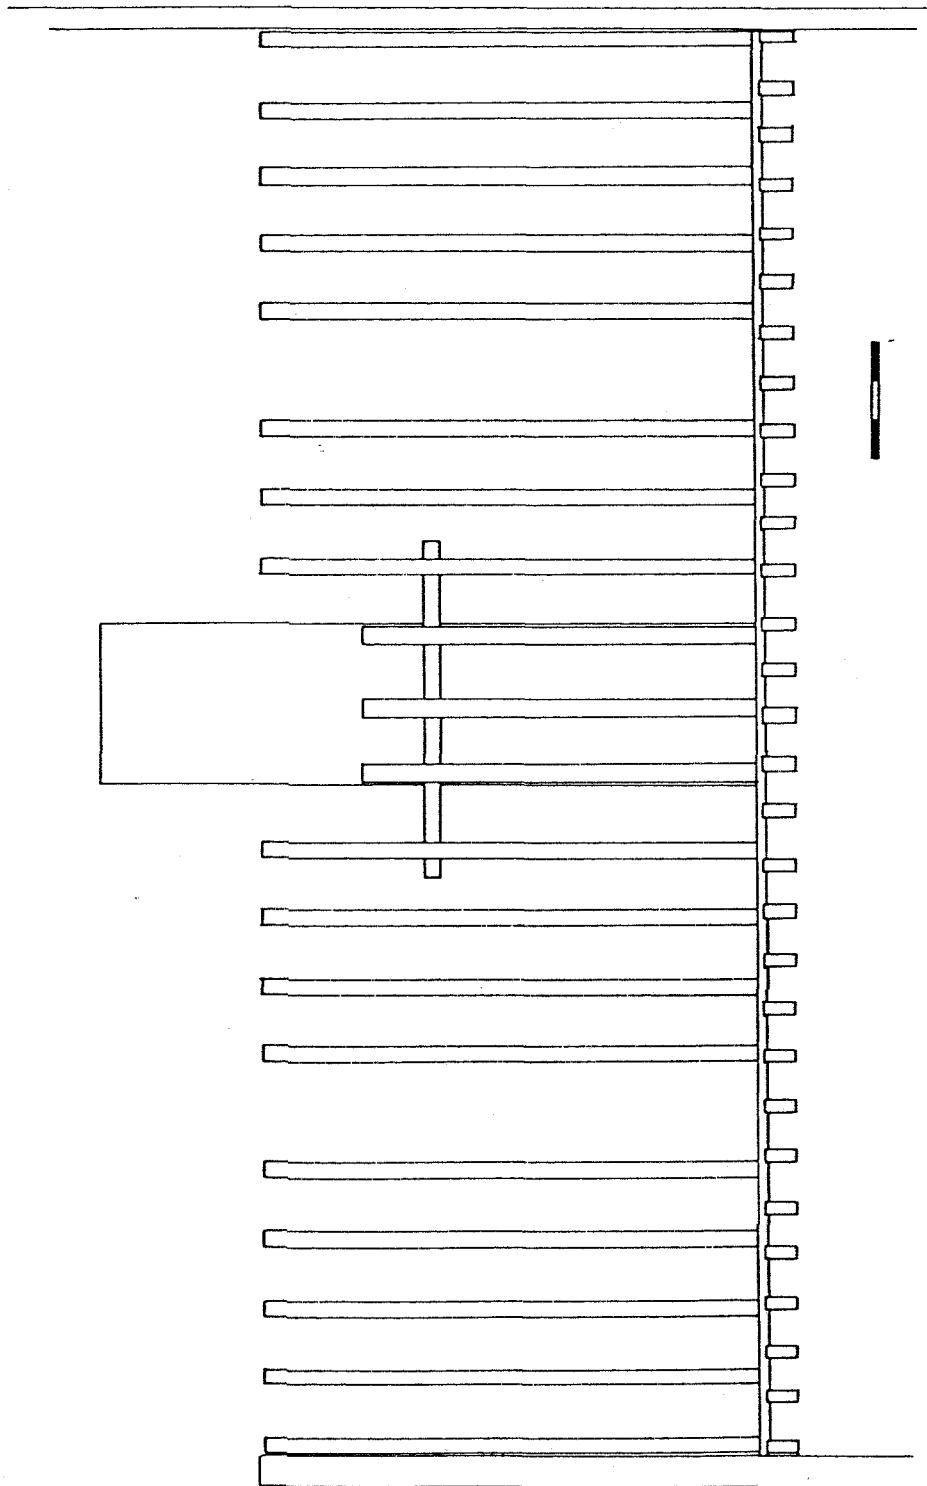
FIGURE 5

MENDENHALL TENANT HOUSES
RECONSTRUCTED ROOF SECTION, ca. 1805

Figure 5: Mendenhall Tenant Houses: Reconstructed Roof Section, ca. 1805. Although the roof framing for 221 East Front Street had been replaced in the latter half of the 19th century, the first period roof system for the adjoining property at 223 East Front Street survived intact. A pair of cut chimney braces spiked to the underside of the rafters and a bridled scarf joint in the false plate seating the rafter feet indicated a parallel extension of the roof framing system for 223 East Front Street over 221 East Front Street. This assumption was verified during the demolition of these properties in July 1981, when the later mansard roof over 221 East Front Street was removed, revealing the ghost of the original gable bedded into the wall of 219 East Front Street.

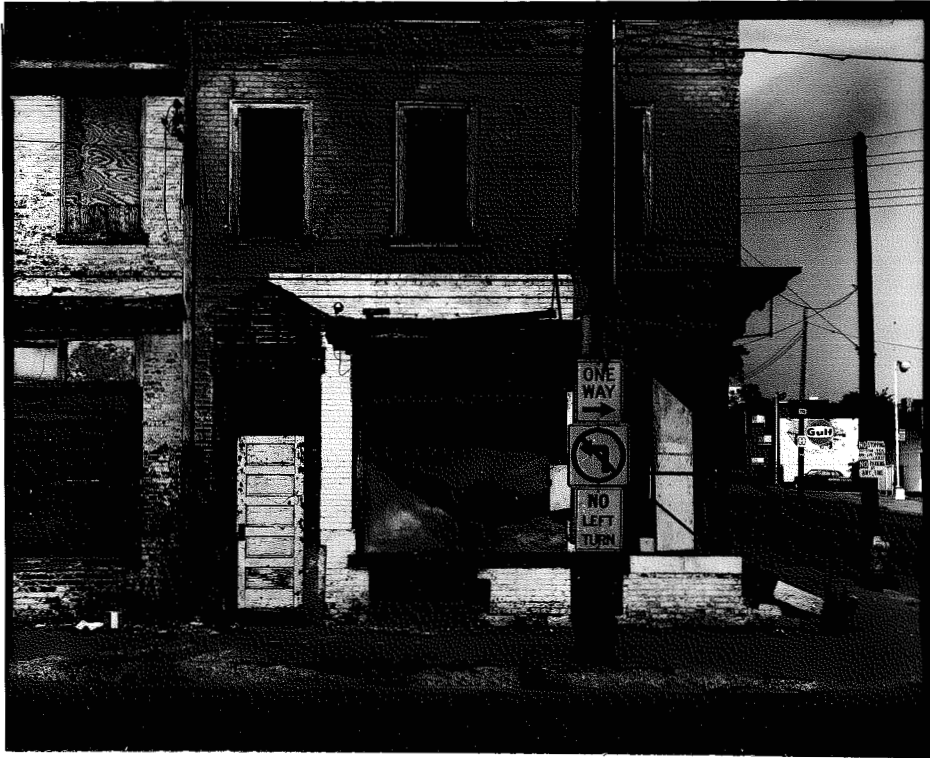
B.5. Porches, Stoops, Balconies, Bulkheads. As originally built the Mendenhall House had no porches. In the latter half of the nineteenth century however, a corner store front porch was carved out of the original fabric of the building. With the masonry removed, the load bearing function of the corner was replaced by a single cast iron Doric column footed on reused King of Prussia marble steps. The architrave of the corner door consists of recessed panel reveals with the intermediate rails dressed with machine-turned wooden bosses. The triangular porch ceiling is finished in the same manner with a centrally placed and recessed medallion from which a gas light fixture formerly depended. The porch cornice, carried by the corner column and a flattened pilaster at either juncture of the architrave and wall, rises from a plain frieze to a cyma molded cornice. On each face of the porch is a pair of machine-produced Italianate brackets. The whole of the cornice is covered by a flat seam tin roof flashed into the earlier brick walling.

PLATE 4: CAPTAIN THOMAS MENDENHALL HOUSE
19TH CENTURY FRONT STREET COMMERCIAL FACADE

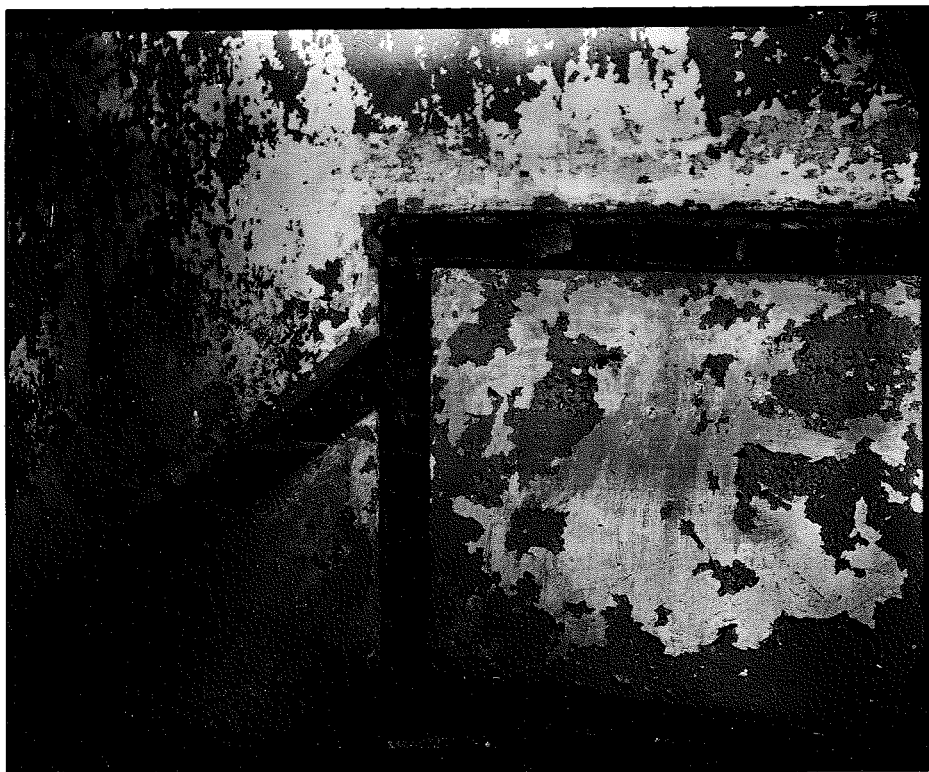
PLATE 6: CAPTAIN THOMAS MENDENHALL HOUSE
2ND FLOOR LANDING CHAIR RAIL SCAR

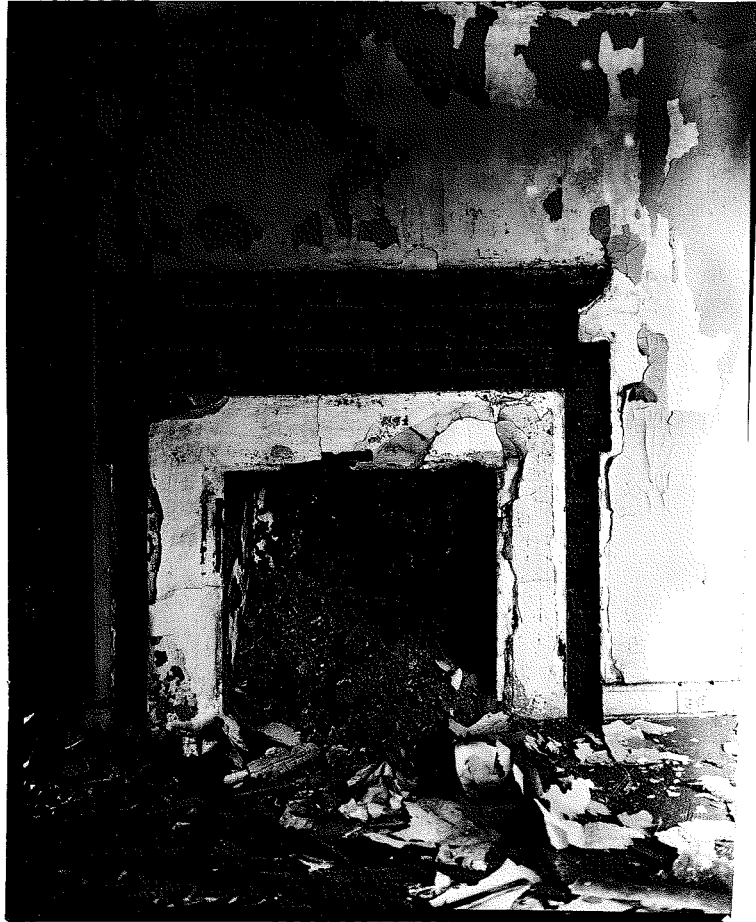
PLATE 11: CAPTAIN THOMAS MENDENHALL HOUSE
3RD FLOOR FRONT CHAMBER MANTEL GHOST

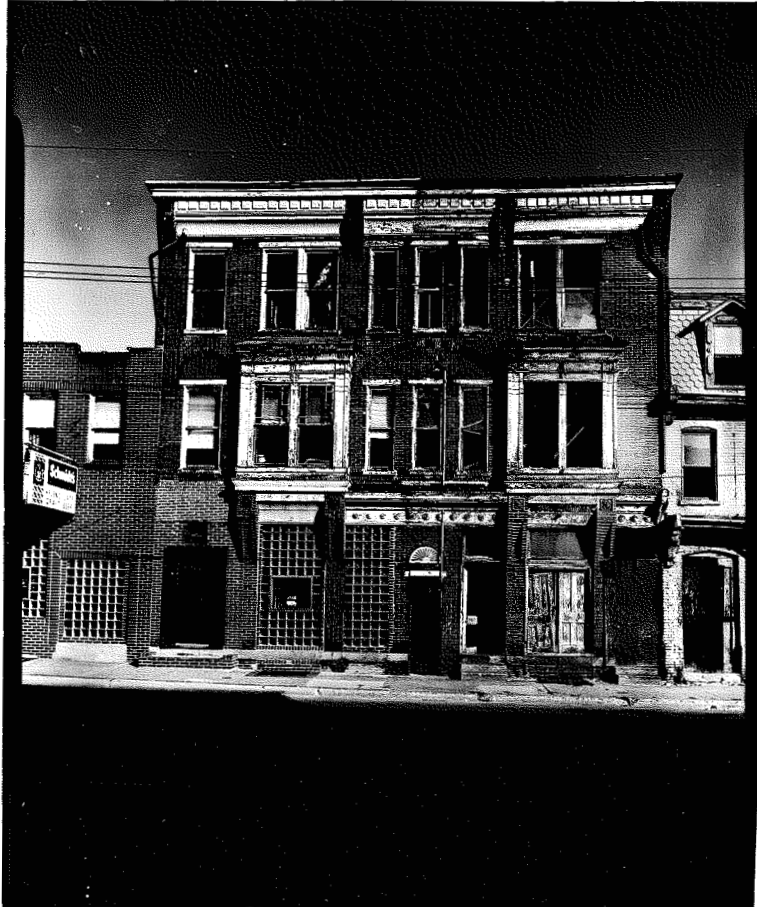
A.2. Condition of Fabric. While 217 remains in use as a tap room and boarding house, 219 has fallen into an advanced state of decay in which the interior has largely collapsed in on itself. 217 has suffered structural damage from the roughshod demolition of adjacent properties, however, its structural condition is currently problematical.

PLATE 13: 217 AND 219 EAST FRONT STREET

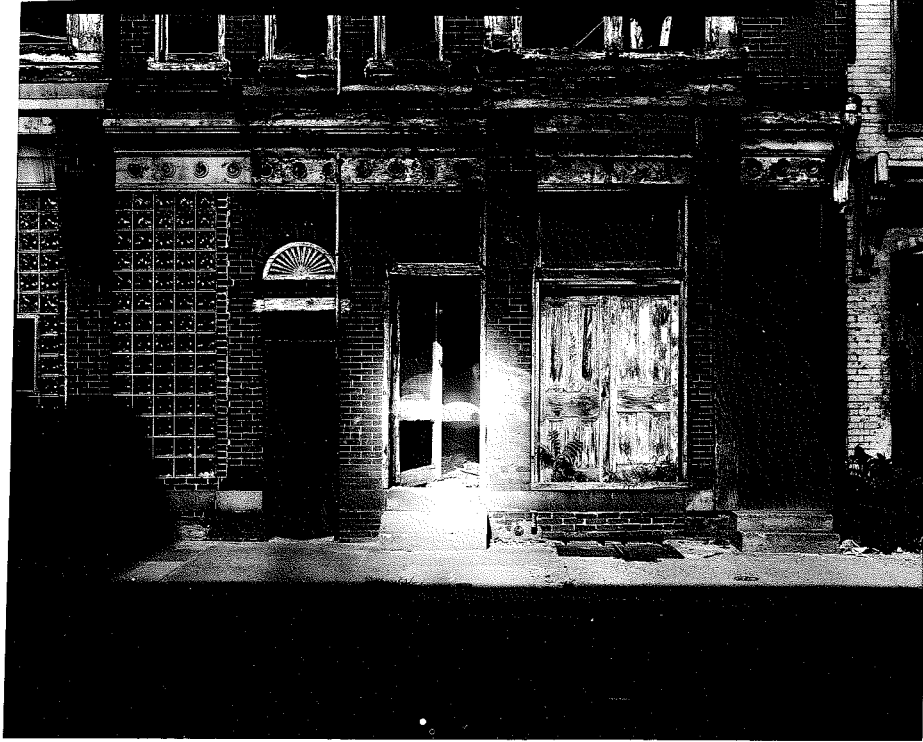
B.7. Exterior Openings. The fenestration at street level remains unchanged for 219, although it has been broken up and altered for 217. As built, the first floor shop front was divided into a seven-bay, tripartite balanced facade. The central element was the opening to the alley way between the units/above the actual entry way a fanlight with a wood grill in fill provided a central visual element. To either side, a doorway with a tall single-light transom opened into a commercial space illuminated by a full height store front window with fixed transom lights echoing the doorway. The display windows were further set off by the springing for the consoles visually carrying the oriel windows at the second floor level. To the far gable ends, a single door opening into an enclosed stair provided street level access to the upper residential floors of the building. The upper level windows consist of the oriel windows previously described and one-over-one light sash windows capped with unadorned beam lintels. The balance

PLATE 14: 219 EAST FRONT STREET
19TH CENTURY STOREFRONT
