Documentation of Threatened Buildings

NEW CASTLE COUNTY

Site Name: Dawkins-Marim House
CRS Number: N - 128
HABS Number: DE - 000

Location: 1847 Clayton-Delany Road
Blackbird Hundred
New Castle County, Delaware

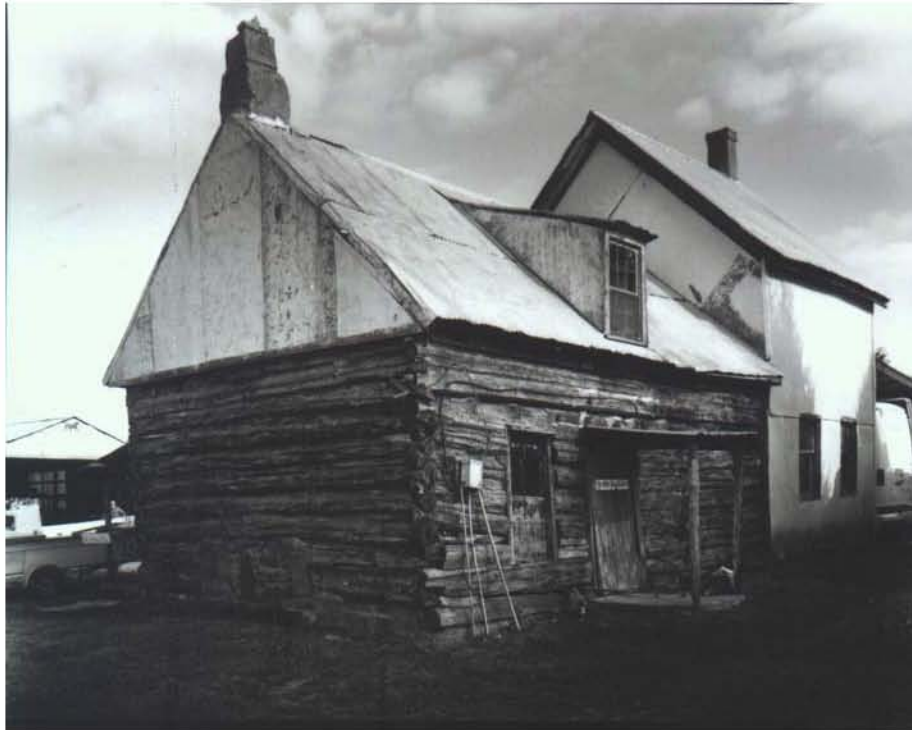
Figure 3: Dawkins-Marim House, perspective of south and west elevations, looking northwest.

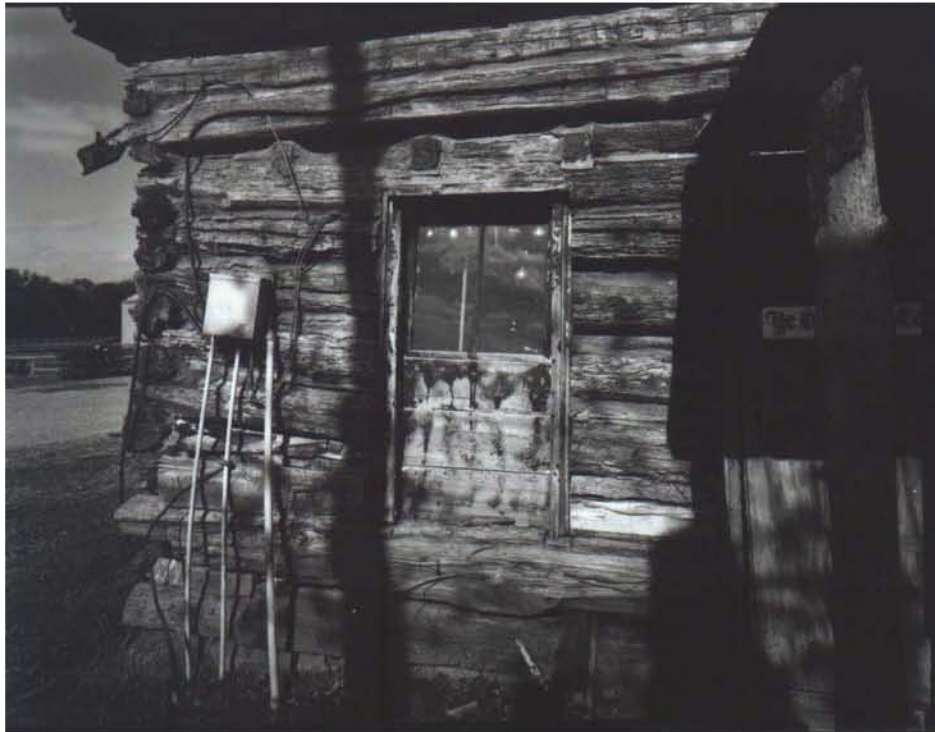
The exposed south or front elevation of the log section clearly shows the construction of this section of the house. The logs are V-notched at the southwest corner. The chinks between the logs are filled with mortar and stone rubble. The south elevation is twelve logs high and has a door located centrally in the elevation. To the left of the door there is a two-light window; three boards cover the lower half of the window. There is evidence of either a door or a window opening to the right of the door near the former southeast corner of the building. The ends of the second floor joists are exposed on the exterior. The spaces between the joists are filled with separate pieces of log. The joists are located nine logs up from the ground.

Figure 4: Dawkins-Marim House, detail of log construction on south elevation, looking north.

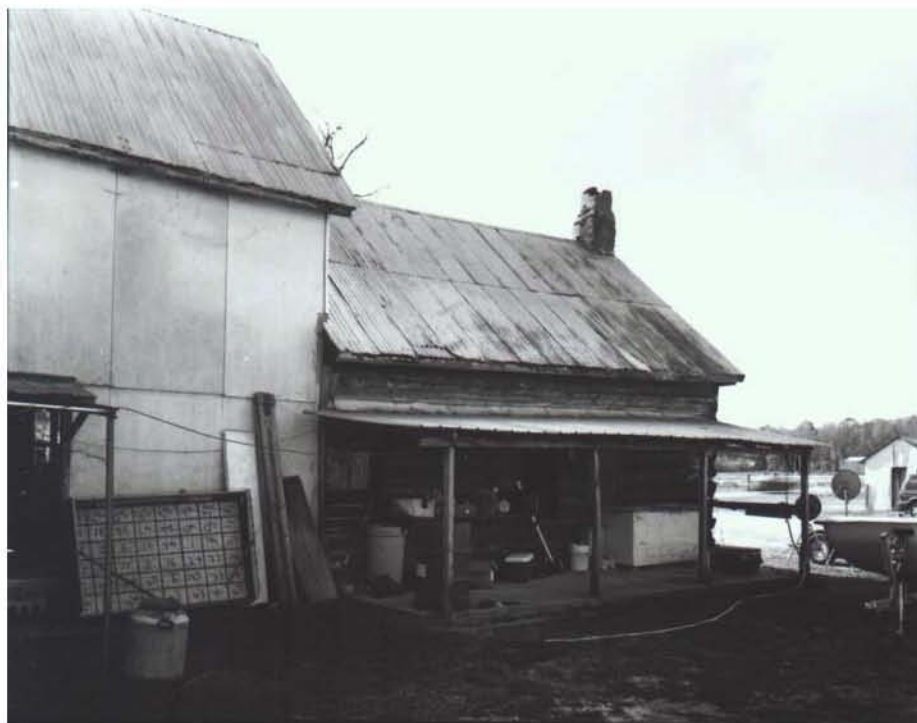
The north elevation of the log section has a new porch roof covering the first floor. The ends of the logs making up the interior partition are exposed on this elevation also and an entrance door is centered on the main room. Two windows are located to the left of the door,

Figure 5: Dawkins-Marim House, perspective of north elevation, looking southwest.

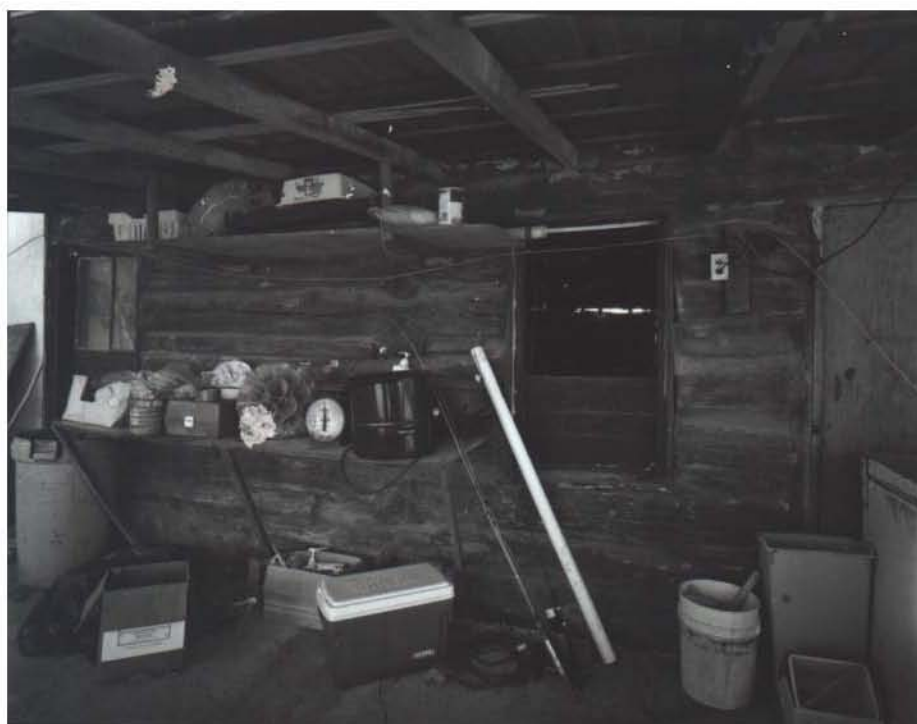
Figure 7: Dawkins-Marim House, detail of log construction on north elevation, looking south.

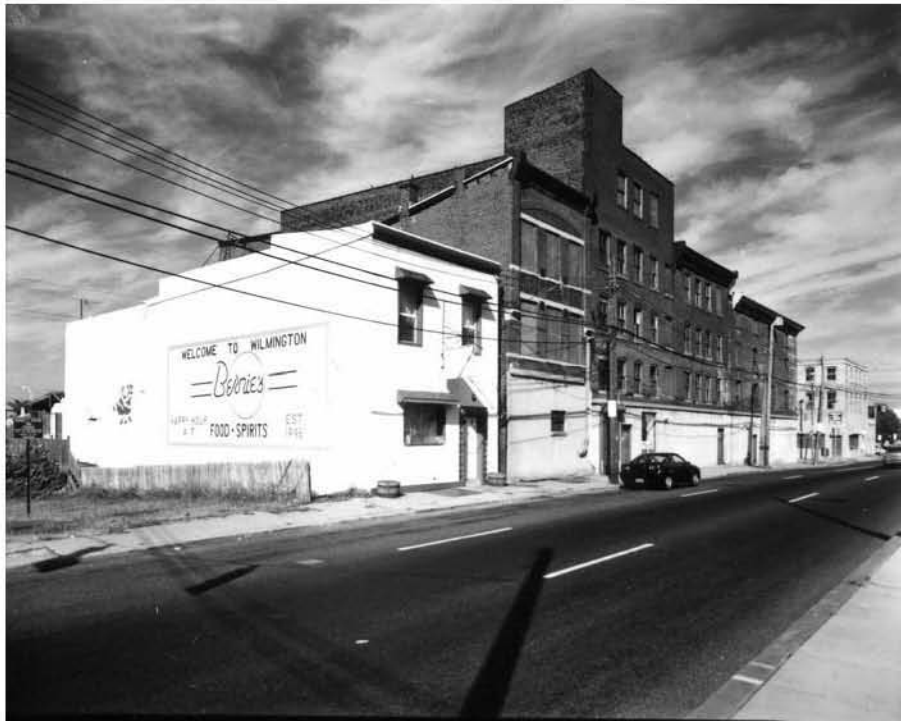
Threat: The Diamond Chemical Block has been vacant for a number of years. During that time a fire damaged the roof and part of the interior, resulting in later water damage to major sections of the building. The current owners of the block have applied to the City of Wilmington for a demolition permit.

Figure 11: Diamond Chemical Block, perspective of northeast and southeast elevations of block, looking west along Second Street from King to Market streets.

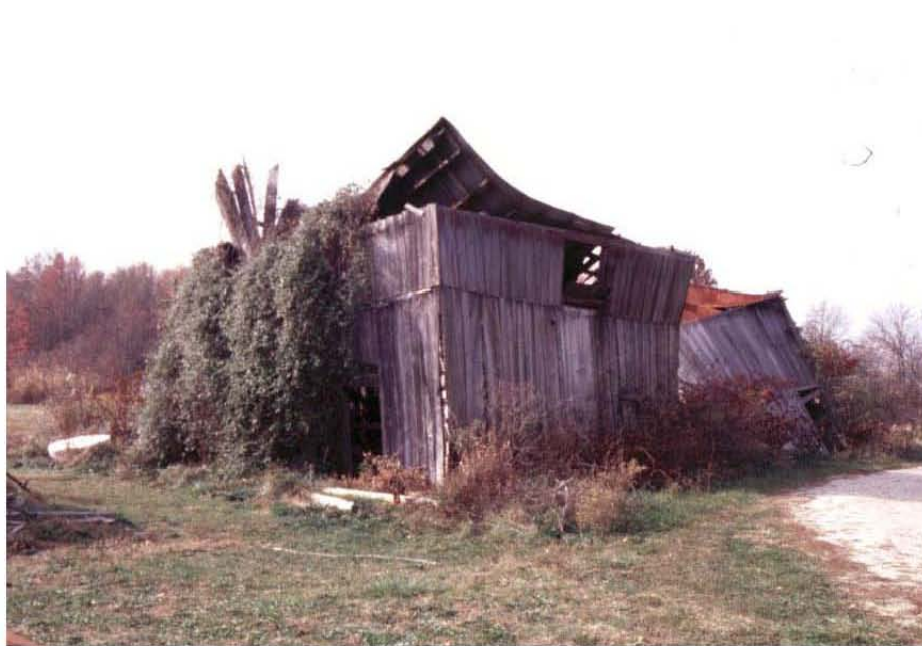
Threat: The stable has been vacant and unused for many years. Neglect and exposure to the elements have resulted in extreme deterioration and partial collapse of the roof and the adjoining barn.

Figure 23: Walker-Reynolds Stable, perspective of the north and east elevations, looking southwest.

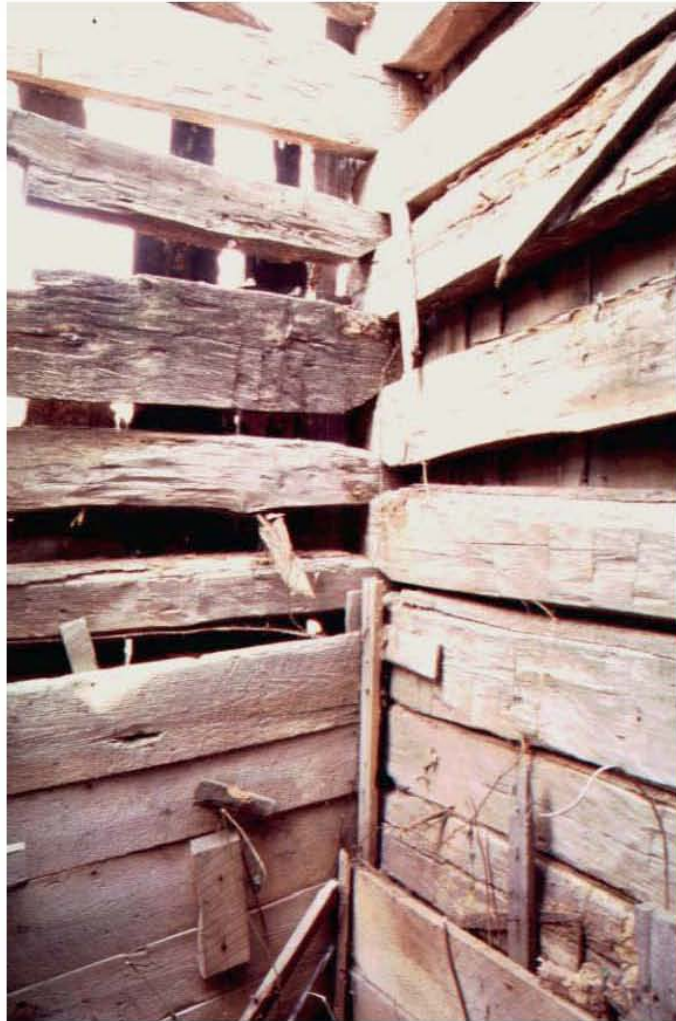
The stable is constructed with planks that are hewn on two sides with the bark remaining on the tops and bottoms. V-notches in the planks provide the joinery at the corners of the building; the planks are trimmed to create a flat surface beneath the siding. Ceiling joists run east to west; these appear to have been reused from another building, since some are planed and finished with a beaded edge while others are rough-hewn with bark remaining in places. The planks continue for about three feet above the ceiling height; above the top log is a frame construction to support the later roof.

Figure 24: Walker-Reynolds Stable, interior detail of the plank joinery in the northwest corner.

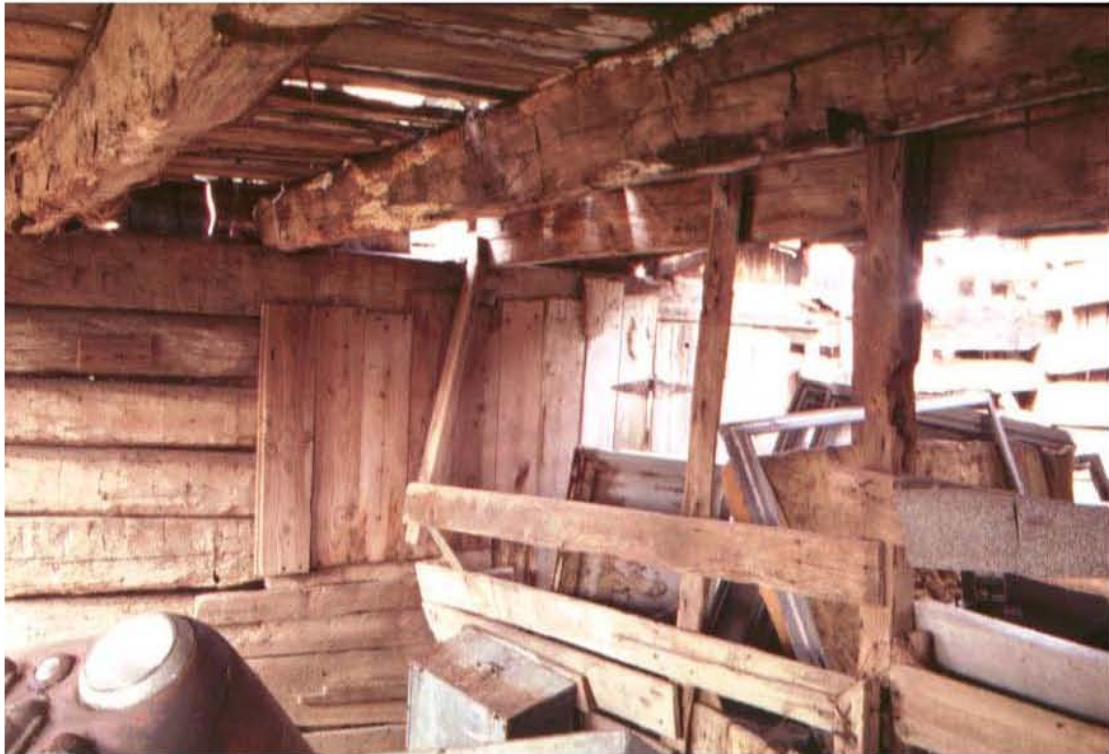
The stable is divided into two sections on the ground floor, by a half height partition wall that runs east to west and appears to be of a later construction than the main part of the stable. Two doors in the west elevation lead into these separate sections. The southern section has a door centrally located in the south wall and what appears to be a window opening in the east wall next to the dividing partition.

Figure 25: Walker-Reynolds Stable, interior view of the partition wall and west wall, looking northwest.
