Site Name: Causey Mansion Kitchen/Slave Quarter and Ice House
CRS Number: S-1116.26
HABS Number: DE-000

Date of Field Work: November 1998

Type of Documentation: Level II: Partial Intensive
Annotated field notes (5 sheets)
Measured drawings (3 AutoCAD format)
4" X 5" black-and-white photos (7)
Architectural Data Sheet

Site Name: R. D. Stevenson House
CRS Number: S-2947
HABS Number: DE-000

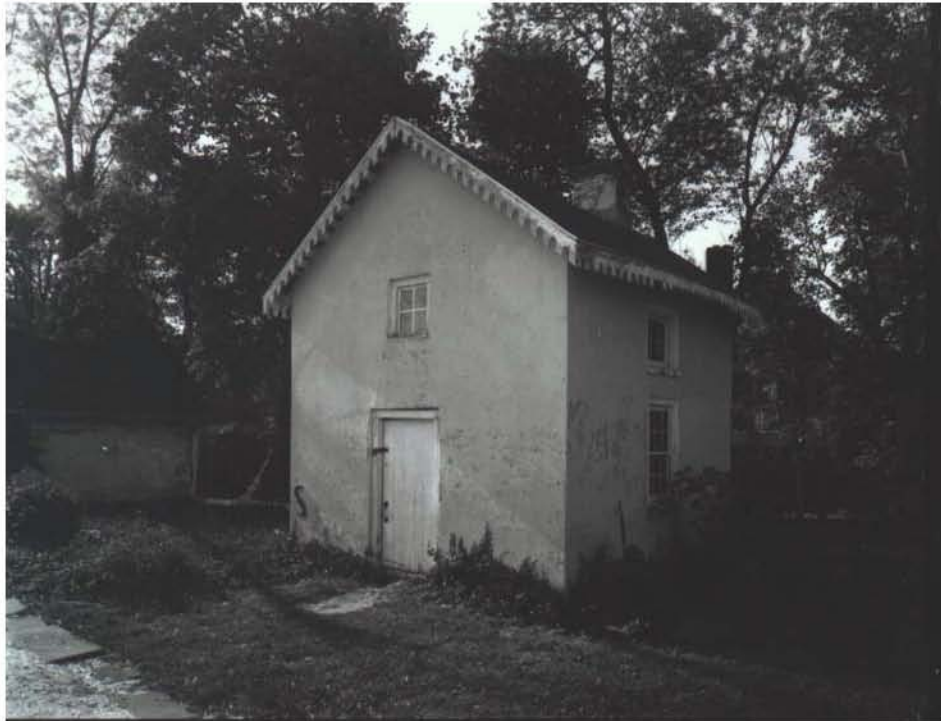
Figure 77: Causey Mansion Kitchen/Slave Quarter, perspective of the southeast and northeast elevations looking west.

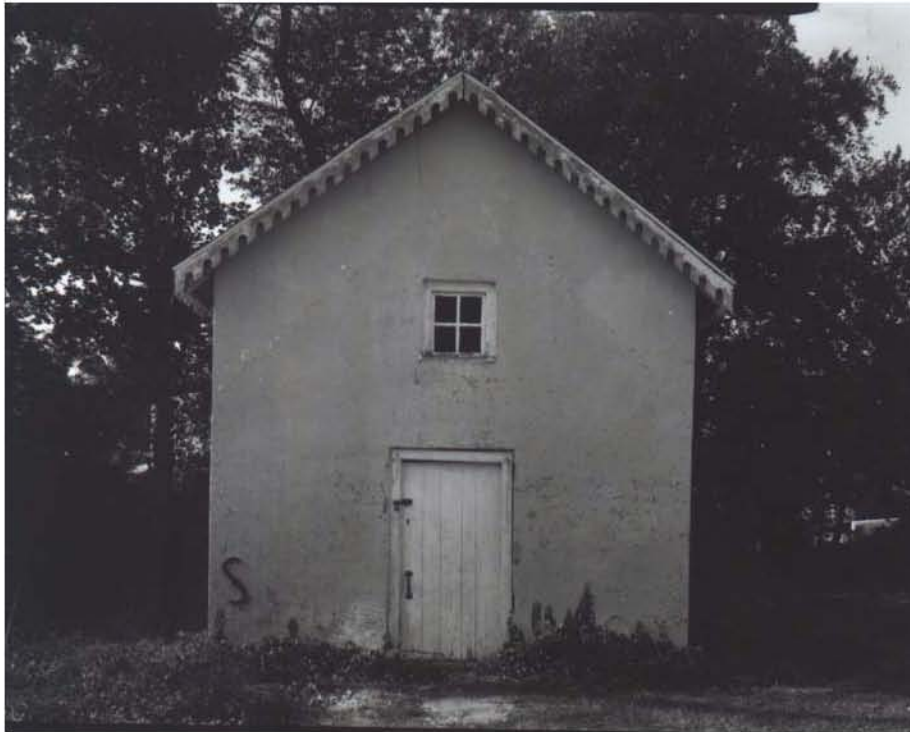
Figure 78: Causey Mansion Kitchen/Slave Quarter, view of the southeast elevation looking northwest.

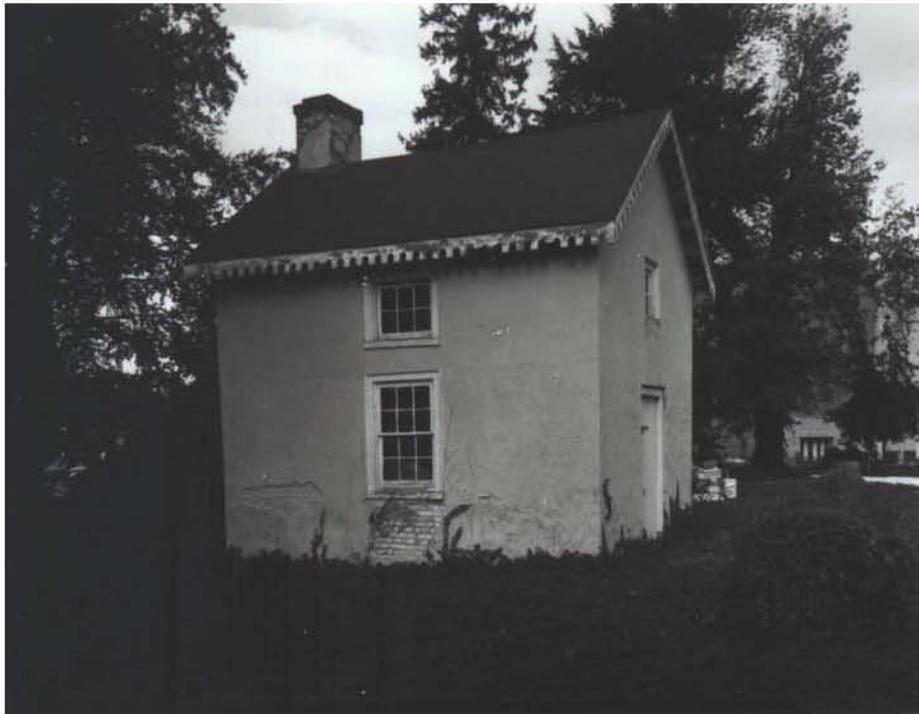
Figure 79: Causey Mansion Kitchen/Slave Quarter, perspective of the southwest and southeast elevations looking north.

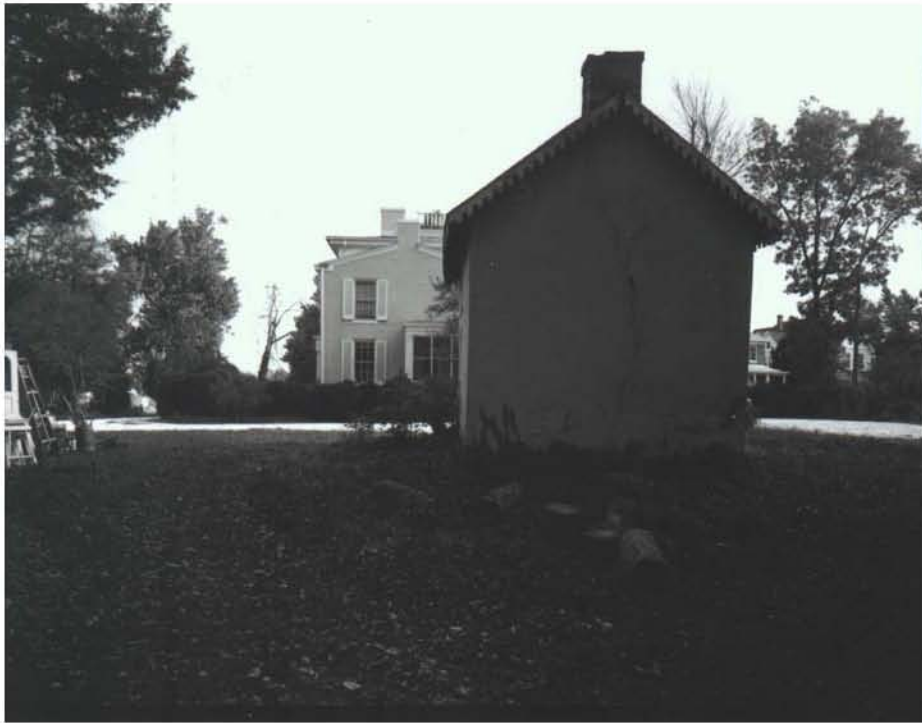
Figure 80: Causey Mansion Kitchen/Slave Quarter, environmental view of the northwest elevation looking southeast.

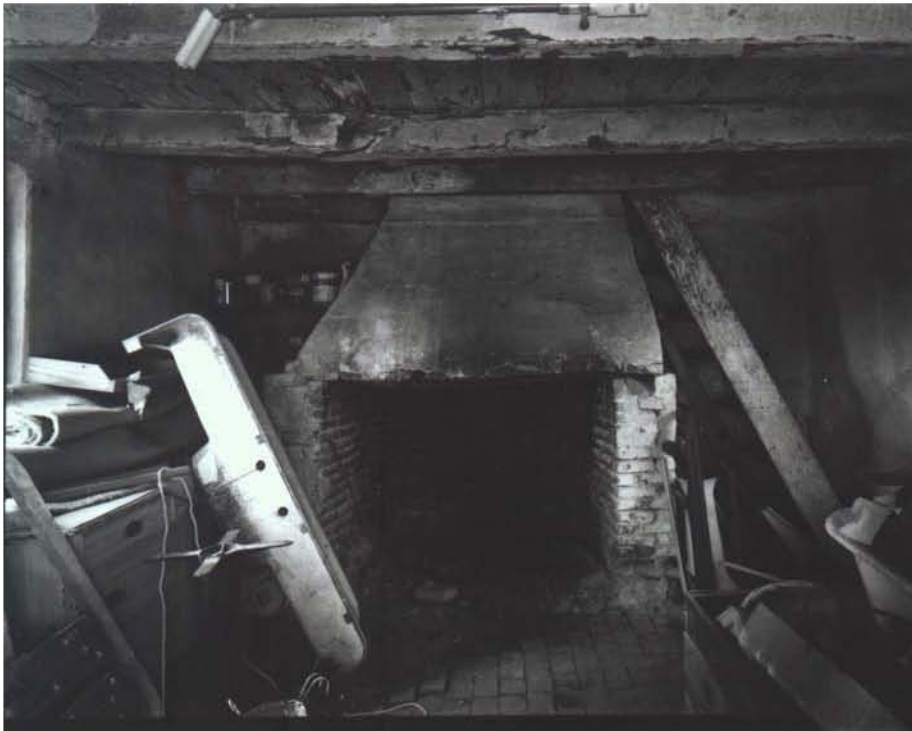
Figure 81: Causey Mansion Kitchen/Slave Quarter, interior, first floor: view of northwest wall looking northwest.

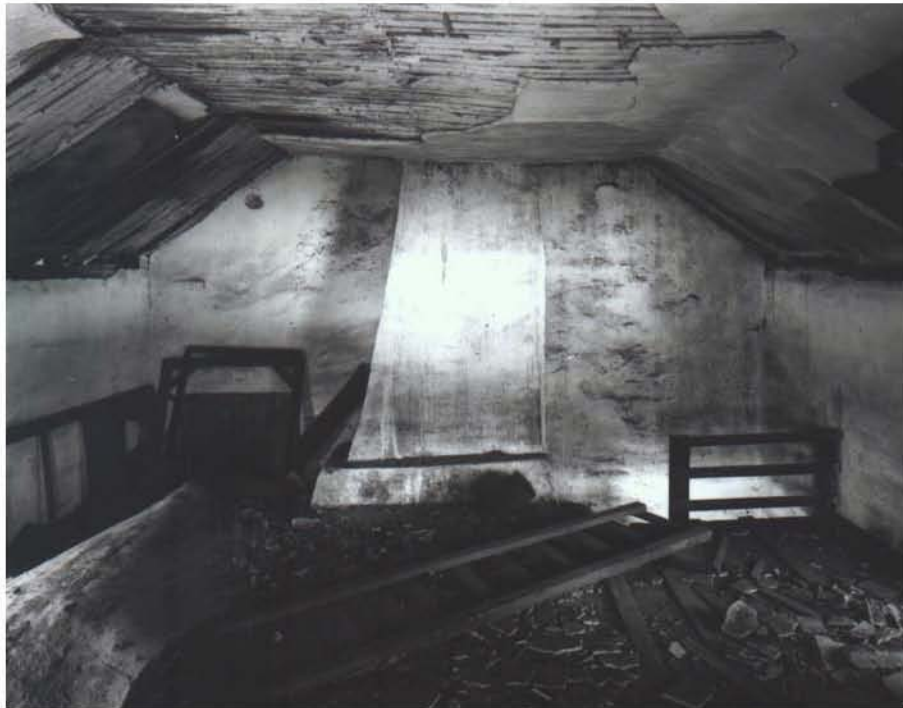
Figure 82: Causey Mansion Kitchen/Slave Quarter, interior, second floor: view of northwest wall looking northwest.

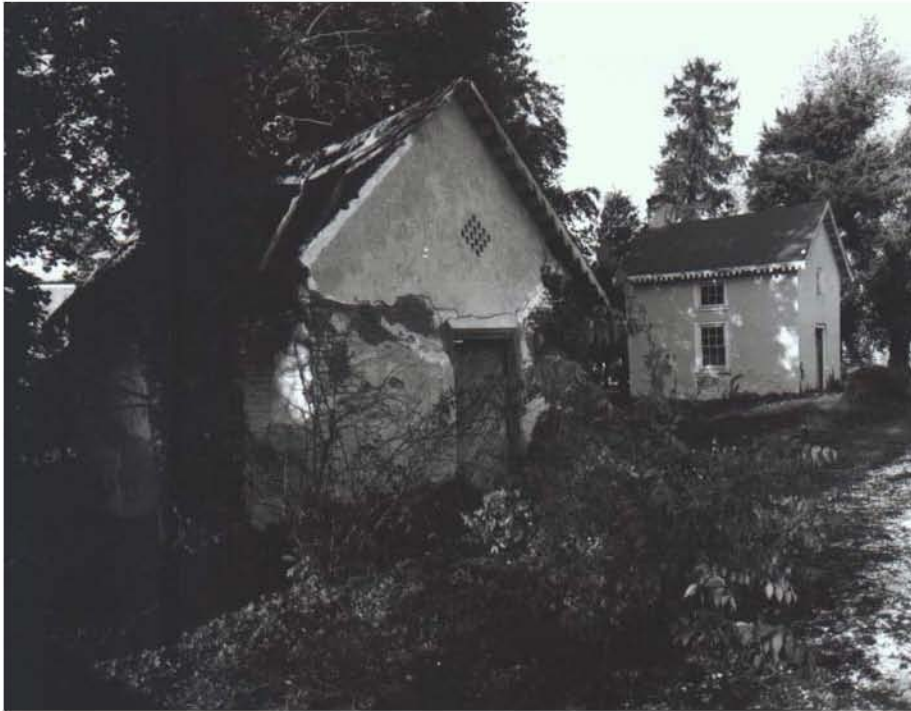
The second outbuilding, the ice house, is much plainer than the first and far more deteriorated, but the roof has the same rake board trim. The only openings in this building are a door located in the west elevation and a decorative brick opening in the gable above the door. The floor is about ten inches below grade and paved with brick. The wood framing for the roof is hewn on two sides and vertical sawn on the other two. There are six exposed ceiling joists spanning between the north and south walls, extending nine inches beyond the bearing wall. The roof rafters bear on the ends of these joists. There are two levels of collar ties dovetailed into the rafters above the ceiling joists.

Figure 83: Causey Mansion Ice House, environmental view of southeast and northwest elevations looking north.

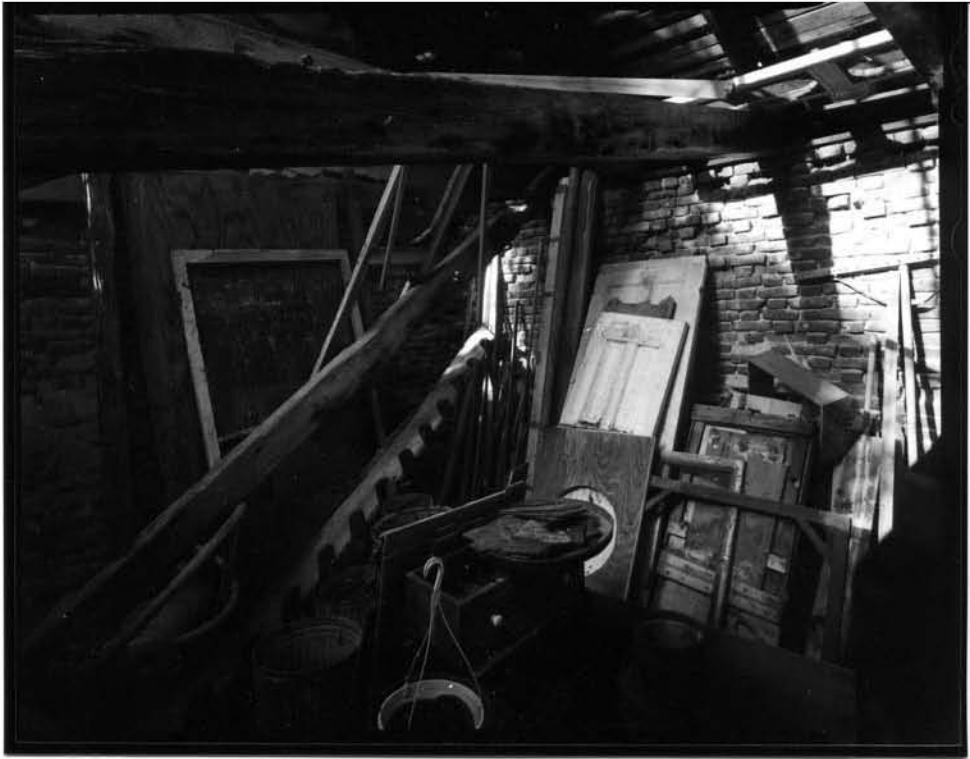
Figure 84: Causey Mansion Ice House, first floor, view of northwest and southeast walls looking north.

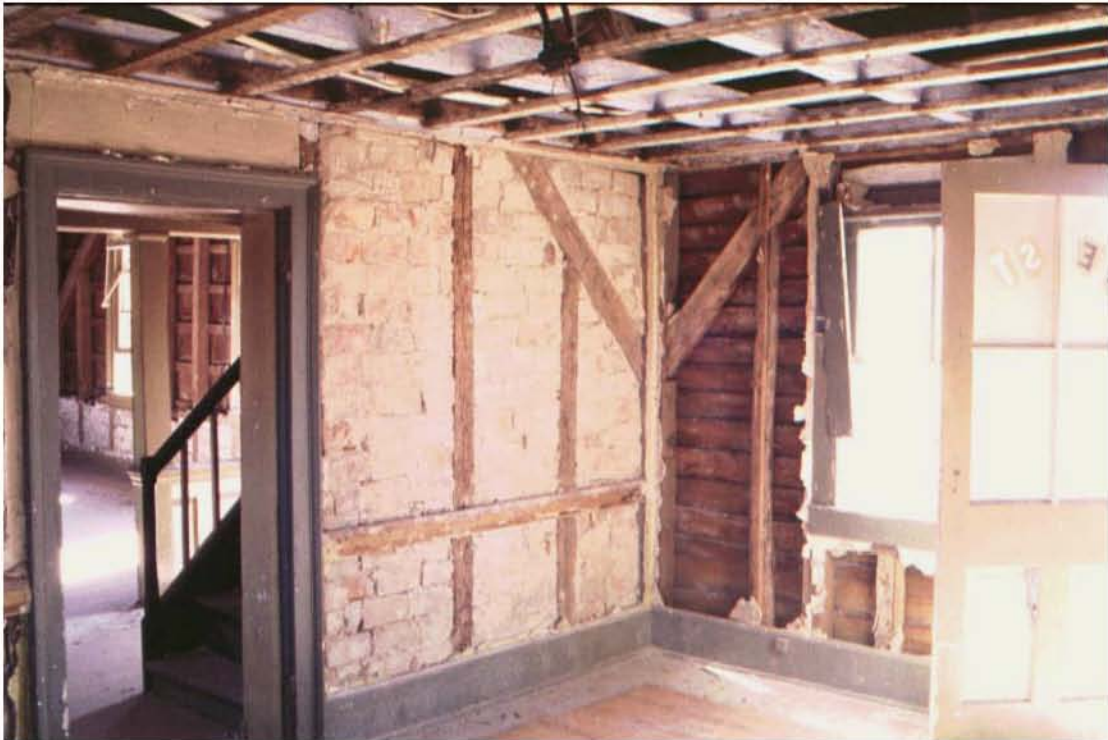
Figure 90: Stevenson House, interior, first floor, Period I section: view of frame and nogging in southwest corner of south room, looking southwest.

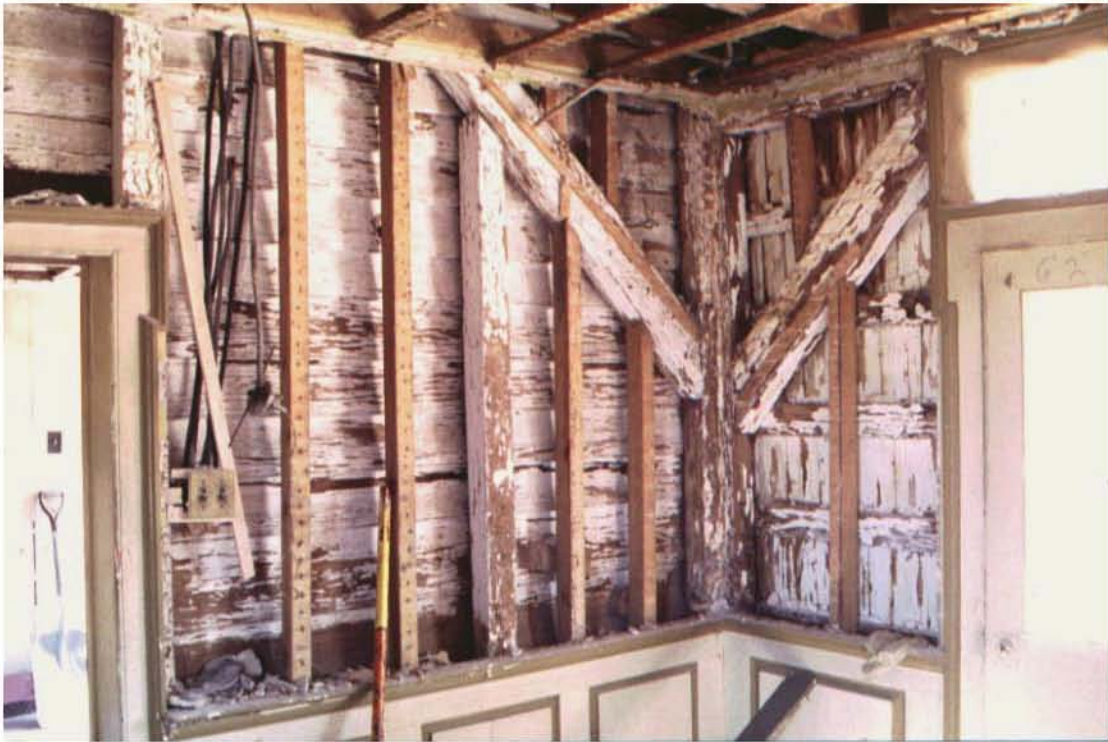
Figure 94: Stevenson House, interior, first floor, Period II section: view of framing and exposed siding in northeast corner of entry hall, looking northeast.
