FINAL PROJECT REPORT #56

SAN BRUNO CALIFORNIA,  
SEPTEMBER 9, 2010  
GAS PIPELINE EXPLOSION AND FIRE

**Disaster Research Center Final Project Report  
University of Delaware, Newark DE**

**August 2011  
(revised May 2012)**

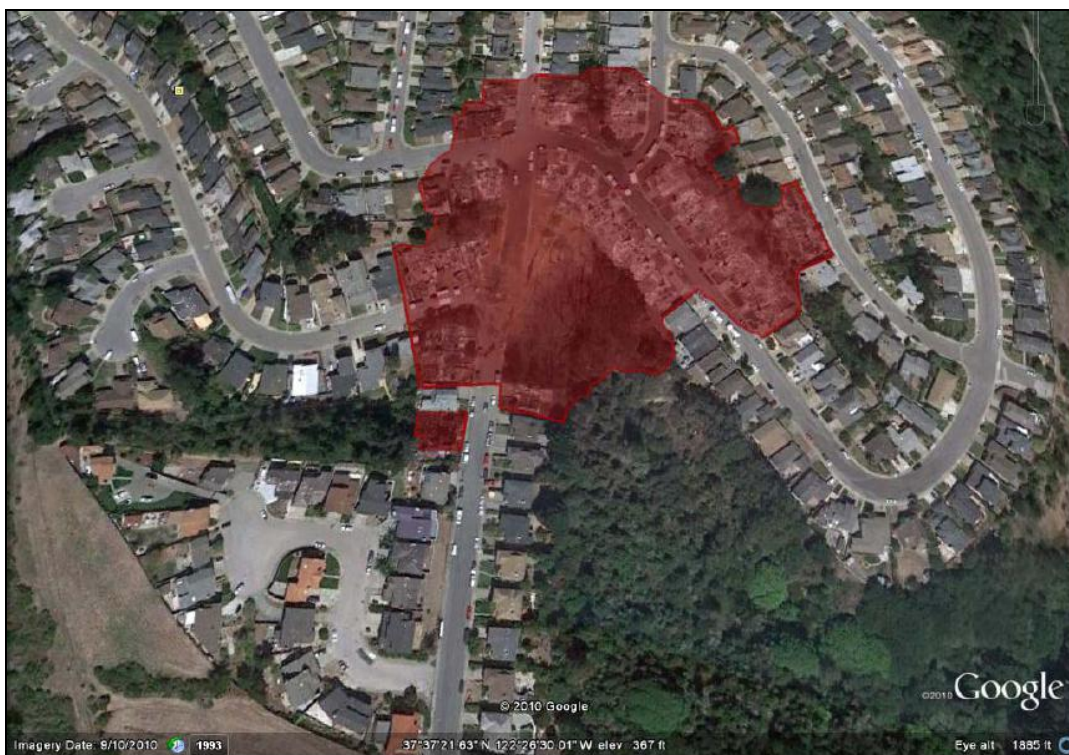
The released natural gas was ignited very shortly after the rupture. Eight people died and a total of 58 were injured (ten seriously), and many more were evacuated from the area. The resulting fire also destroyed 38 homes and damaged 70 (NTSB 2011g). Figure 4 shows an aerial view one year before the incident. Figure 5 shows the damage to the surrounding houses, vehicles, and land extending approximately 180 m (600 ft) from the blast center with most of the damage radiating out in a northeast direction away from the center of the crater (NTSB 2011a). Figure 6 provides a close up of some of the damage.

Figure 4 Area of damage (NTSB 2011a)

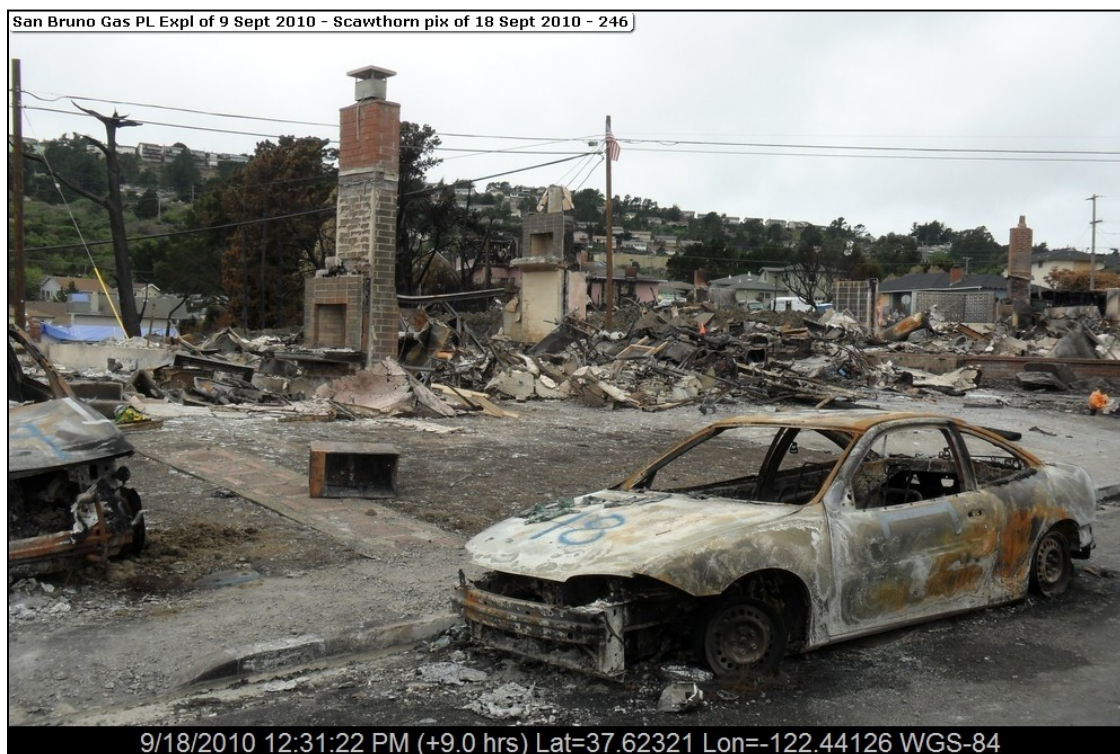
Figure 5 Houses and vehicles destroyed (C. Scawthorn)

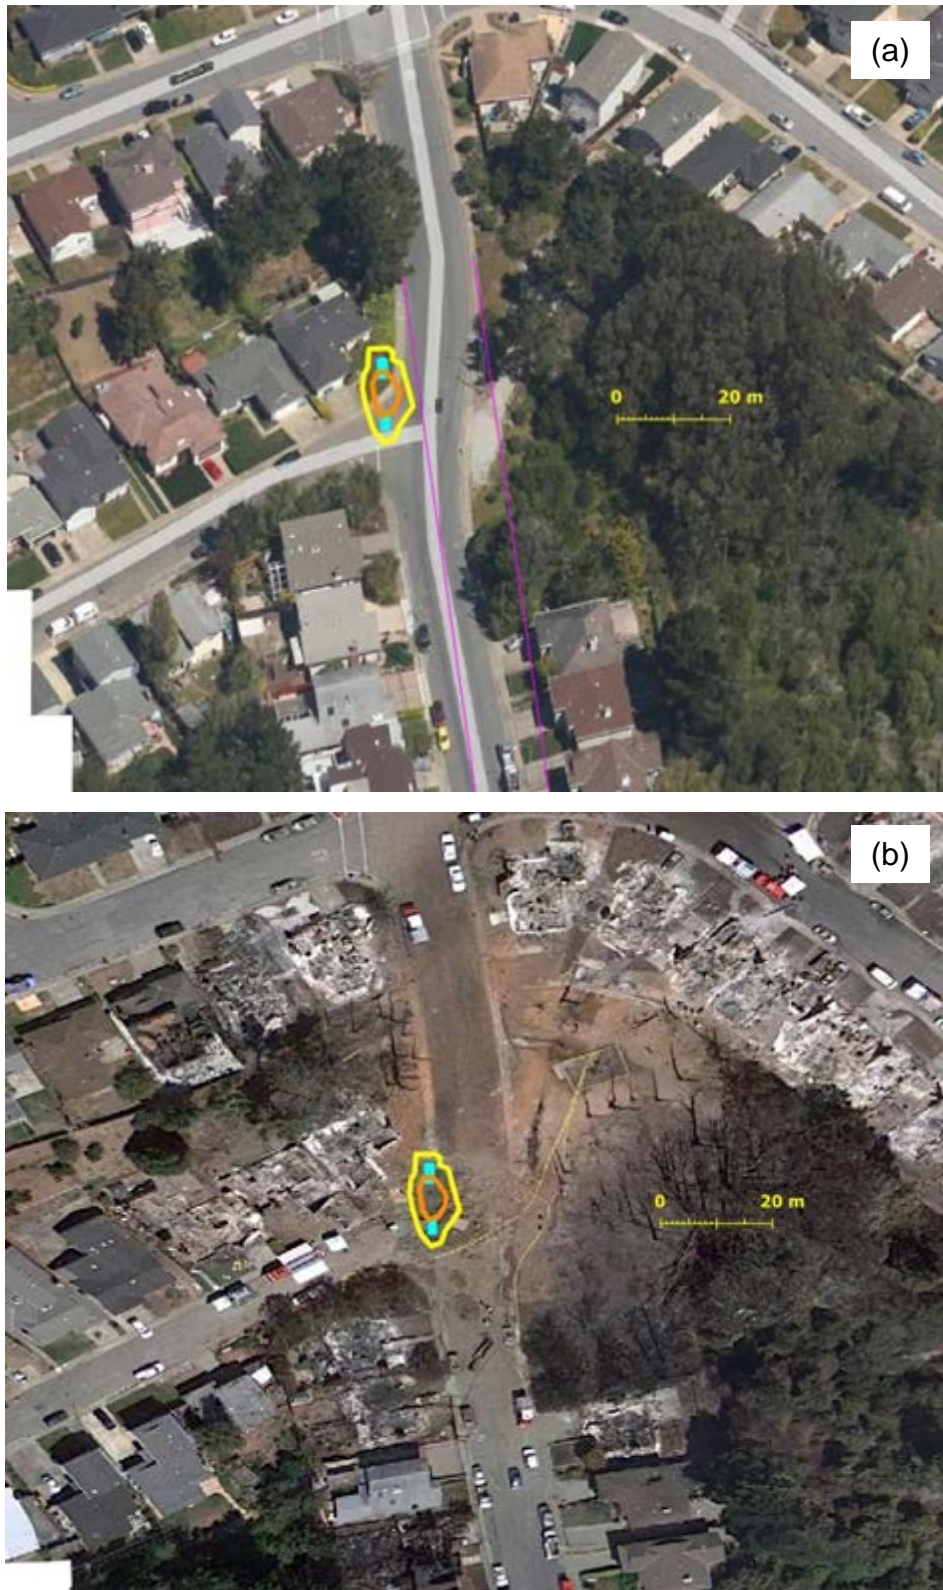
The rupture created a crater approximately 22 m (72 ft) long by 8 m (26 ft) wide at the intersection of Earl Avenue and Glenview Drive (Figure 3, and Figure 8). A pipe segment approximately 8.5 m (28 ft) long was found about 30.5 m (100 ft) south of the crater. PG&E estimated that 1.35 million m<sup>3</sup> (47.6 million standard cubic ft) of natural gas were released as a result of the rupture. Nearby damaged utilities included a 0.152 m (6 in) cast iron water main, a 0.254 m (10 in) sanitary sewer line and 0.102 m (4 inch) gas distribution line (NTSB 2011b).

Figure 6 Site (a) before and (b) after explosion with crater's approximate upper (yellow) and lower (orange) outline

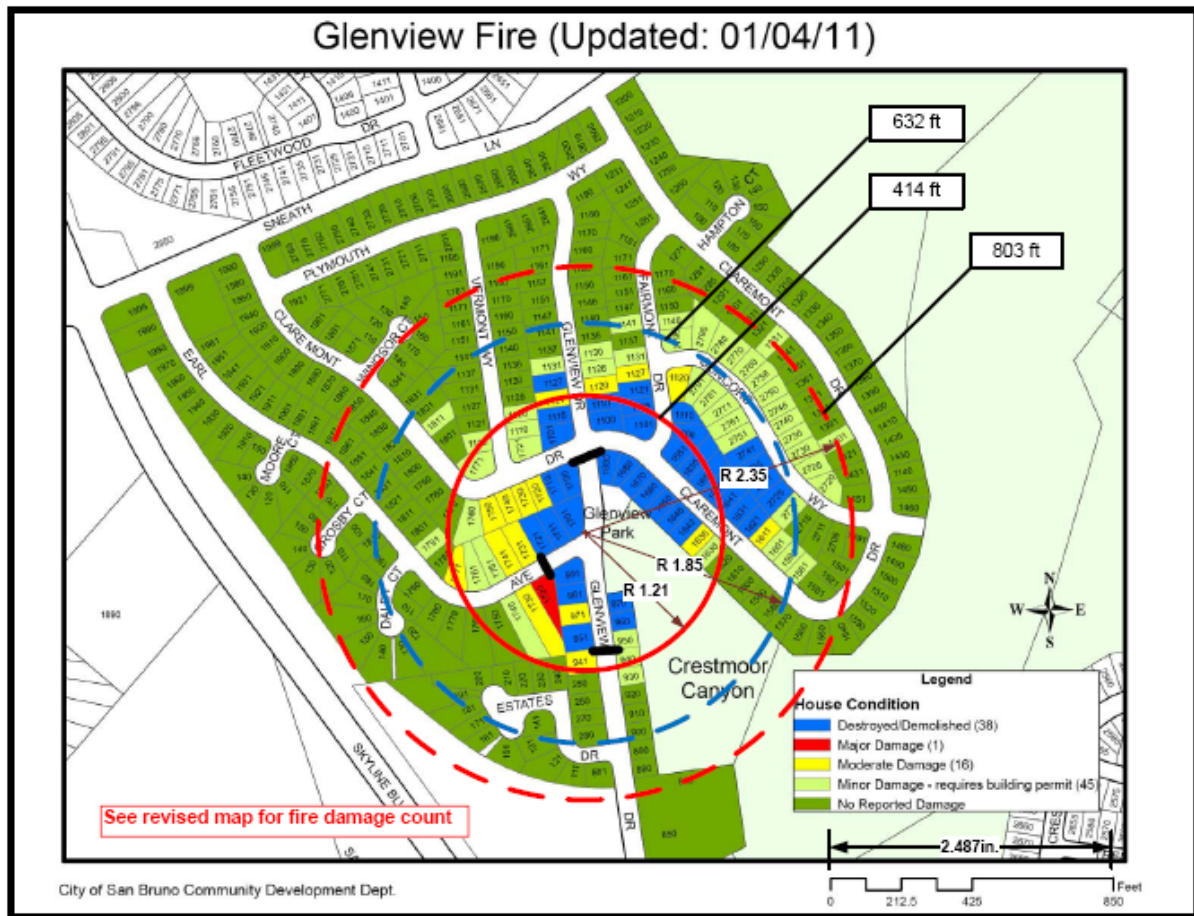
By 3:00 pm or 4:00 pm, all homes in the affected area were posted with red, yellow and green tags to denote the extent of the damage. Red tags indicated that the building or lot was destroyed or unsafe to enter. Yellow tags indicated the building was damaged, potentially unsafe to enter, and not suitable for occupancy. Green tags indicated the building was safe for re-entry and occupancy. Based on these decisions, color-coded maps of the disaster site were developed and provided to each department that was working at the scene (e.g., Figure 22). This information proved useful when the first town meeting was held to inform citizens on the conditions of the disaster area. However, damage assessments and changes in the status of buildings continued to occur for several days and weeks.

Figure 22 Map showing damage levels by parcel (Source: Map accessed from the National Transportation Safety Board's Docket No. SA-534, Exhibit No. 2-BC)

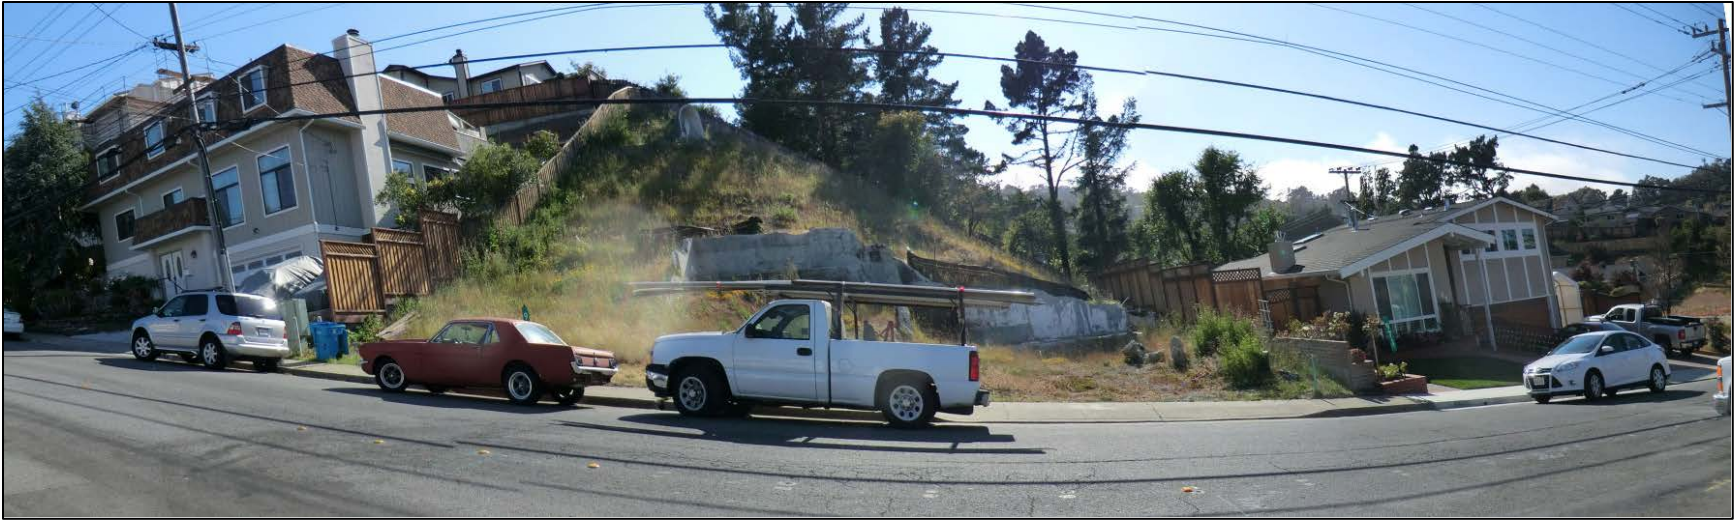
Figure 35 Looking west from location indicated by red star in Figure 32 (May 30, 2012) – houses at left and right (941 and 971 Glenview Drive) have completed repairs, house in middle (951 Glenview Drive) has yet to begin application process.
