NATIONAL ARCHITECTURAL AND ENGINEERING RECORD
DUCK CREEK MILL

Bernard L. Herman
and
David L. Ames

College of Urban Affairs and Public Policy
University of Delaware
Newark, Delaware
June 1981

DUCK CREEK MILL

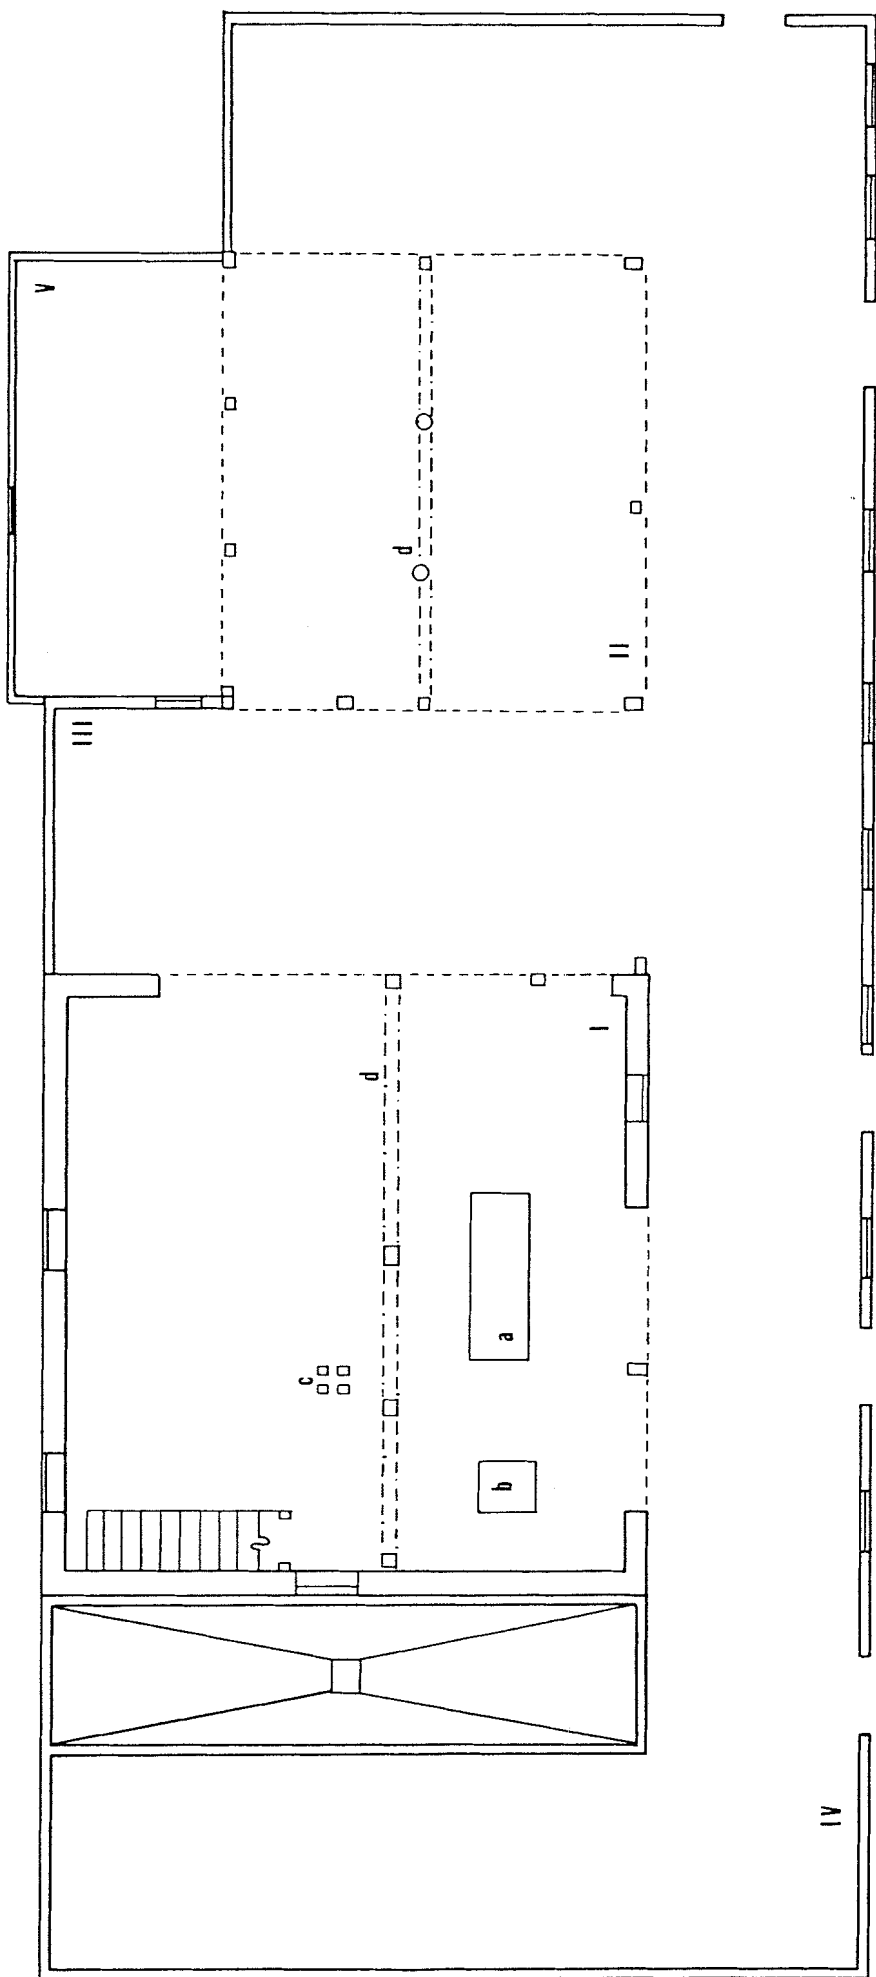
Figure 1: Duck Creek Mill, first floor plan showing
Phases I through V.

- a. "Western Corn Sheller"
- b. corn bin chute from second floor
- c. grain elevators
- d. summer beam locations

1. Overall Dimensions: The overall demensions of the Duck Creek Mill are approximately 102' by 44'. The plan of the building, however, contains a number of discrete spatial units (numbered I to V in Figure 1). Phase I was a two-story brick structure of about 31' by 32'; Phase II was a smaller one- or two-story timber-framed structure measuring nearly 24' by 22'; and Phase III a framed-in link between I and II, 31' deep and 13'6" wide. Phases IV and V enlarged the mill to its present size.

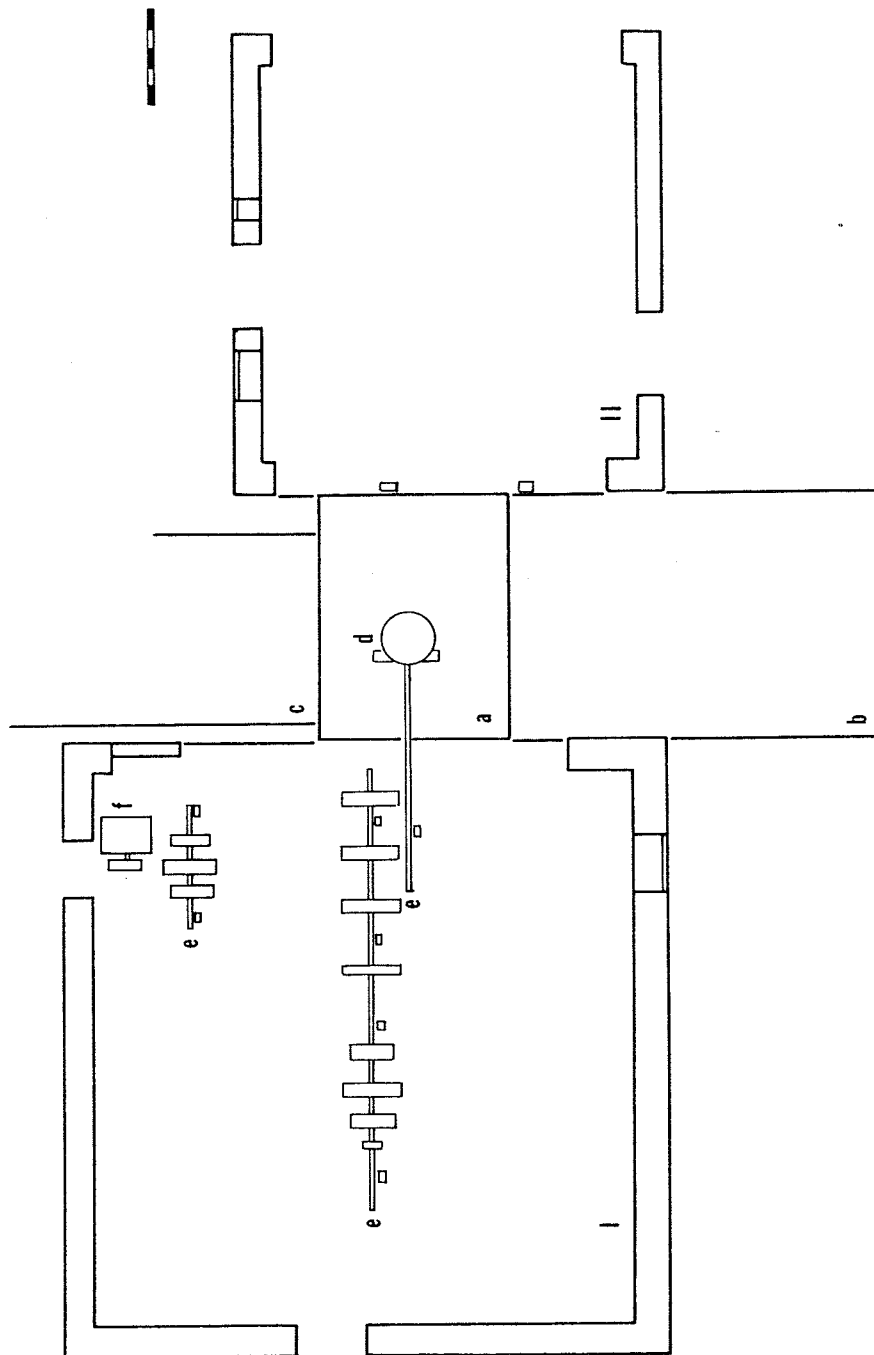
Figure 2: Duck Creek Mill, basement floor plan showing extant drive train and line shafting.

- a. turbine housing
- b. head race
- c. tail race
- d. head gear
- e. line shafting with belt wheels
- f. electric generator

a. Basement level. The basement level of the Duck Creek Mill is banked along the western elevation and straddles the head and tail races where they enter and exit the structure. The first and second phases of the building are defined by common bond brick walls and contain the remnants of the belt drive system of line shafting that conveyed power to all stages of the milling operation. The south gable end of the Phase I basement facing the turbine housing has been removed, and both the north and south gable ends of the Phase II building have been demolished. The mechanical systems surviving in the basement level are described in Section C-6.

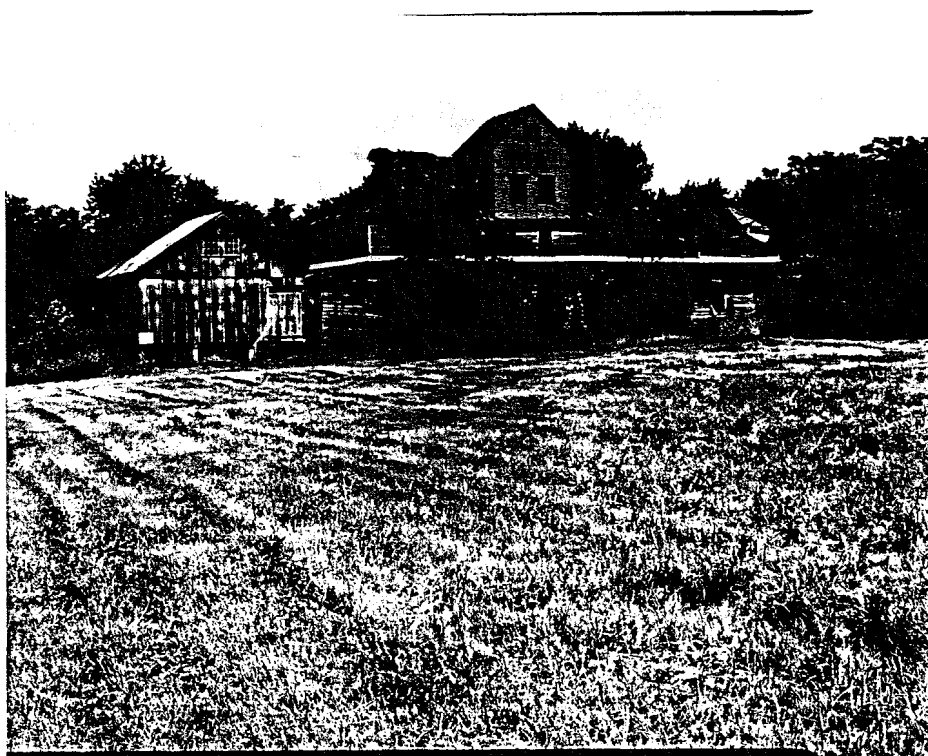
PLATE 1: DUCK CREEK MILL, WEST ELEVATION

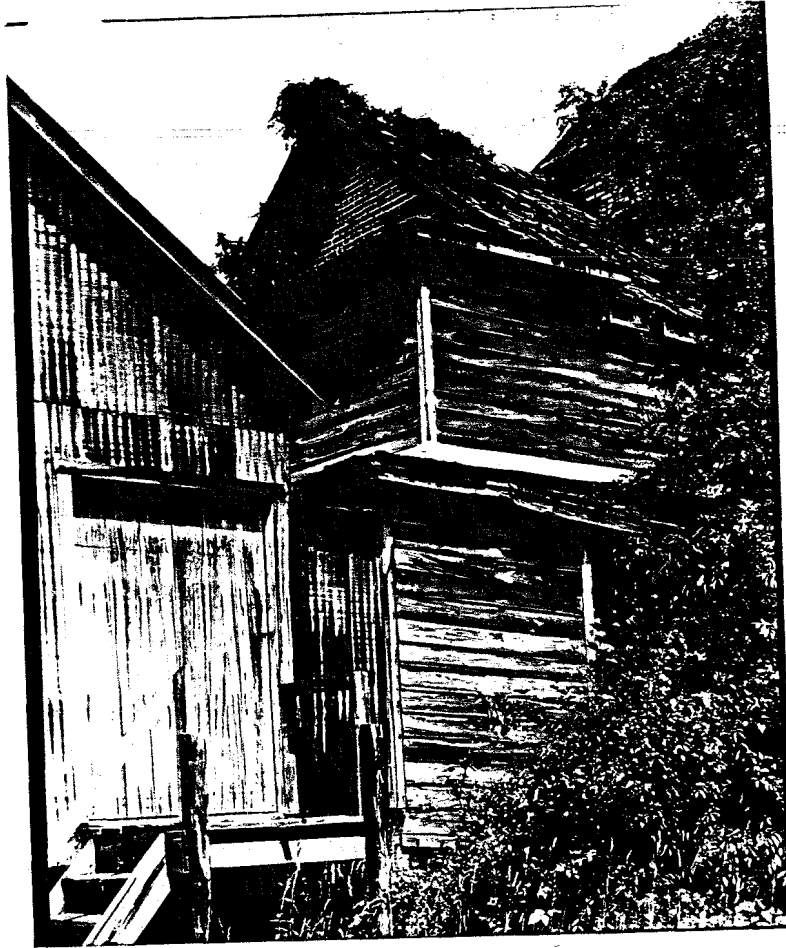
PLATE 2: DUCK CREEK MILL, NORTHWEST ELEVATION

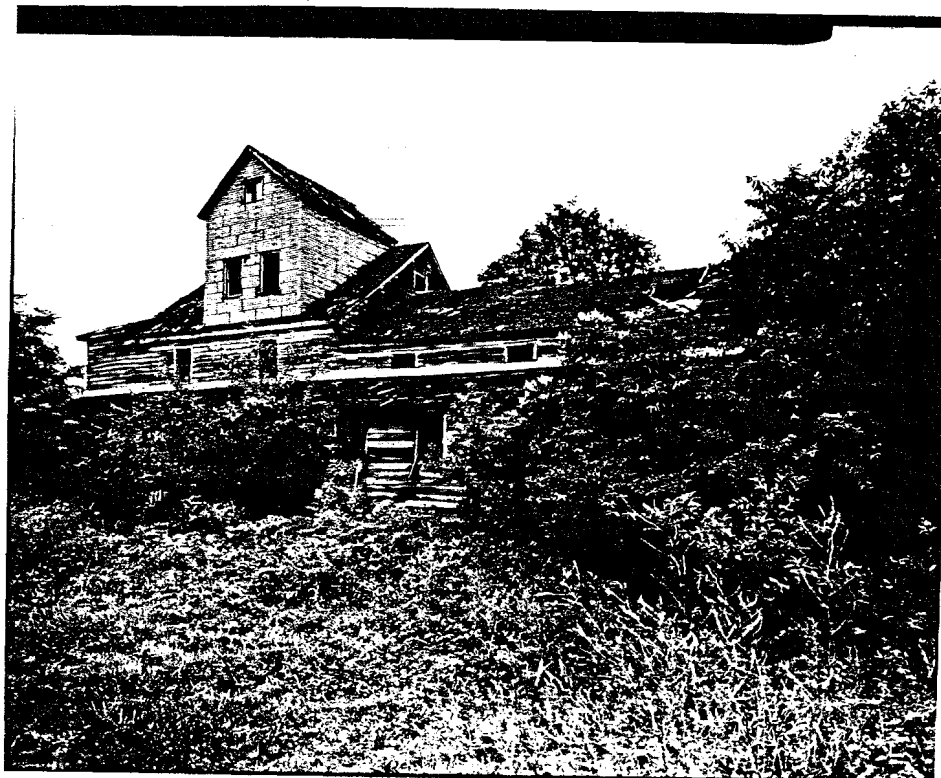
PLATE 3: DUCK CREEK MILL, SOUTHWEST ELEVATION

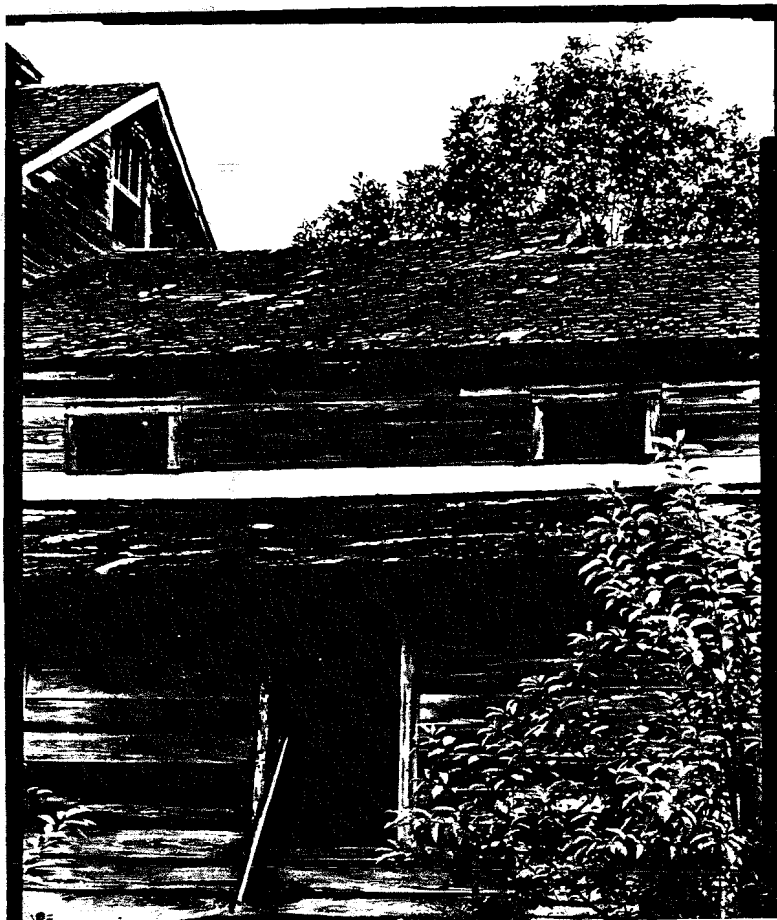
PLATE 4: DUCK CREEK MILL, WEST ELEVATION OF
PHASE III LINK BETWEEN THE EARLIER FREE-STANDING
MILLS (SEE FIGURE 1)

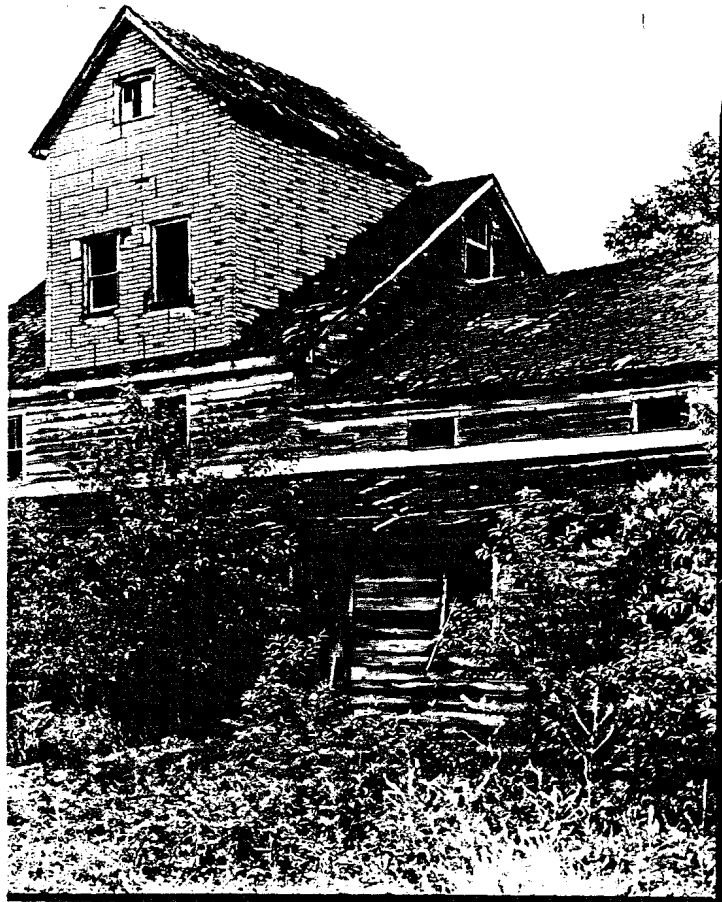
PLATE 5: DUCK CREEK MILL, SOUTHWEST ELEVATION
OF PHASE I STRUCTURE SHOWING TWENTIETH-CENTURY
DORMER WINDOW AND EXTENDED EAVES

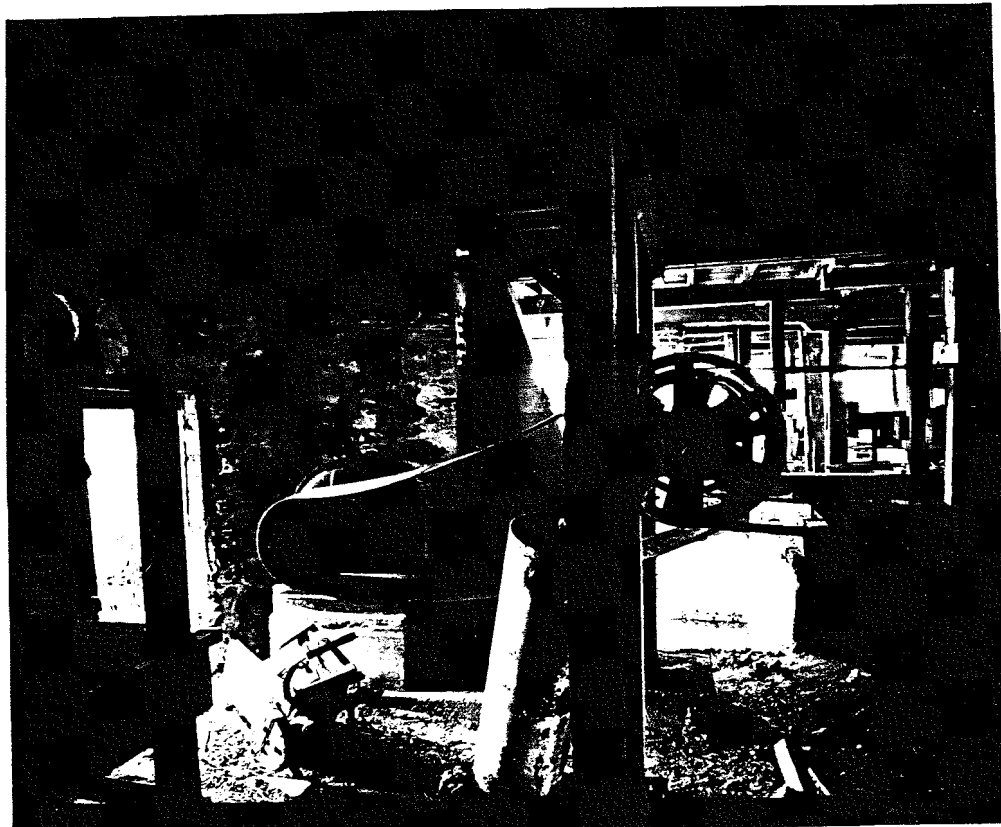
PLATE 8: DUCK CREEK MILL, INTERIOR PHASE I
BASEMENT LEVEL SHOWING BELT DRIVEN ELECTRIC
GENERATOR IN SOUTHEAST CORNER

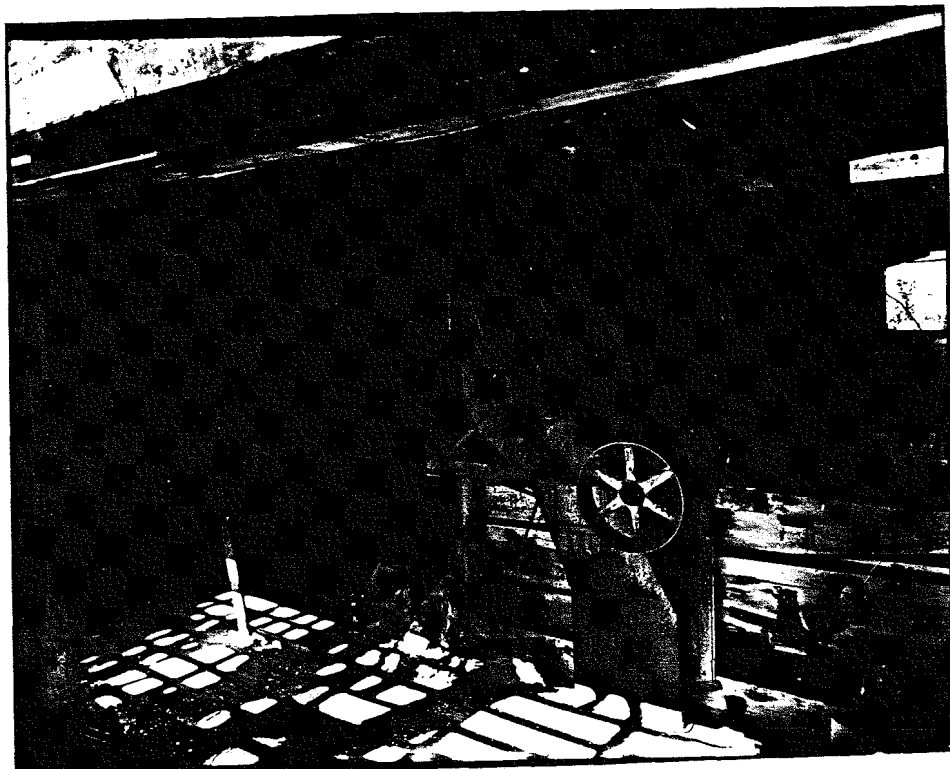
PLATE 9: DUCK CREEK MILL, "WESTERN CORN
SHELLER" AND CORN BIN, INTERIOR FIRST FLOOR
OF PHASE I STRUCTURE

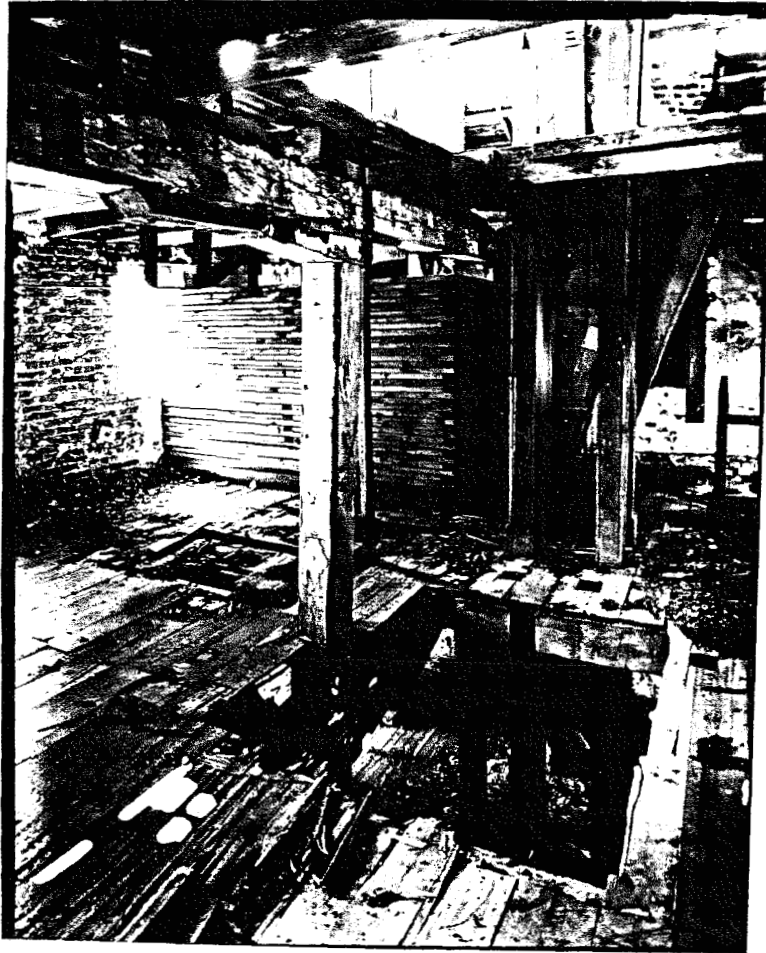
PLATE 10: DUCK CREEK MILL, INTERIOR SECOND FLOOR
OF PHASE I STRUCTURE. NOTE SUMMER BEAM, SANSOM
POST AND PILLOW CONSTRUCTION SUPPORTING THIRD
FLOOR JOISTS AND FLOORING. IN THE BACKGROUND
NOTE THE CORN BIN TO THE LEFT AND BANK OF GRAIN
ELEVATORS TO THE RIGHT

The second floor and cellar framing systems are based in the same structural periods as the first or main floor. On the second floor the joists were mechanically, vertically-sawn 9" by 3-1/2" timbers on approximate 2' centers, with one end bedded in the masonry and the other carried by the summer beam.

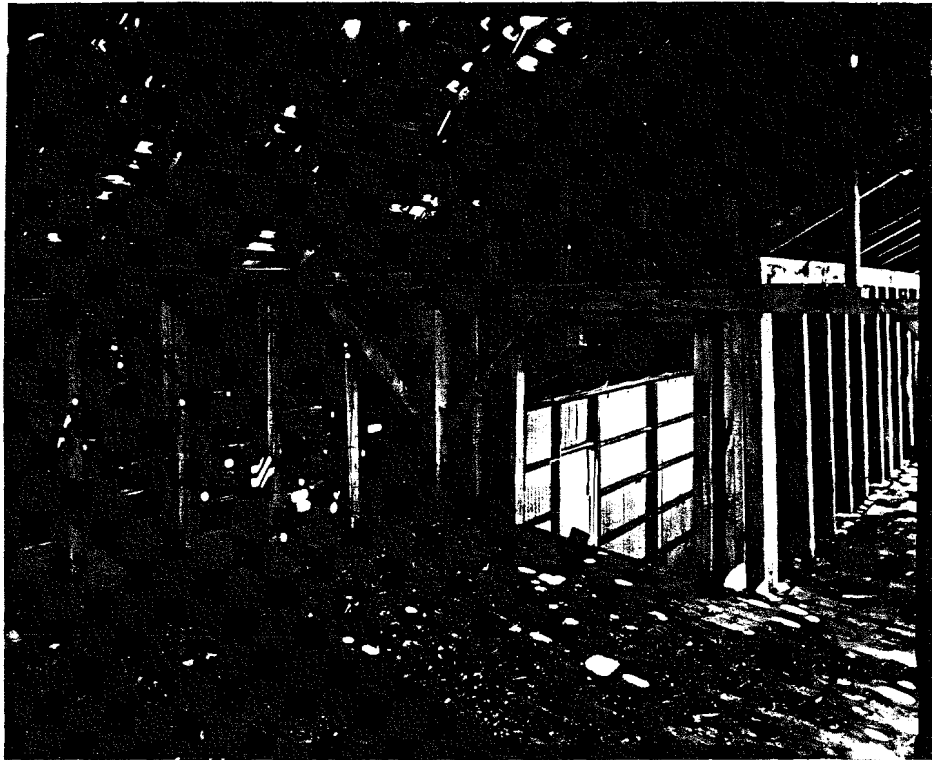
PLATE 11: DUCK CREEK MILL, INTERIOR SECOND FLOOR
OF SOUTHEAST CORNERS OF PHASE II AND III STRUCTURES.
FRAMING IS PRIMARILY OF REUSED TIMBERS REWORKED AT
VARIOUS TIMES THROUGHOUT ITS HISTORY
