MID-ATLANTIC HISTORIC BUILDINGS SURVEY

BELL FARM

Walker School Road, Blackbird Hundred
Taylor's Bridge Vicinity
New Castle County, Delaware

Center for Historic Architecture and Design
University of Delaware
Newark, Delaware
1999

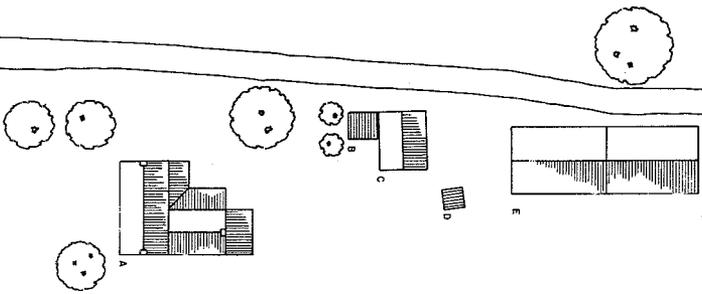
- A HOUSE
 - B SHED
 - C SHED
 - D TOOL SHED (COLLAPSED)
 - E MODERN WASHING SHED
- SCALE 1"=20'
-

There are four outbuildings on the property, three small frame sheds and a modern machine shed. They are arranged along the north side of the farm lane, west of the dwelling.
