**A CASE STUDY:
THE IMPACT OF THE 1962 NORTHEASTER
ON DELAWARE'S ATLANTIC COASTLINE**

A thesis submitted to the Faculty of the University of Delaware in partial fulfillment of the requirements for the degree of Master of Science in Geological Sciences.

Fall 2009

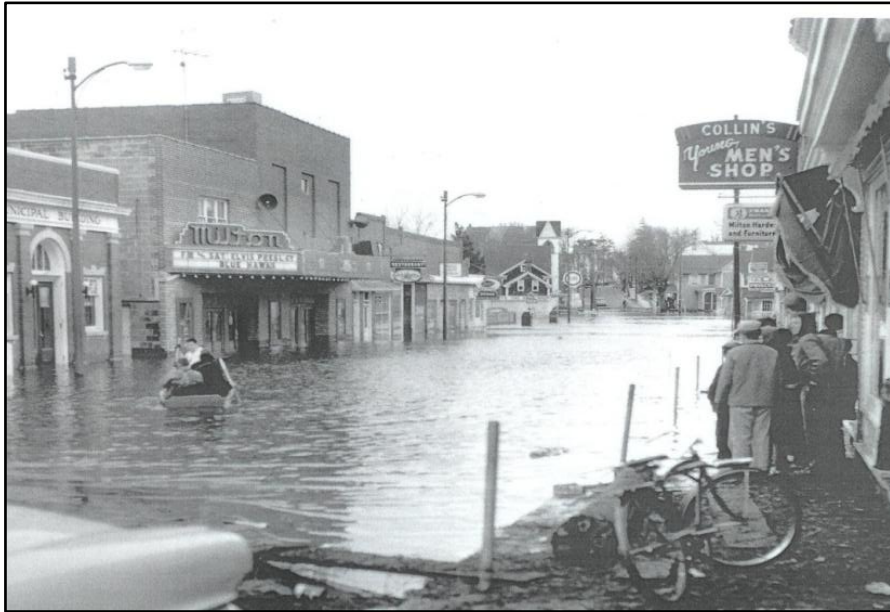
Figure 1.6 Flooding in Milton, DE. Even in towns as far as 11 km from the coastline flooding occurred during the 1962 Northeaster. Areas close to tidally influenced streams and inlets were greatly affected by the storm (Photograph courtesy of the Delaware State Archives).

The next day, the low pressure system associated with the storm stalled off the Mid-Atlantic Coast (Oates: Carey, 2007). This brought stalling conditions to the Delaware beach area. As each consecutive tidal cycle passed, the storm surge level amplified, reaching a maximum of 2.9 m (9.5 ft) above mean sea level (Carey & Dalrymple, 2003). As the water continued to rise and waves reached further across the barriers and beaches, dune systems began to fail and ocean waters began to meet waters of the Inland Bays along almost every stretch of Delaware's barrier islands (Oates: Carey, 2007). Even towns off the coast, such as Milton and Millsboro experienced extreme flooding due to the rising of tidally influenced tributaries (Figure 1.6).

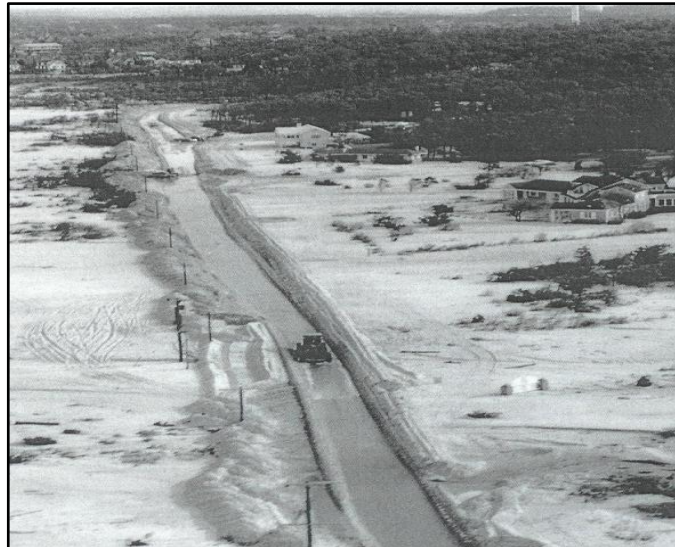
Figure 1.8 Recovery Operations. When waters receded, sand was removed from the streets, yards, and homes and placed back onto the beach for renourishment. No outside sources of sediment were necessary (Photograph courtesy of the Delaware State Archives).

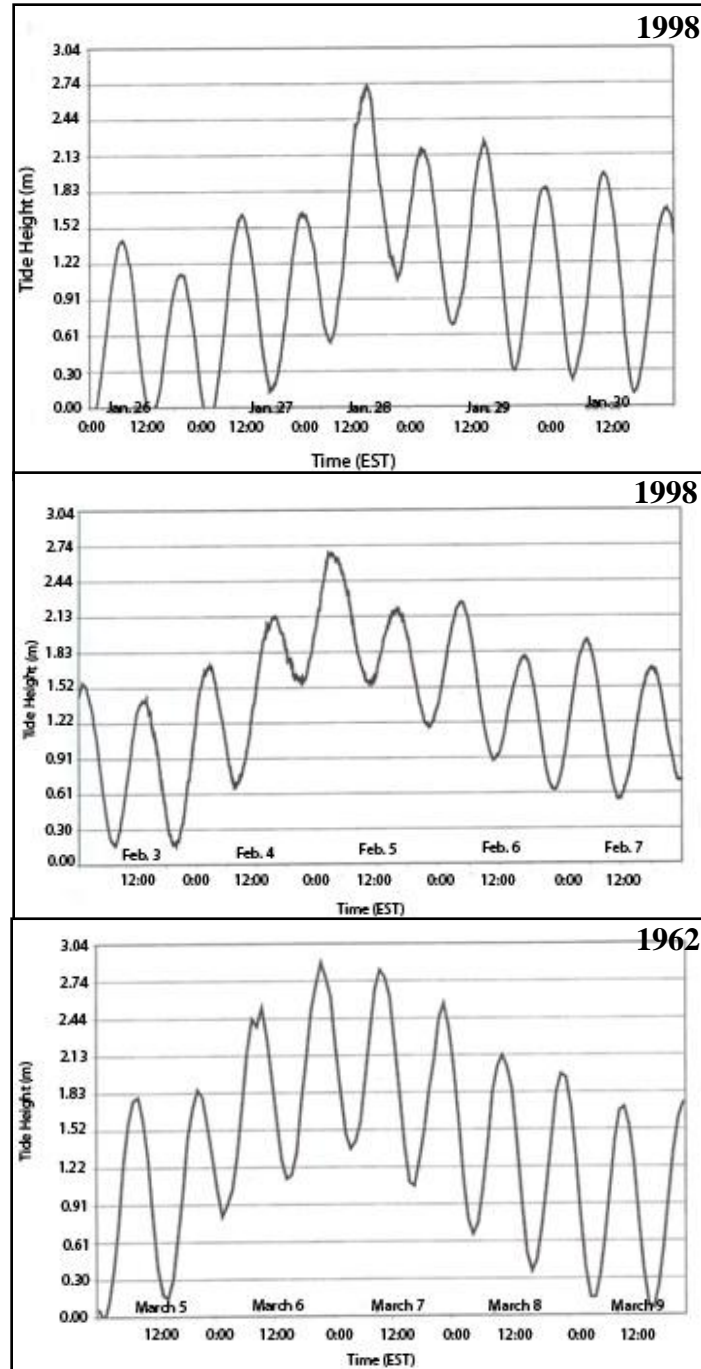
Figure 1.10 Storm Tidal Levels for the 1998 Coastal Storms and the 1962 Northeaster. Jan. 26-30, 1998; Feb. 3-7, 1998; Mar. 5-9, 1962. Levels based on MLLW datum at Lewes, DE tidal gauge (Ramsey et al., 1998). Note: Scale was modified to be shown in meters.

Another set of large storm events that affected Delaware was a set of coastal storms occurring through January 27-29 and February 4-6, 1998. As shown in Figure 1.10, the highest observed storm tide levels measured in Lewes, DE occurred on January 26th at approximately 2.7 m, and February 5th at just under 2.6 m (Ramsey et al., 1998). These levels are not as high as the tidal levels recorded during the 1962 Northeaster, where the height exceeded 2.9 m (9.5 ft) (Figure 1.10). The coastal damage from these storms was due mostly to flooding and high winds, but there was also some dune and

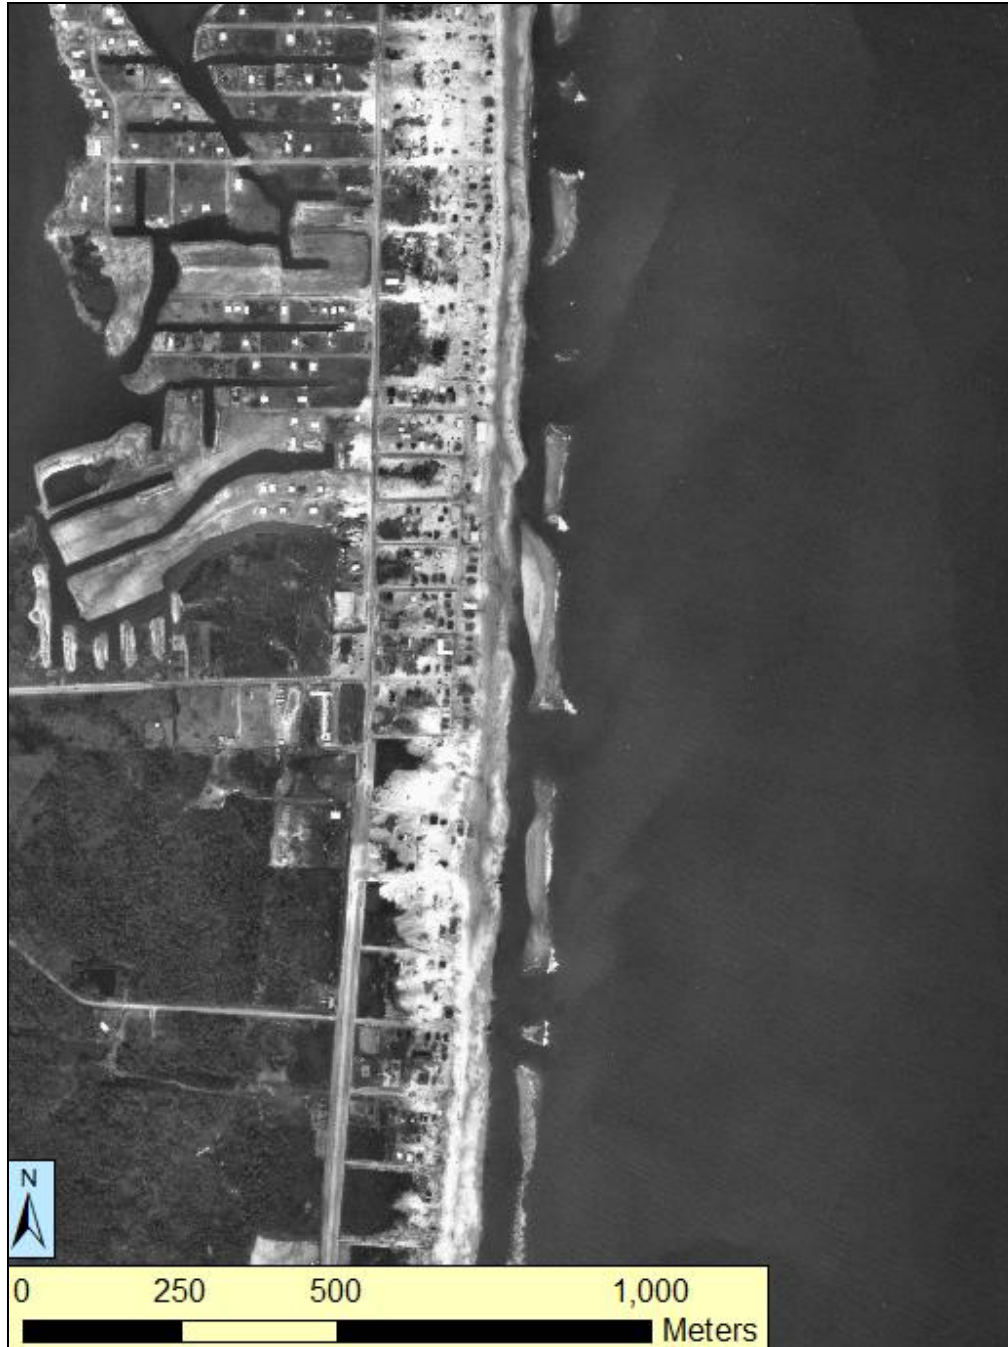
Figure 3.6 Double Bar Feature (Zone 12). This photograph shows more closely the apparent double-bar feature that occurred due to the northeaster in the area of Fenwick Island. Notice the “islands” of sand that will eventually become re-attached to the coastline.

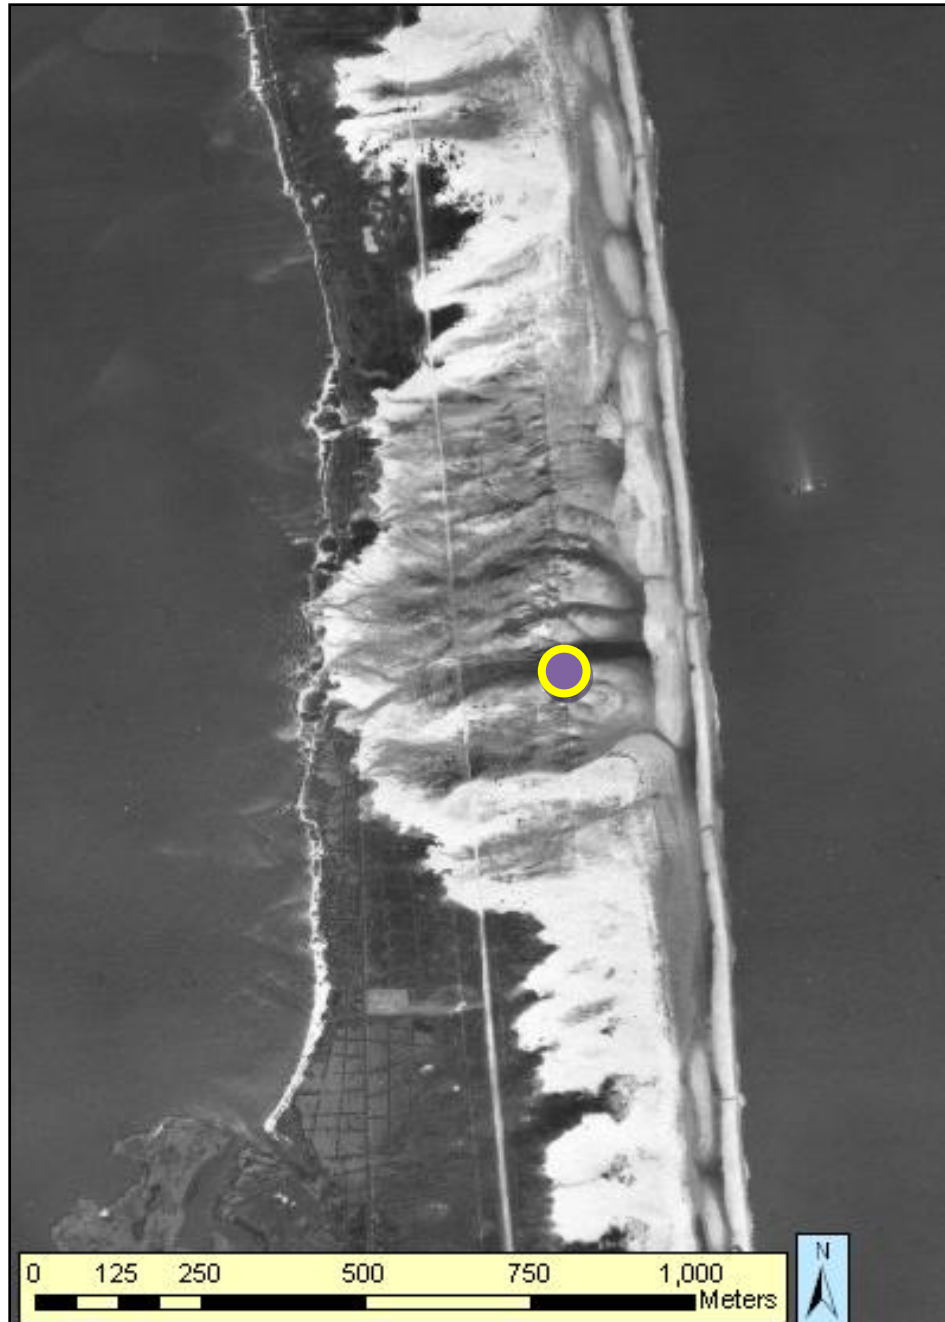
Figure 3.13 1962 Aerial Photograph of the Overwash Area. Shows the area south of Bethany Beach, 7 days after the 1962 Northeaster went through the area. The purple dot shows where the structure was. Not only does the overwash breach the island, but the ocean almost meets the bay, and probably did during the storm.

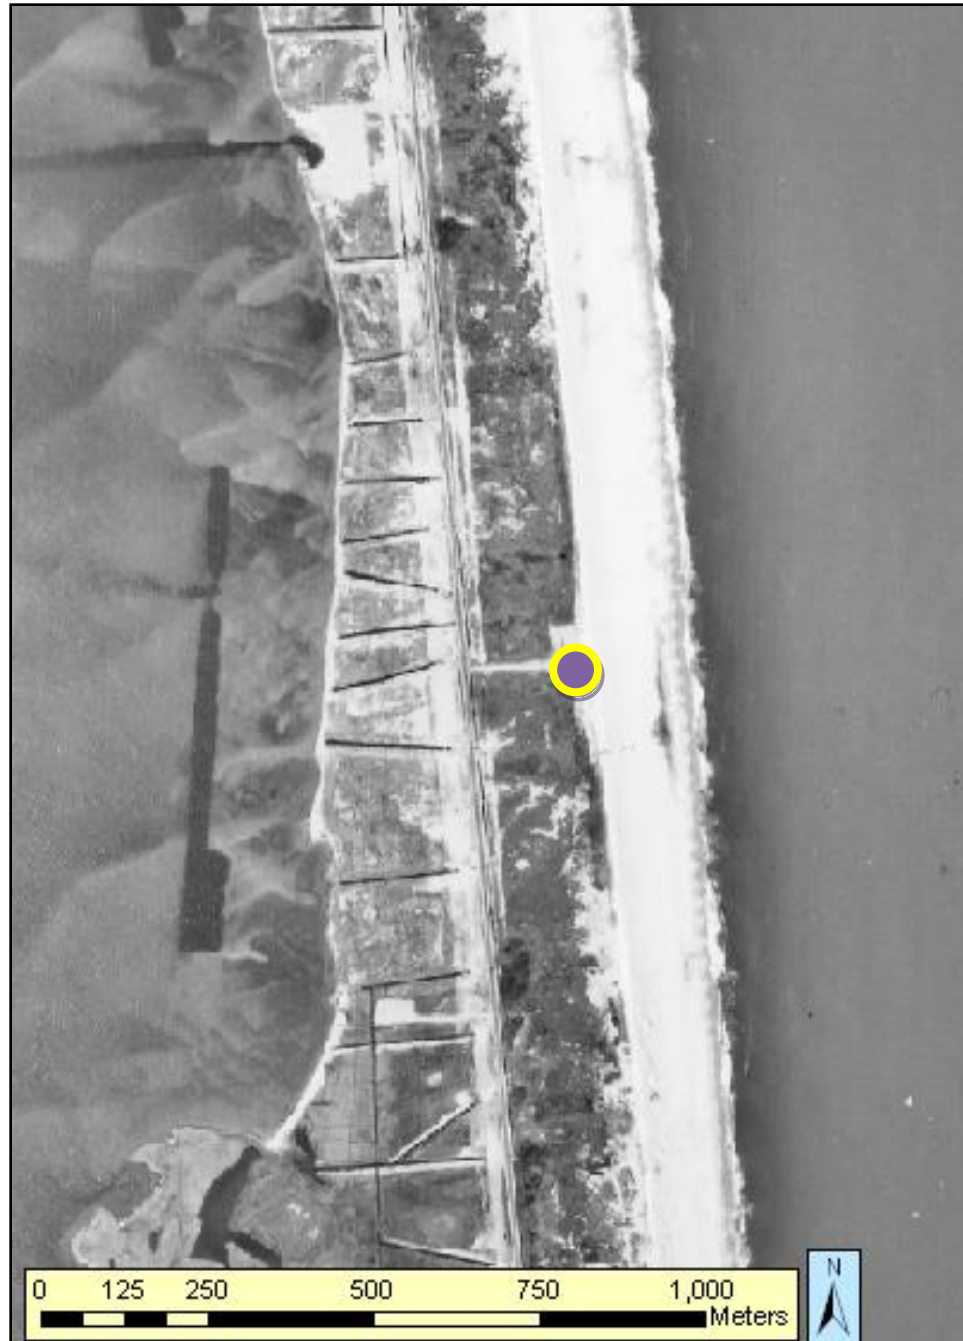
Figure 3.14 1968 Aerial Photograph of the Overwash Area. Shows the same portion of the shoreline in 1968. There doesn't appear to be any permanent scarring from the 1962 northeaster. Mosquito channels can be seen on the back side of the barrier.

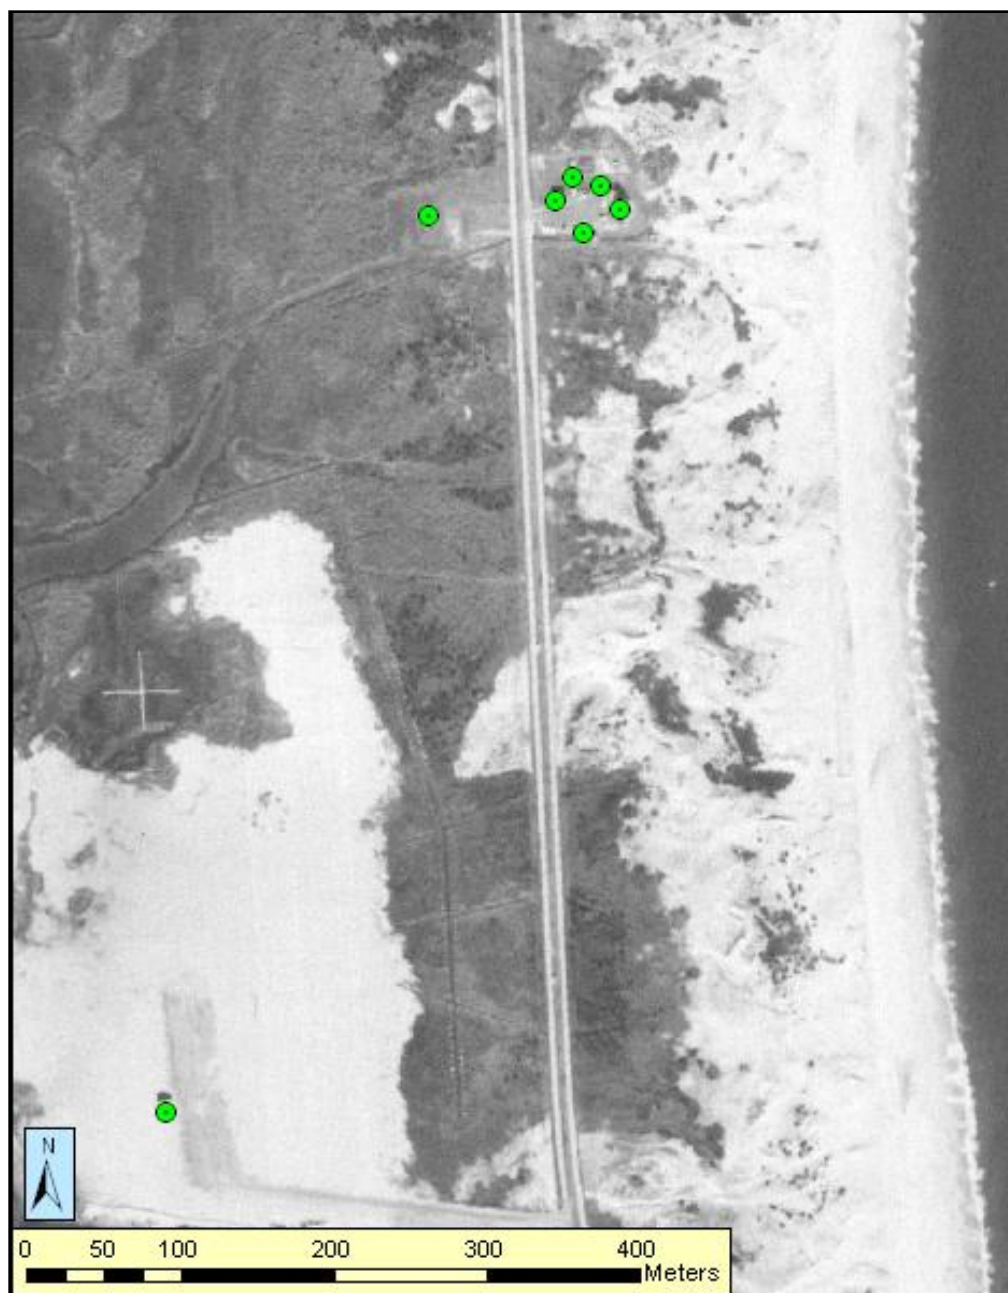
Figure 3.19 Location 2; 1960 Aerial Photograph of 1960 Buildings. The green dots show the preexisting buildings in this 1960 photograph. This locale is south of Location 1, and just north of Indian River Inlet.

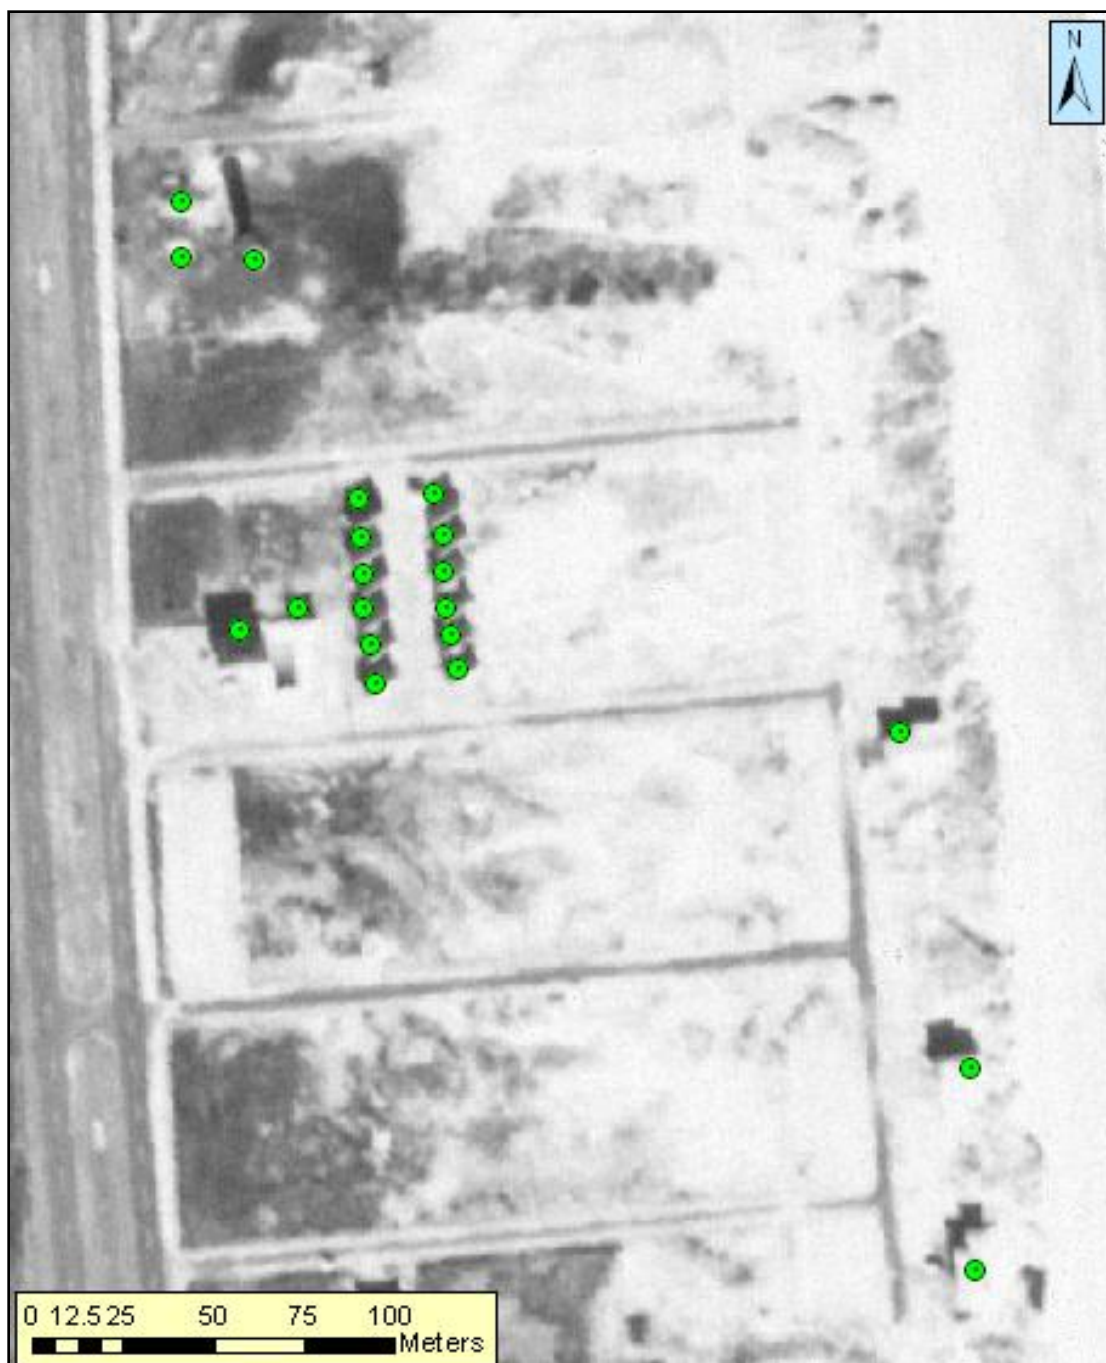
Figure 3.21 Location 3; 1960 Aerial Photograph of 1960 Buildings. The green dots show the buildings in this 1960 photograph. This locale is just south of Indian River Inlet.

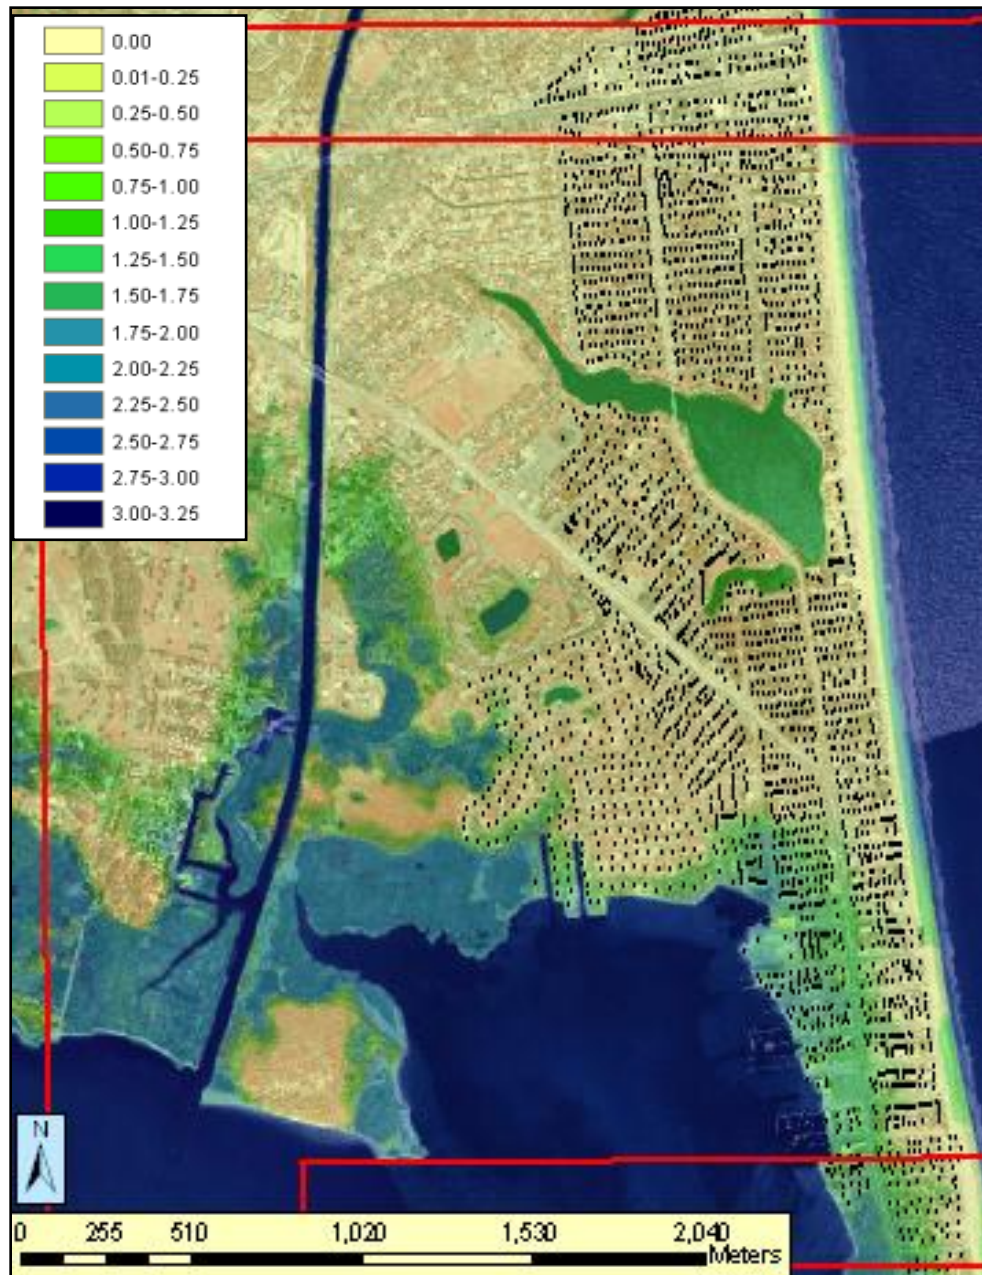
Figure 3.30 Zone 4 LiDAR Inundation Levels. Shows the depth of inundation of the modern shoreline due to a 2.01 m storm surge under conditions similar to those created by the 1962 Northeaster. The black points are the existing buildings and structures. The scale is shown in meters.

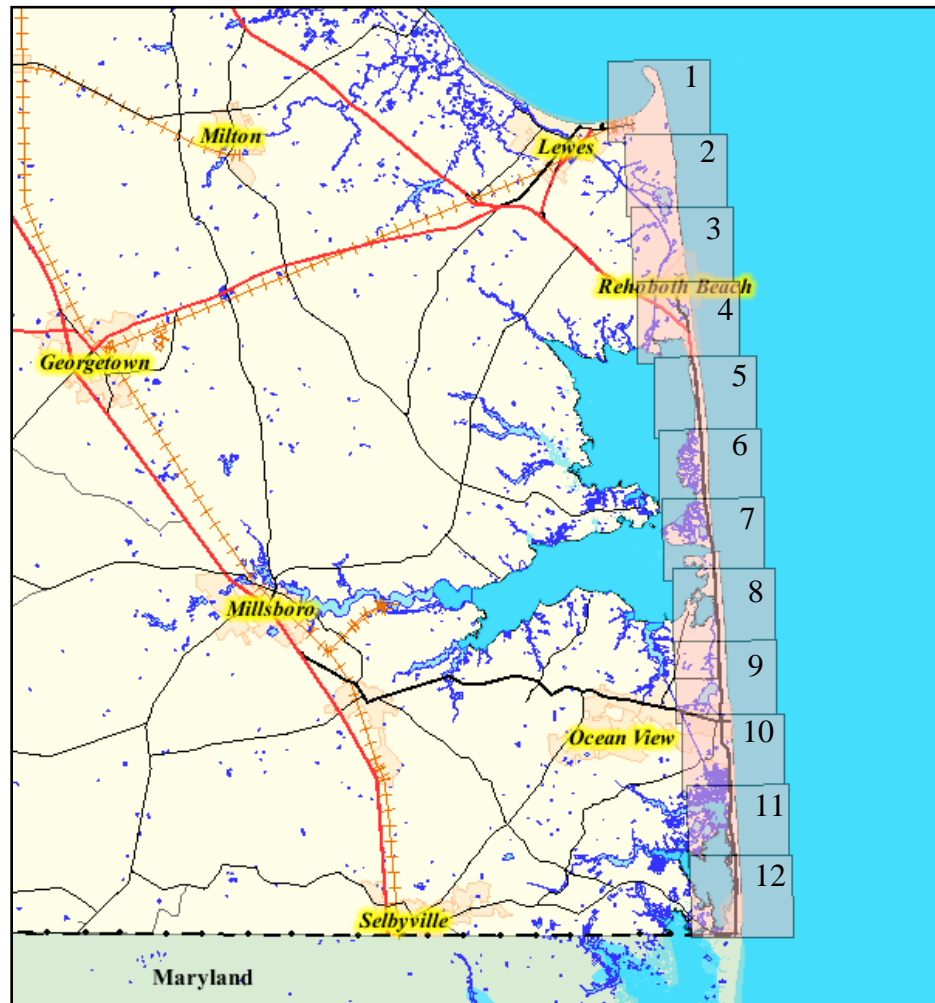
Figure AA.1 Zones of the Study Area. The study area divided into 12 zones so that changes in shoreline, overwash, and building destruction can be seen and compared.

This appendix contains all digitized shorelines, separated by Zones. The Zone map is also included for reference. Shorelines are superimposed upon the 1962 aerial photographs, and was done so that the damage caused by the storm can be seen and compared to the pre- and post-storm shorelines. Each shoreline is represented by a different color, which is included in the figures. Methods for georeferencing the aerial photographs and digitizing the shorelines are outlined in detail in Chapter 2 of this document. Some of the shoreline segments are discussed in further detail in Chapter 3 of this document.

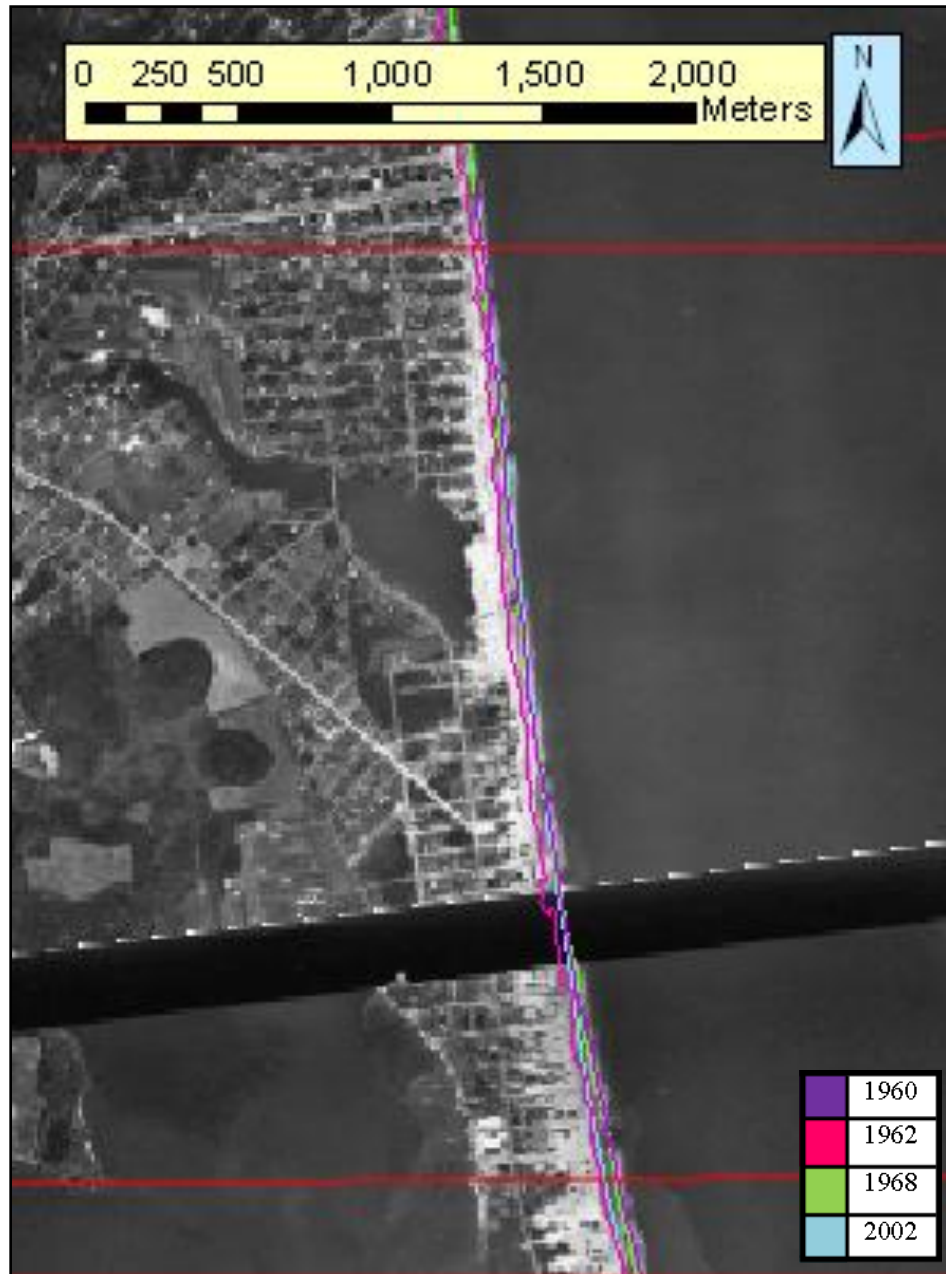
Figure AA.5 Shorelines, Zone 4. Shows the shorelines of Zone 4. As shown by this image, there are no significant anomalies in the 1962 shoreline, although as seen here, the shoreline is still significantly more eroded than the other shorelines. The shoreline rebounded almost completely by 1968.

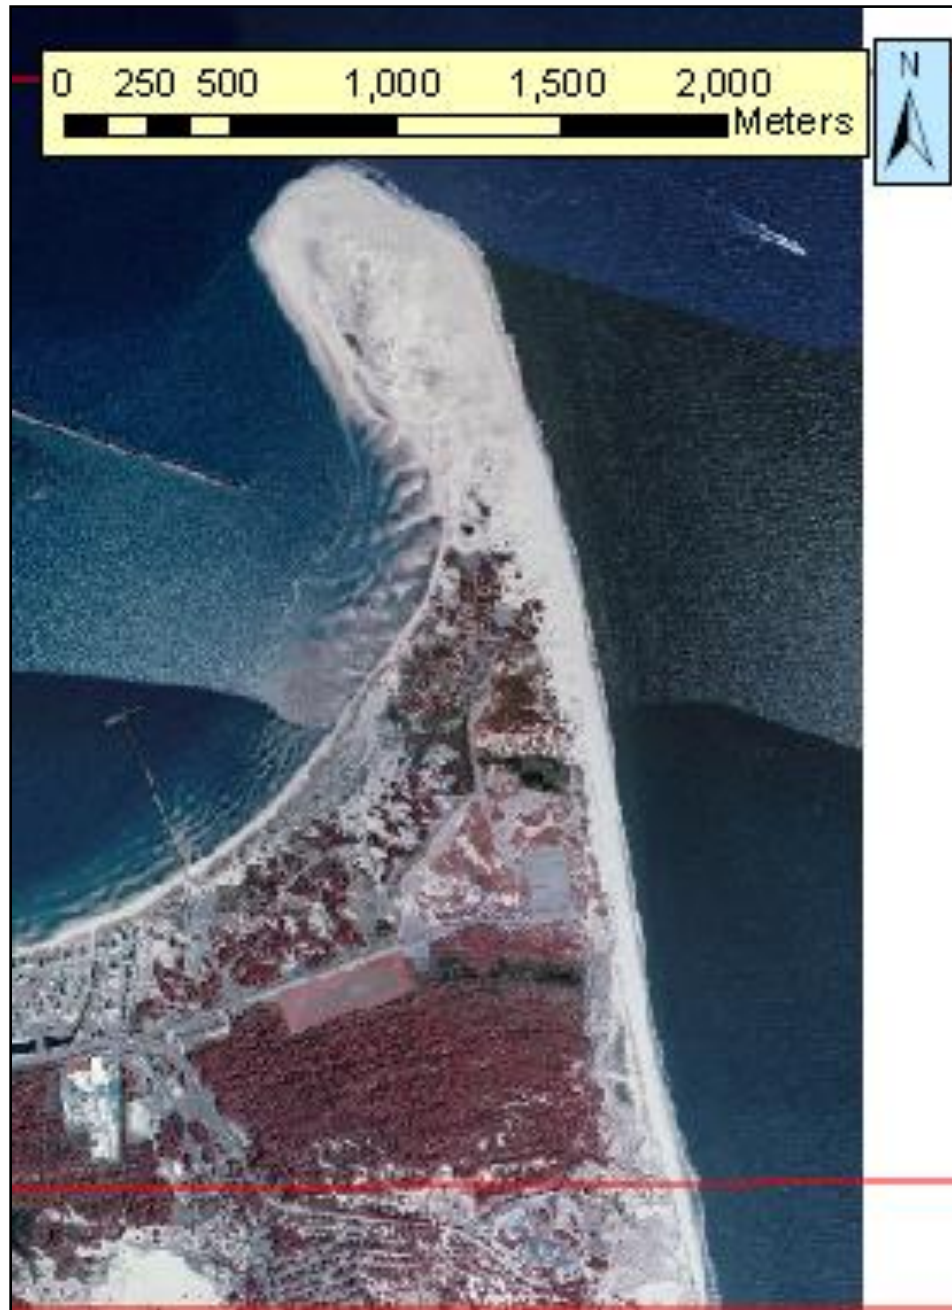
Figure AB.1 Overwash, Zone 1. Shows the Overwash of Zone 1. The overwash is not digitized here, because this area is constantly sandy, and it is difficult to determine where the overwash fans are, if there are any. It doesn't appear that there really are any areas of overwash here.

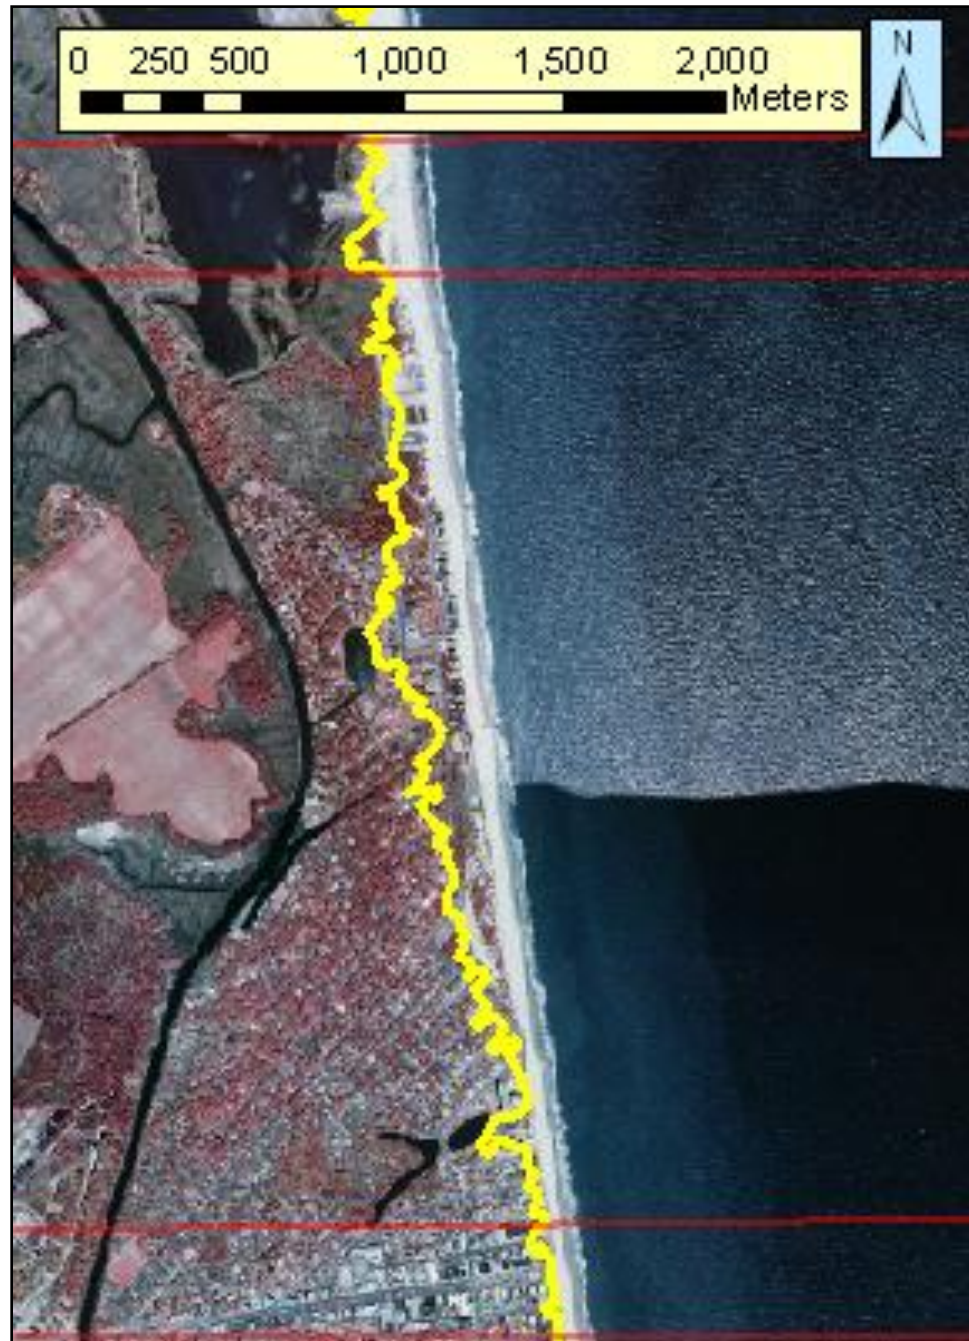
Figure AB.3 Overwash, Zone 3. Shows the Overwash of Zone 3. Overwash for 1960 begins at the very bottom of this image. As this image shows, the 1962 overwash covered a significant part of this shoreline.

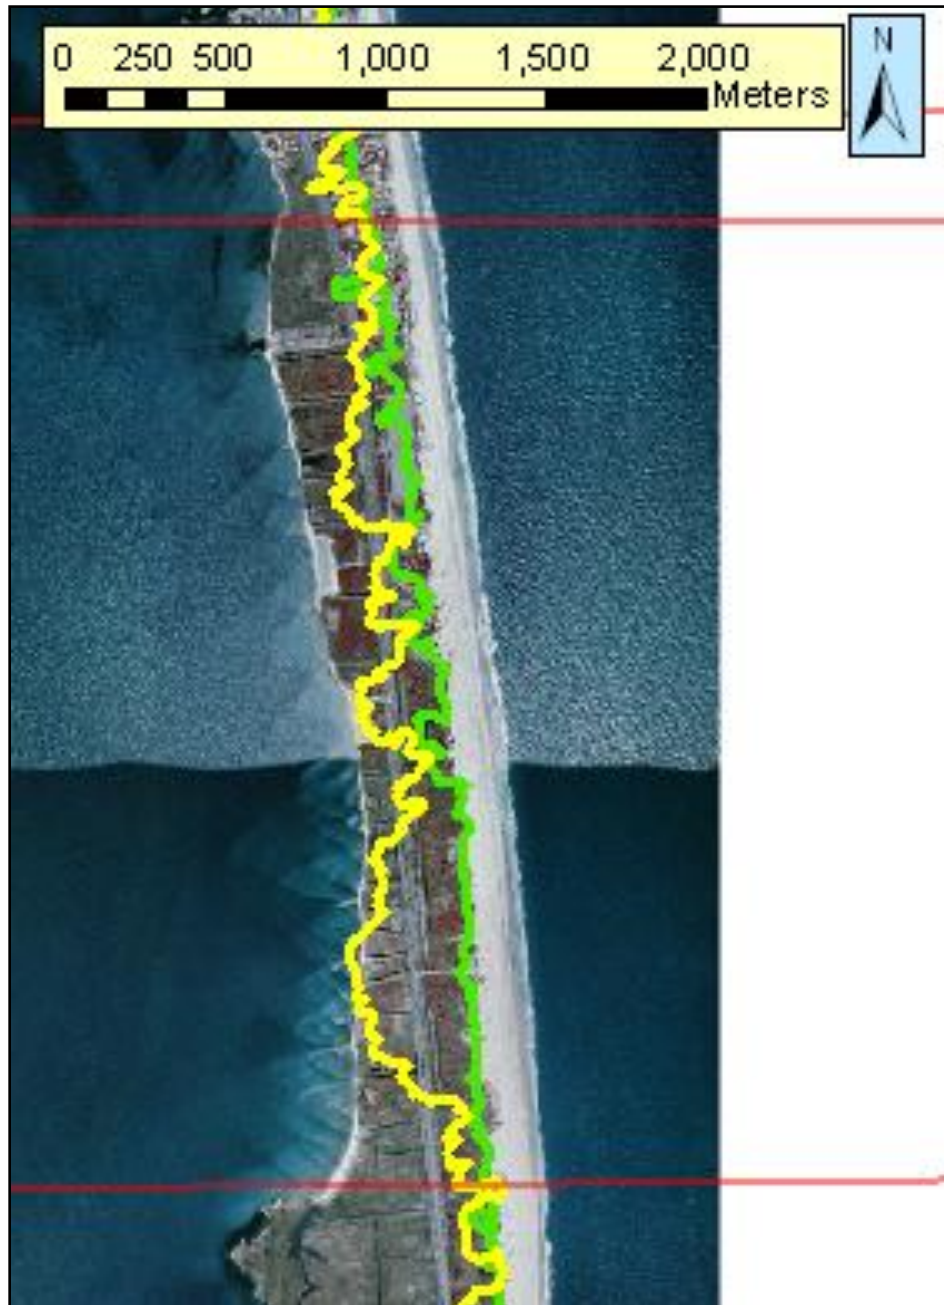
Figure AB.5 Overwash, Zone 5. Shows the Overwash of Zone 5. This image shows significant overwash due to the northeaster. It washes completely over the barrier.

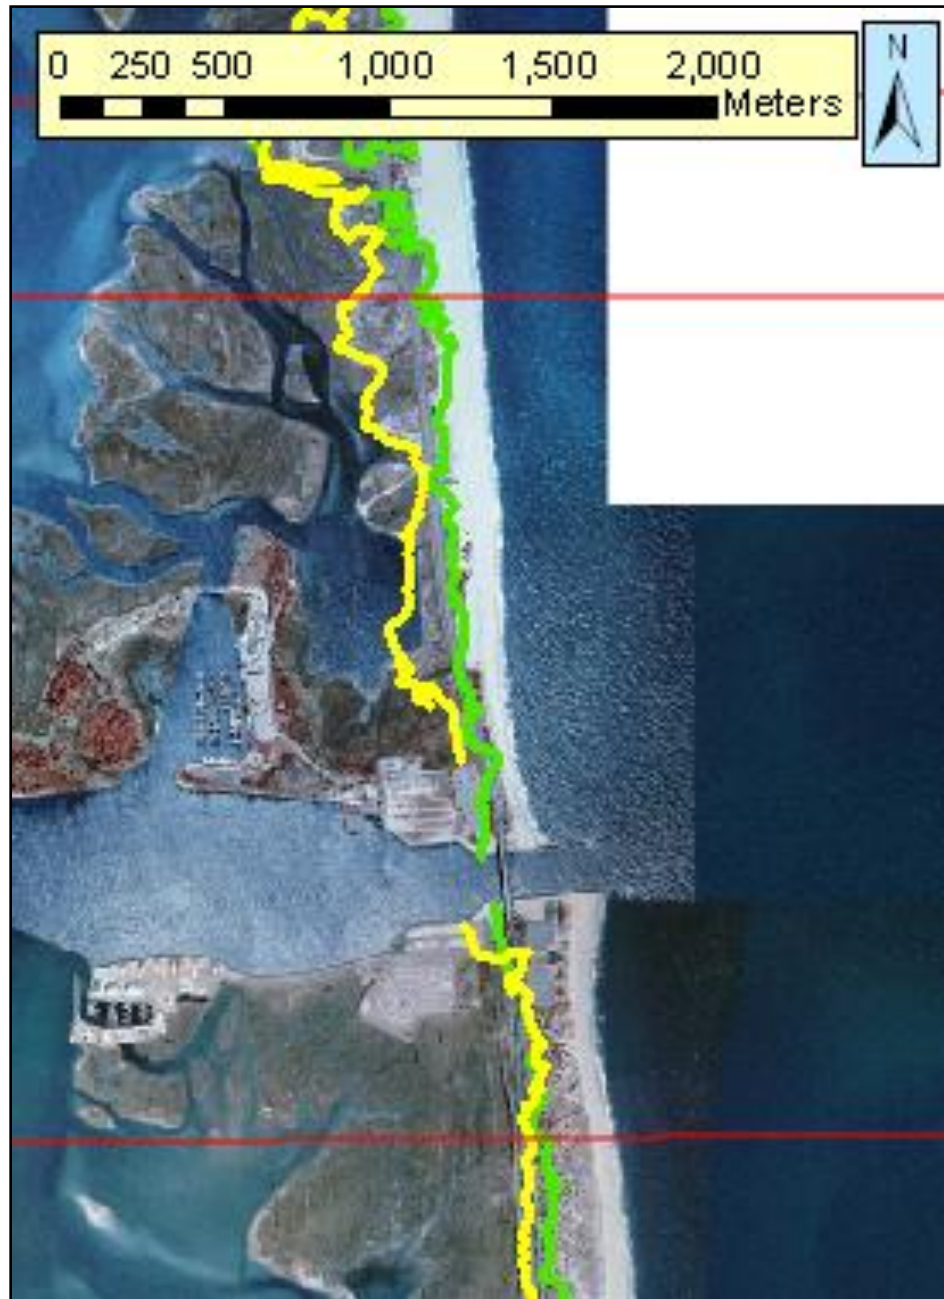
Figure AB.7 Overflow, Zone 7. Shows the Overflow of Zone 7 Again, overflow here breaches the barrier and meets the back-barrier marsh.

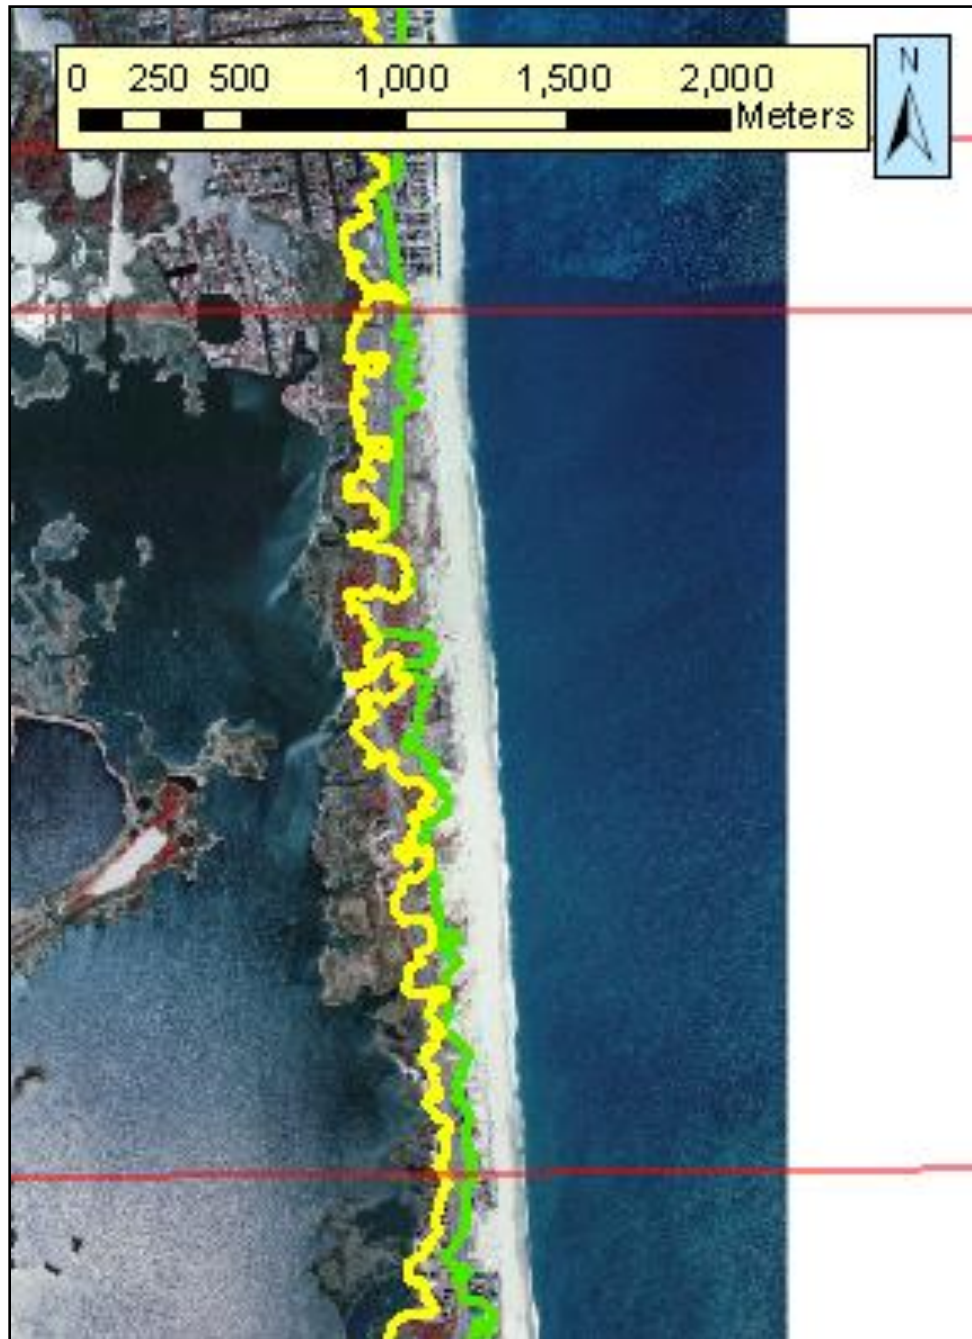
Figure AB.11 Overwash, Zone 11. Shows the Overwash of Zone 11. As in many of the other images, here, overwash covers most of the island, as well as the highway, Rt. 1.

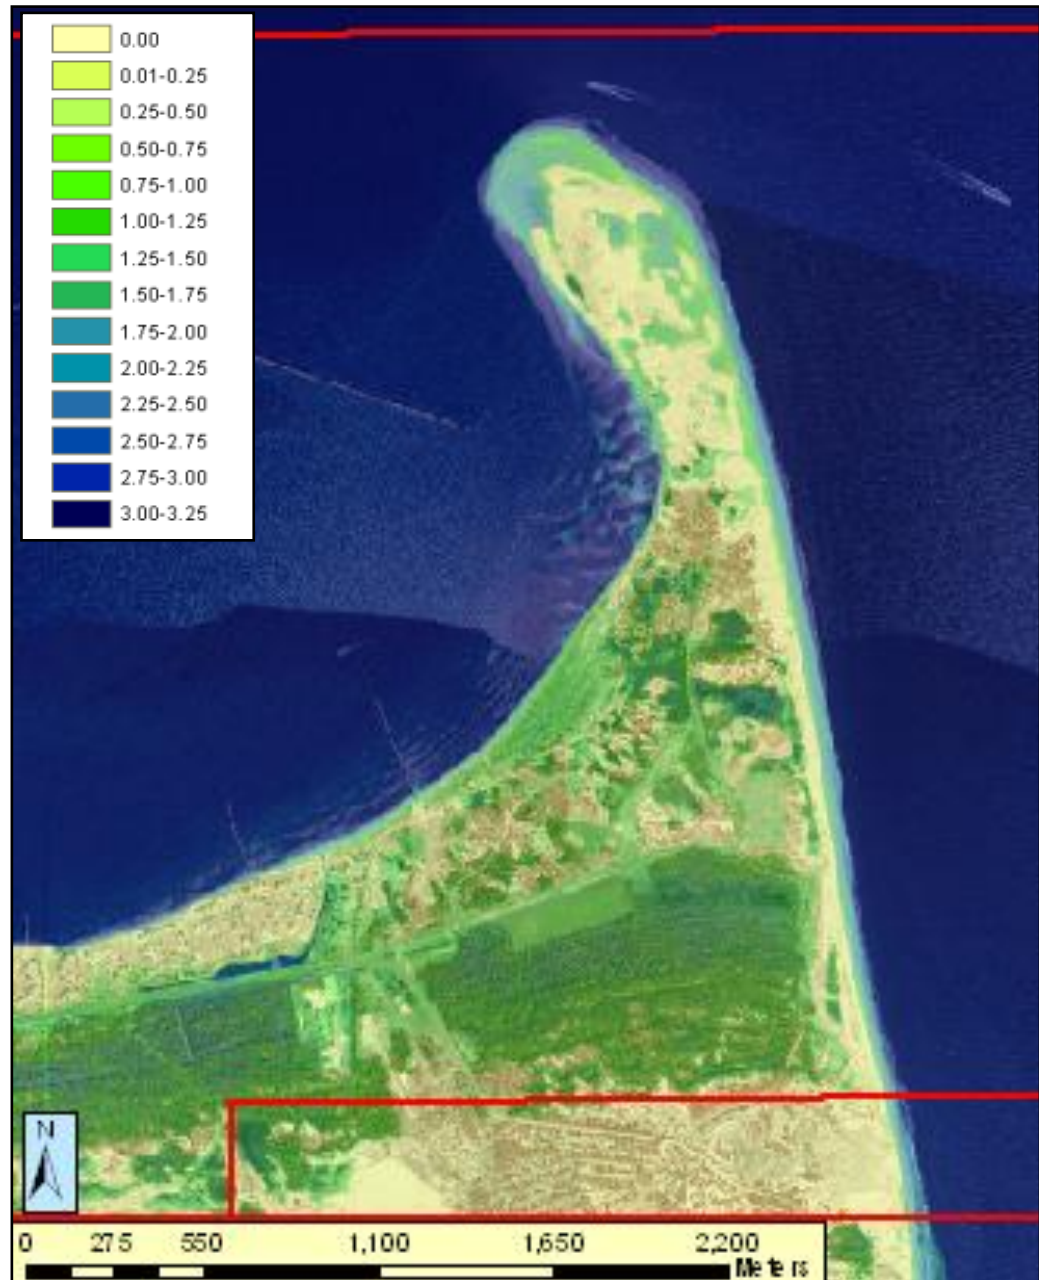
Figure AC.1 LiDAR Inundation, Zone 1. Shows the depth of inundation for Zone 1. As shown by this image, there is a large linear area, just above the scale and perpendicular to the beach that is not inundated. This is the Great Dune at Cape Henlopen State Park. The scale is shown in meters.

This appendix is comprised of LiDAR images of the inundation of Delaware's coastline. LiDAR images were set to be approximately 50% transparent, and overlain on the modern, 2002 shoreline of Delaware, for comparison. The color ramp is meant to show the depth of inundation across the shoreline when a 2.9 m storm surge level is applied. As these images show, there is very little of the populated shoreline that is not inundated with water. As mentioned before in this study, when a 6-9 m average wave height is included, the dune areas that appear not to be inundated in these images would be destroyed and flooded, leaving back-dune areas vulnerable just as in the 1962 Northeaster. Several of these images have been described in this paper previously.
