**ASSESSMENT OF LONG TERM HOUSING RECOVERY AFTER  
HURRICANE SANDY**

A thesis submitted to the Faculty of the University of Delaware in partial fulfillment of the requirements for the degree of Master of Science in Disaster Science and Management

Spring 2015

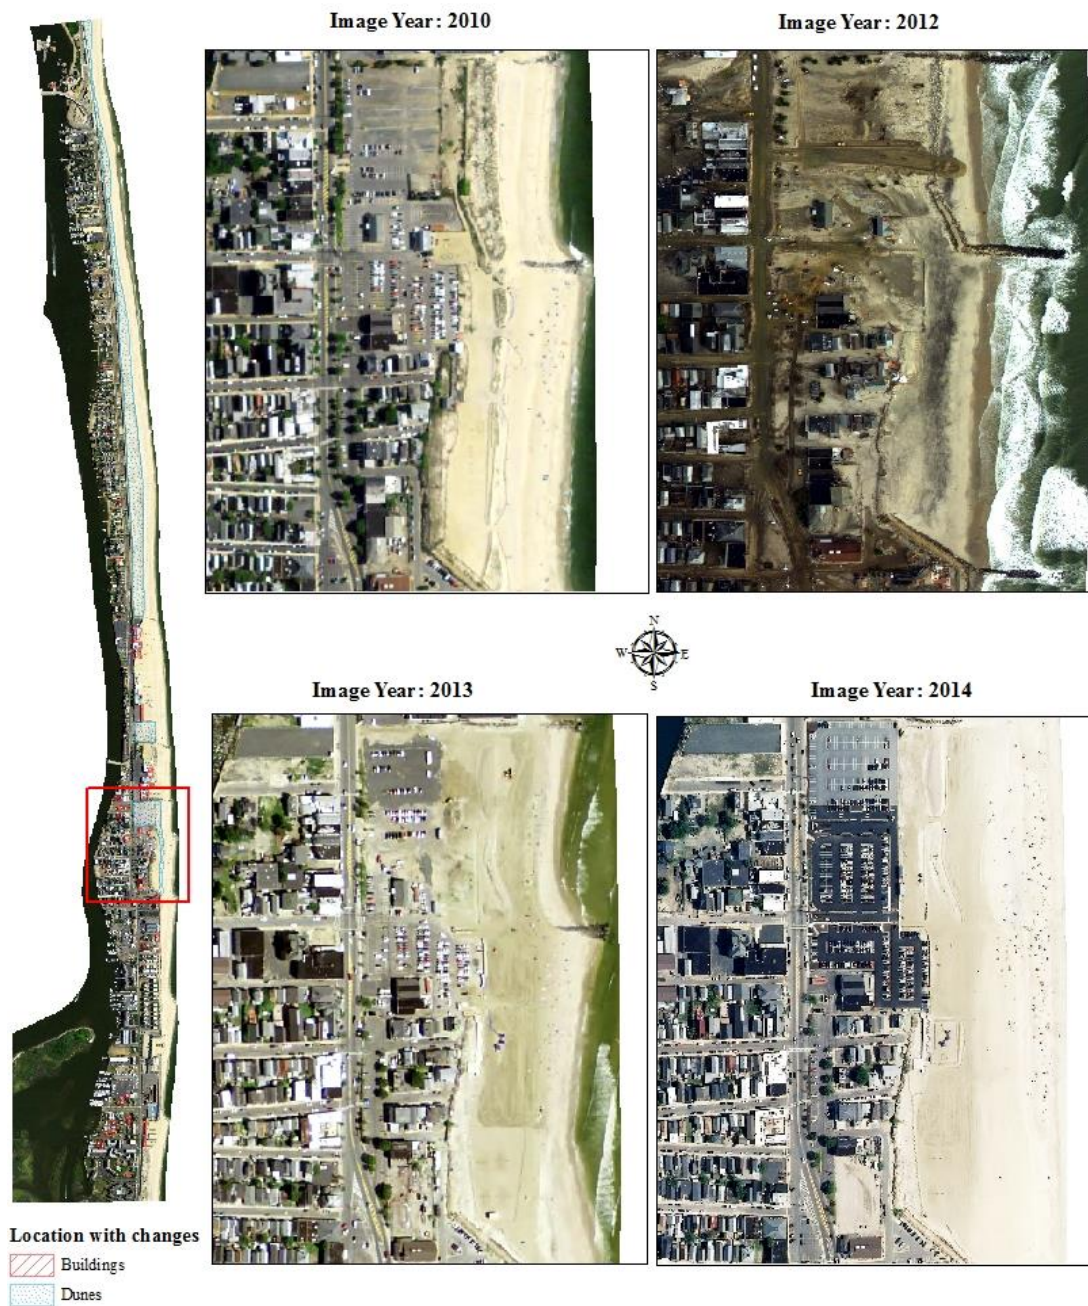
From imagery the change in natural features like continuation of sandy dunes could be identified clearly. However, in the case of buildings, the difference could only be detected if the property was fully destroyed or demolished for rebuilding and after the space has been occupied again in the observed time interval. In the case of the sandy dunes that protect Sea Bright naturally, it is found that in Hurricane Sandy the dunes had been damaged in several places, which had not been repaired until 2014. Figure 4.7 shows a snap shot of this situation.

Figure 4.7: Condition of natural features (dunes) after Hurricane Sandy over years.

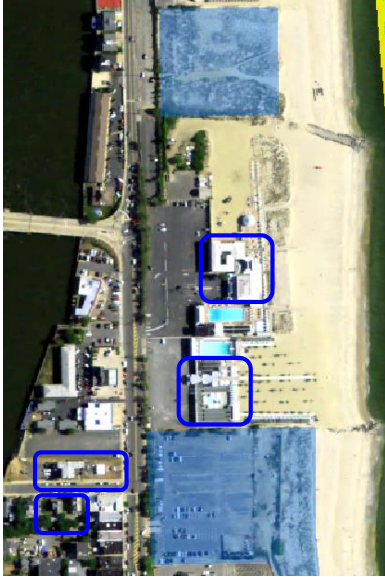
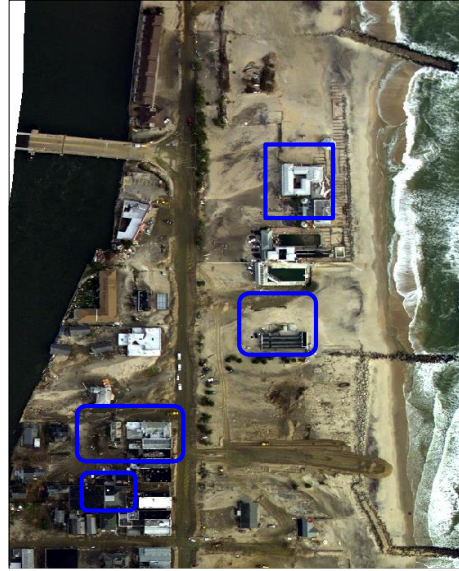
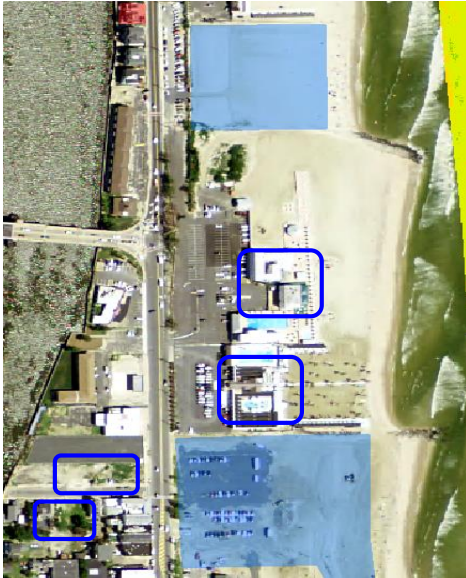
Figure 4.10: Change detection in building structures in pre and post Hurricane Sandy using LiDAR data.

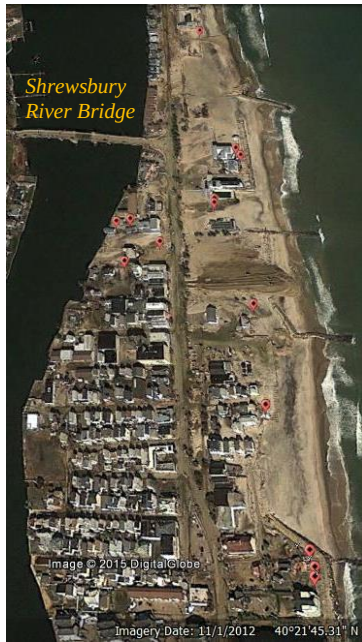
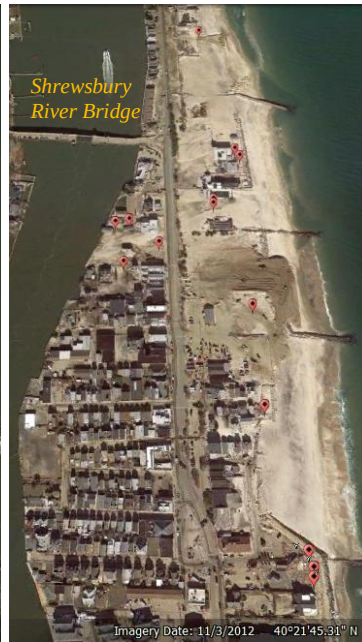
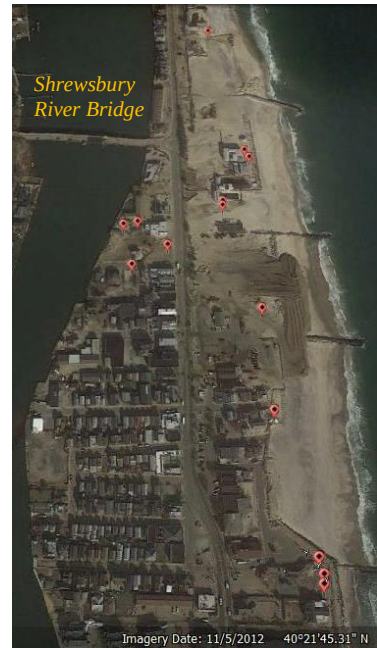
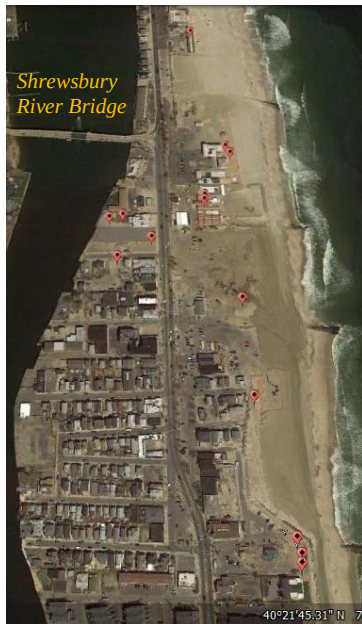
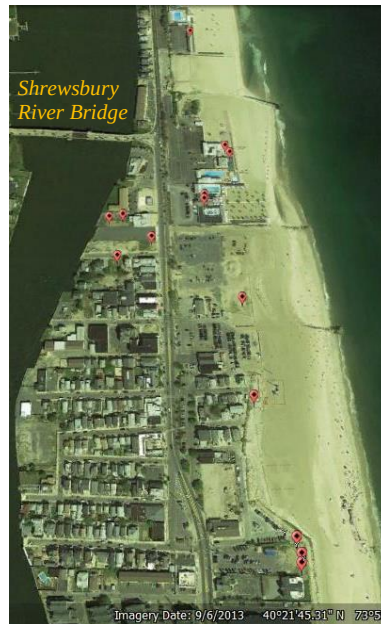
Comparing the recovery among the damaged properties it has been found that the destroyed properties are experiencing slow recovery; although this observation is based on a small sample only one destroyed plot out of three reported in the survey had completed repair. While from the satellite images from Google Earth in different time periods, it has seen that up to April 24, 2014, seven plots out of 18 destroyed plots are in use (i.e. 38.89%), the remaining are vacant with no use. Figure 4.13 shows the trend line with percentage of recovery progress over total destroyed structures considering the use of the land and also the bar shows the number of plots vacant after being destroyed in Hurricane Sandy.

Figure 4.12: Google Earth images in several time to visually detect land use changes in destroyed plots.
