Site Name: John Barber House

CRS Number: K-0000

Type of Documentation: Level II: Partial Intensive
Annotated field notes (2 sheets)
Measured drawings-CAD (1 sheet)
Black and white 4" x 5" photographs (6)
Architectural data narrative

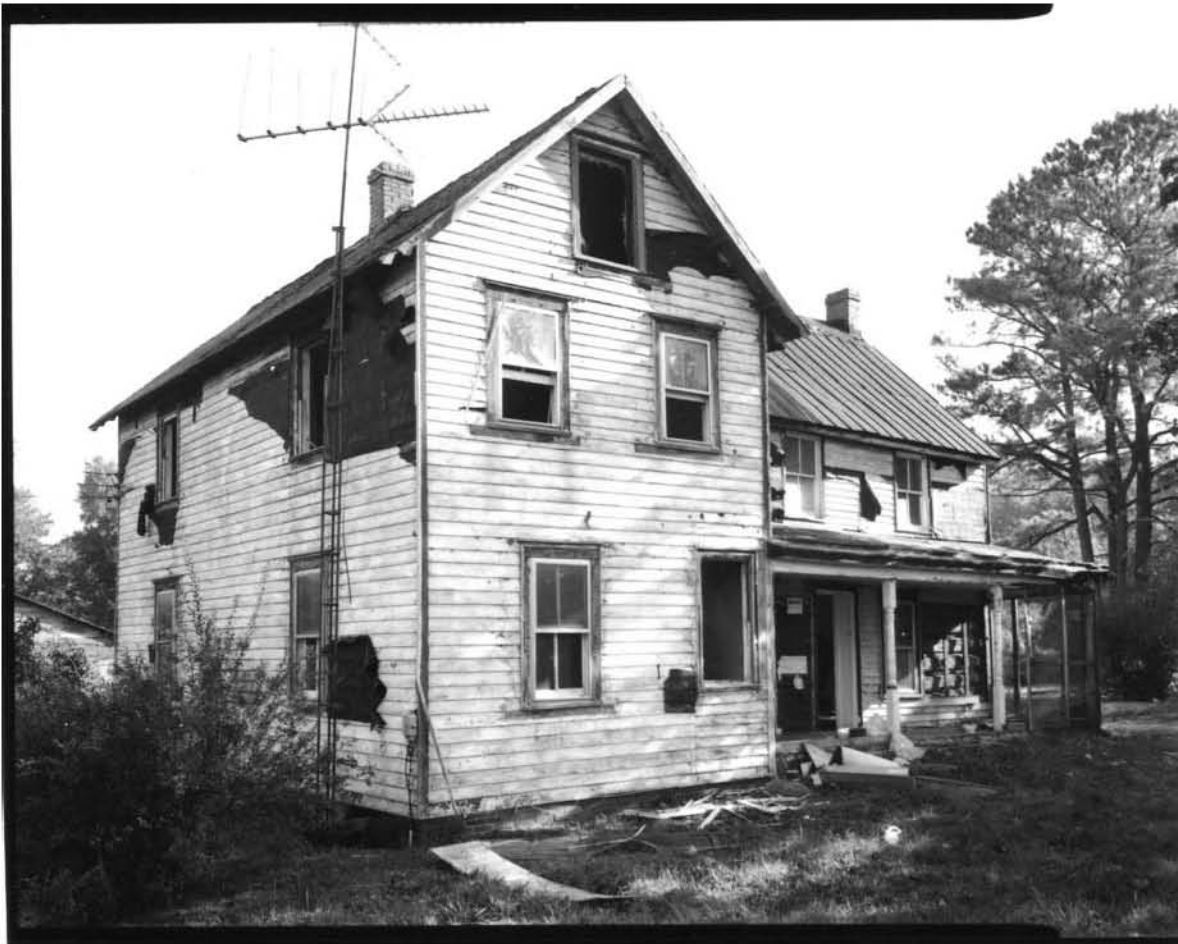
Figure 33: John Barber House, perspective of the south and west elevations looking northeast.

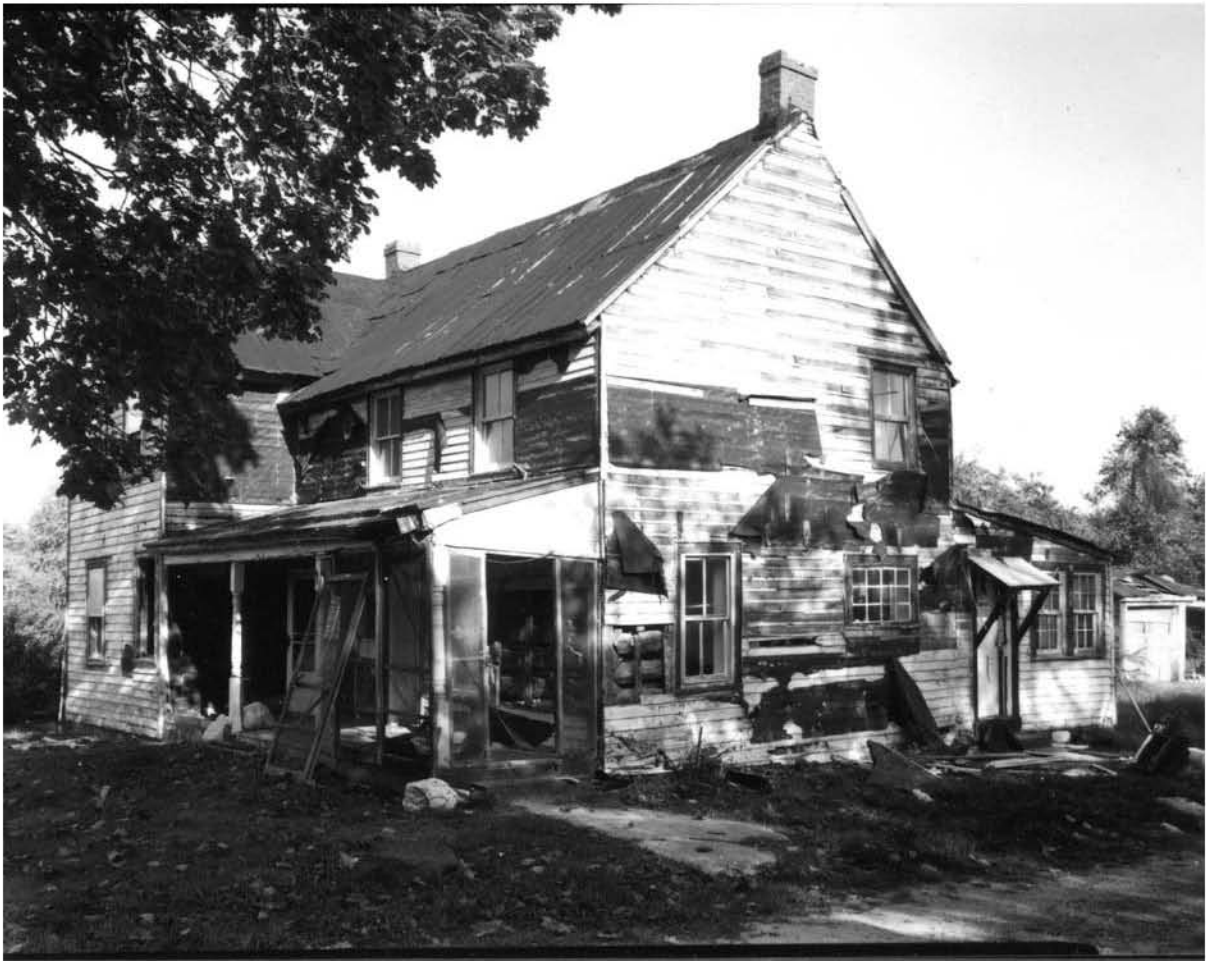
Figure 34: John Barber House, perspective of the south and east elevations looking northwest.

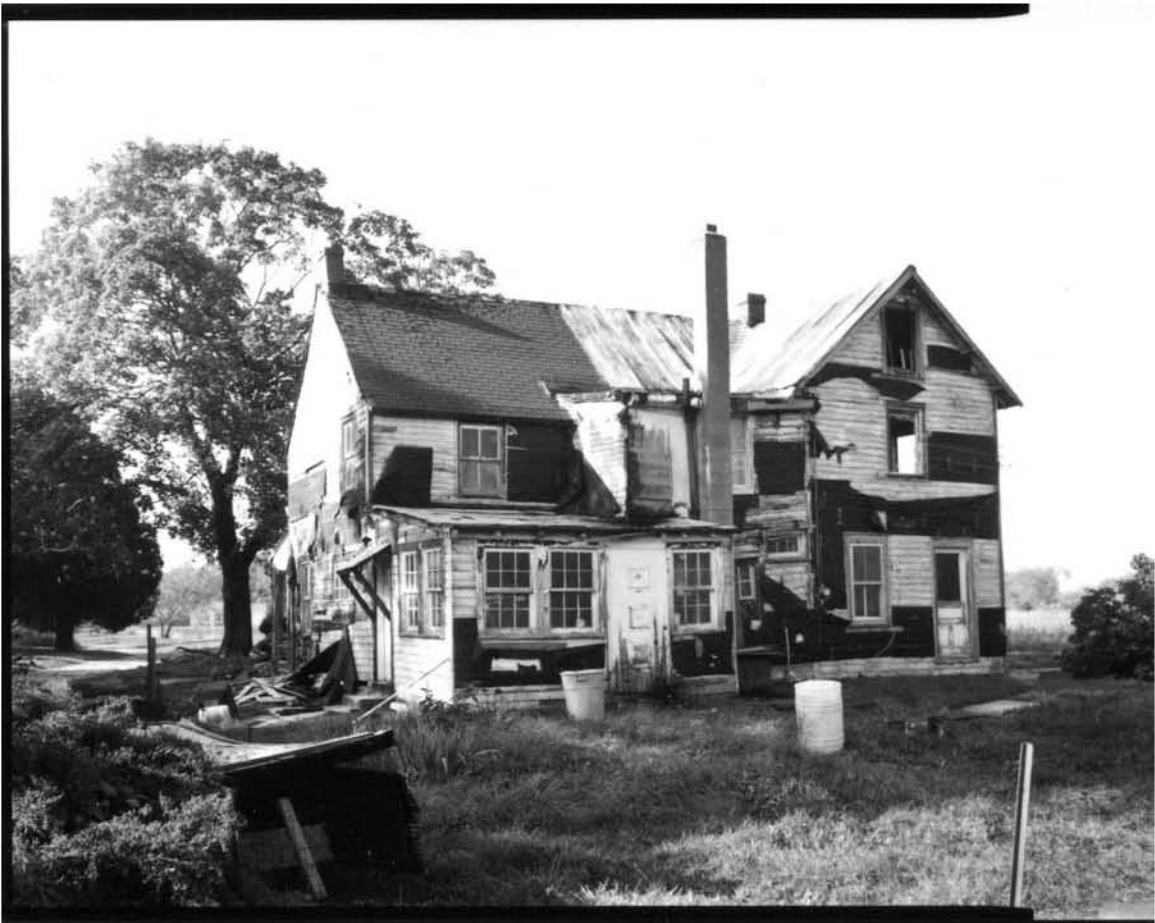
Figure 35: John Barber House, perspective of the north elevation looking southwest.

The two-story Period III rear addition projects from the north elevation of the large, side-T plan addition. This addition features a shed roof and is clad in clapboard with asphalt sheathing on the roof. An exterior concrete block chimney rises from the center of the north elevation. The first floor of the north elevation contains two asymmetrically placed, fixed windows while the second floor contains a single, six-over-six, double-hung-sash window.

The one-story Period IV rear addition projects from the northeast corner of the main block and has a shed roof. This addition rests on a concrete block foundation and features two entrances and both paired and single, six-over-six double-hung-sash windows with wood panel surrounds. The south bay of the east elevation contains a single entrance set beneath a shed hood supported by wood struts. The west bay of this elevation contains a pair of windows. The north, or rear, elevation is divided into three bays: the east bay features a pair of windows, the center bay contains a single entrance, and the west bay contains a single window. The west elevation is relatively featureless, save for a single fixed window.

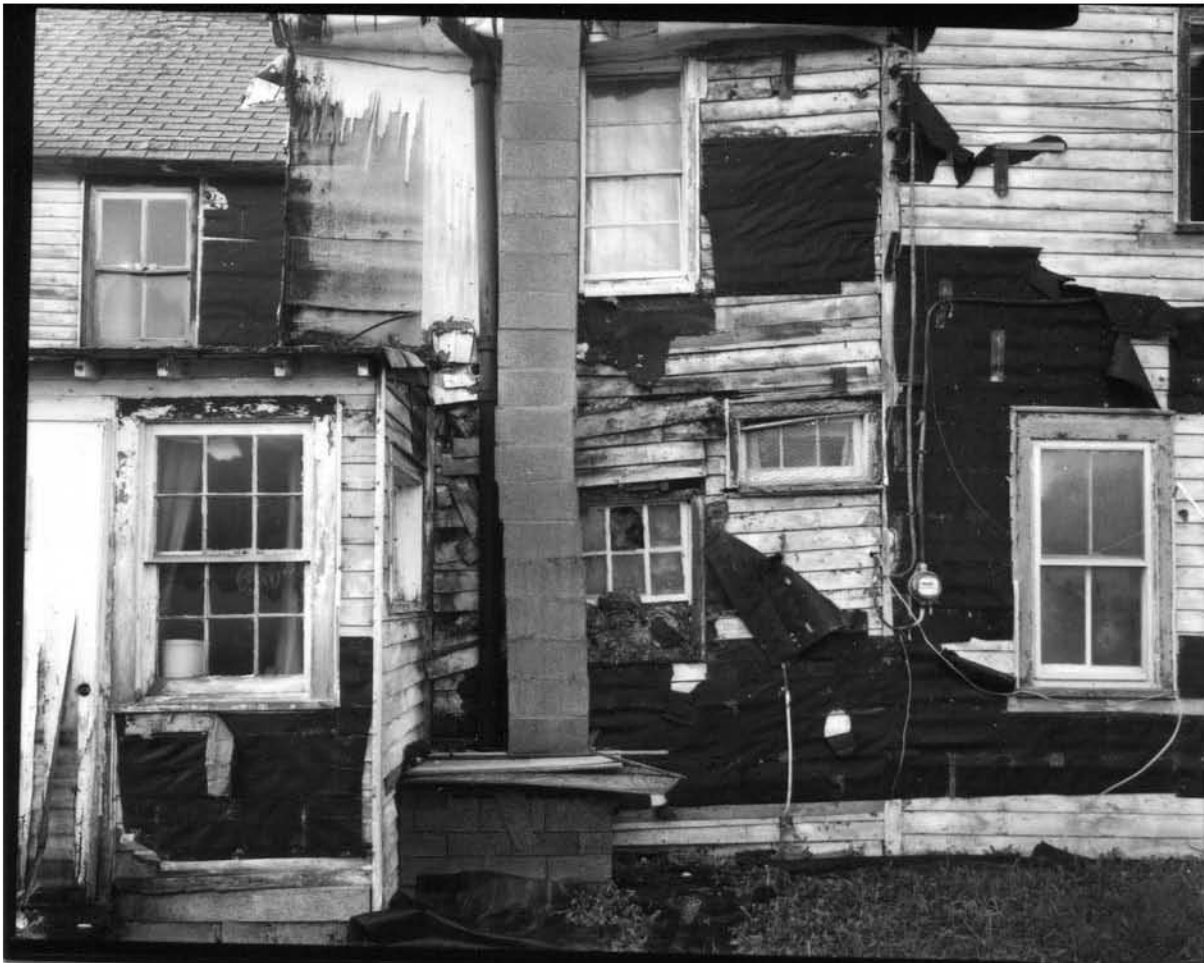
Figure 36: John Barber House, detail of the north elevation showing concrete block chimneystack and juncture of two rear additions.

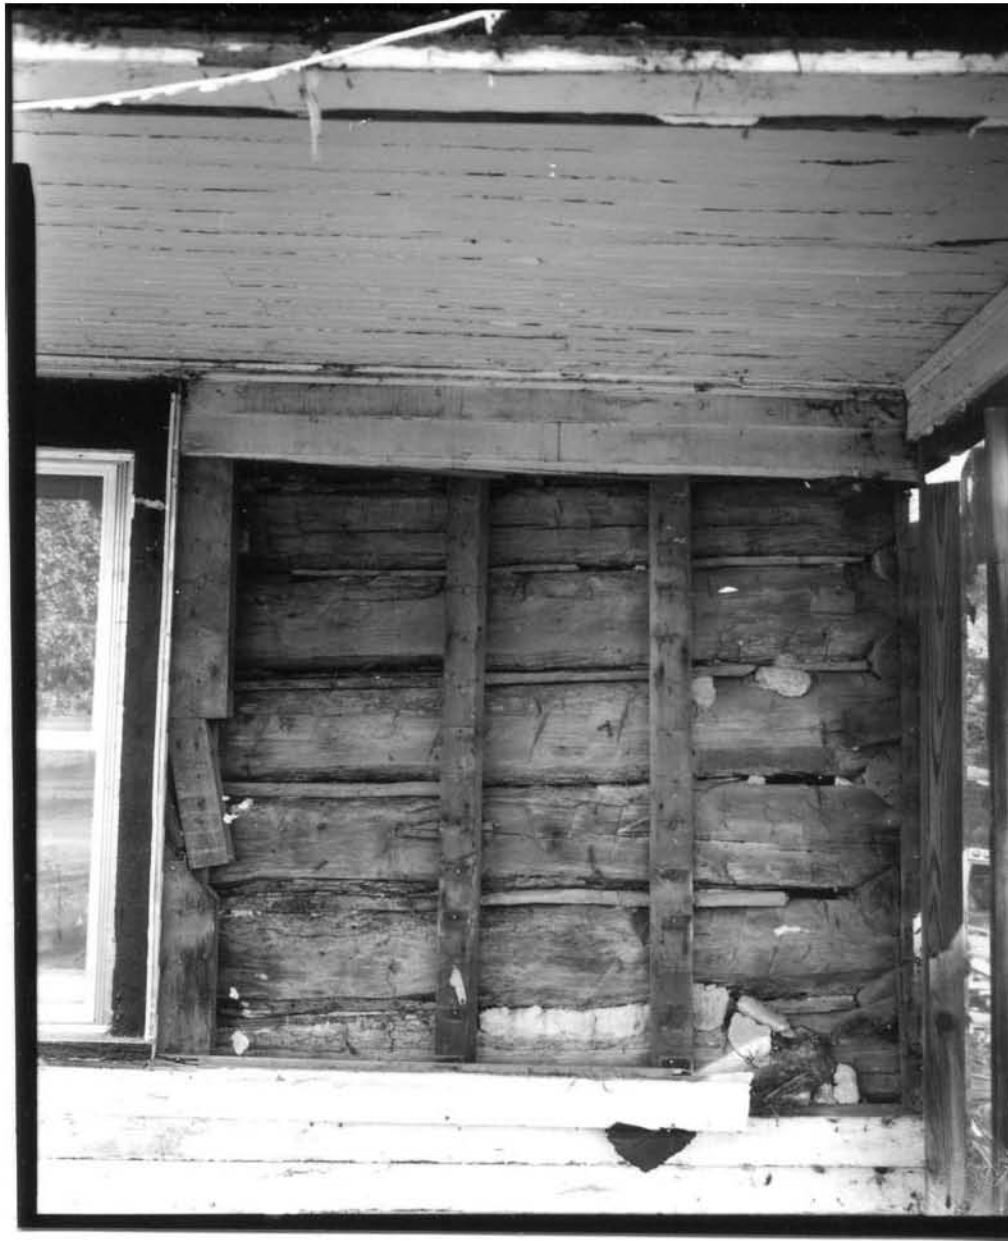
Figure 38: John Barber House, detail of the log construction on south elevation of Period I section.

The removal of siding from the exterior of the Period I section revealed the logs at the first floor of the south and east elevations; the logs are dressed and rough-hewn flat on their inner and outer faces but left round with remnants of bark on the upper and lower sides. The corners are joined by V-notches, with the spaces between the logs filled with scrap wood and soft mortar chinking.
