**EVALUATING RESERVE BRIDGE CAPACITY
THROUGH DESTRUCTIVE TESTING
OF A DECOMMISSIONED BRIDGE**

A thesis submitted to the Faculty of the University of Delaware in partial fulfillment of the requirements for the degree of Master of Civil Engineering

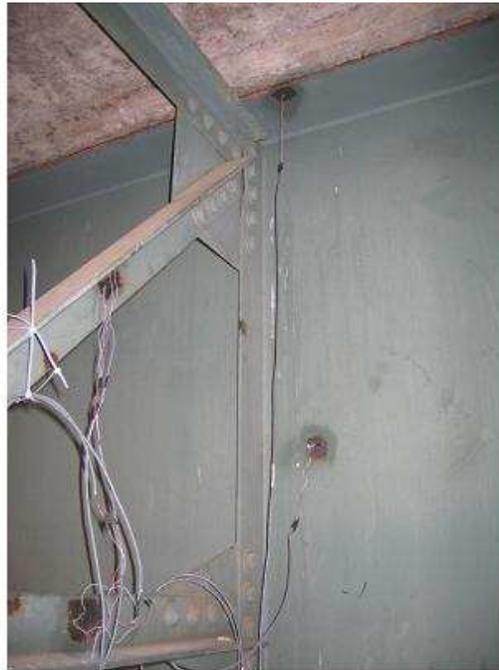
steel angles and are connected together by bolts and gusset plates as shown in Figure 2.4. The steel angle forming the bottom chord of the cross frame has its upper leg connected to the gusset plates that are also connected to the transverse stiffeners, which also serve as cross frame connection plates in these locations. The steel angle forming the top of the cross frames has its bottom leg connected to the connection plates. The inclined members of the cross frames have their bottom legs connected to gusset plates that are also attached to the other angles. Which leg of the angle that was directly connected to the structure was later considered in developing the instrumentation plan, as described in Section 4.4. In addition to the cross frames, end diaphragms were used to brace the end of the girders. The steel plate girder diaphragms were equal in depth to the steel girders.

Figure 2.4 Cross Frame to Gusset Plate Connection

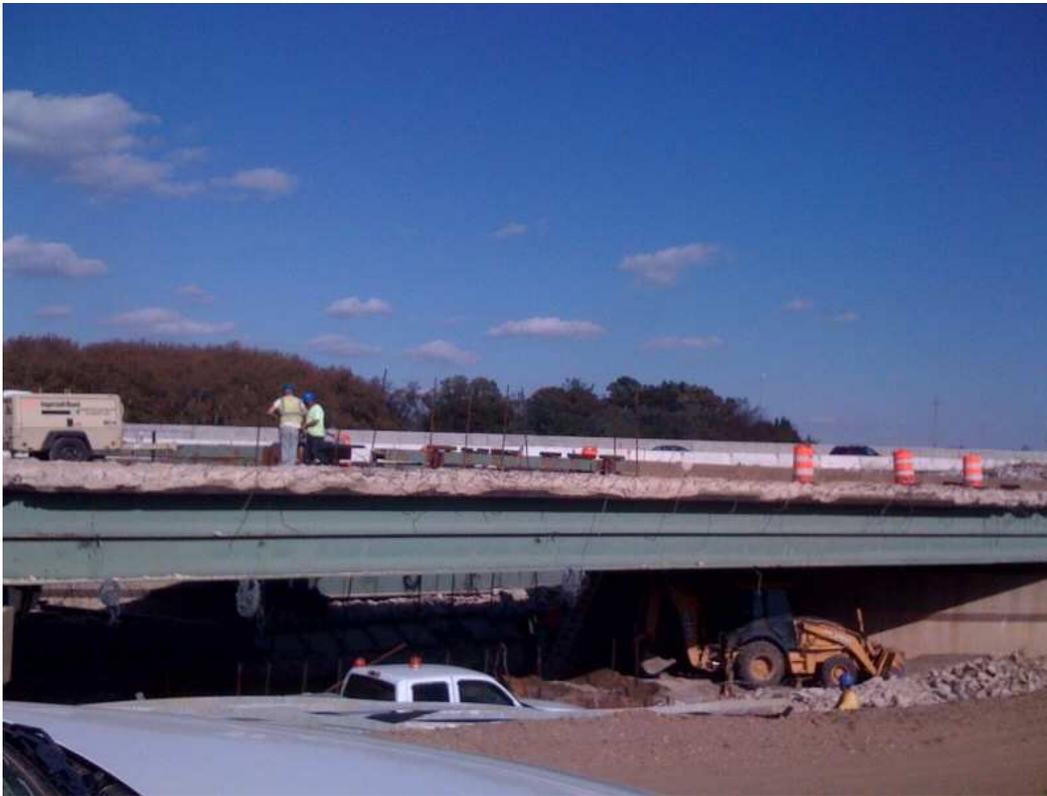
Prior to the bridge test, the concrete parapets were removed in order to make validating the modeling of the bridge easier due to the uncertainty regarding the contribution of the parapets and to decrease the amount of loading needed to cause failure of the bridge. The parapets of the bridge give the bridge some additional strength that was not accounted for in the design of the bridge, which is created from the composite connection between the bridge and parapet, similar to the composite connection of the bridge deck and plate girders. Figure 2.5 shows a photo of the bridge before the test.

Figure 2.5 Photo of middle span w/ parapets removed

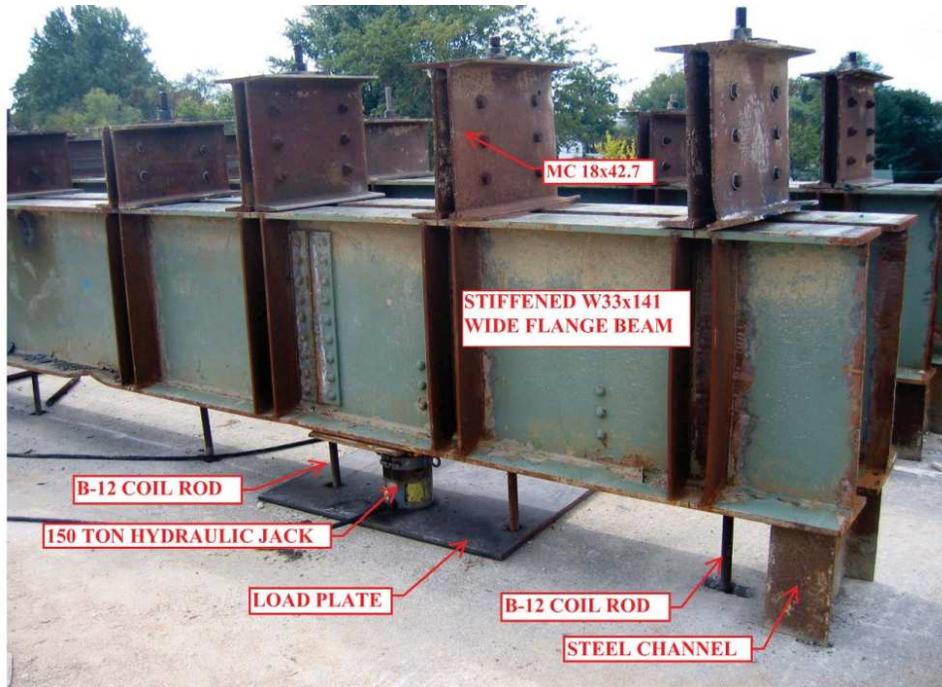
Figure 3.3 Photo of Loading Mechanism, Side View

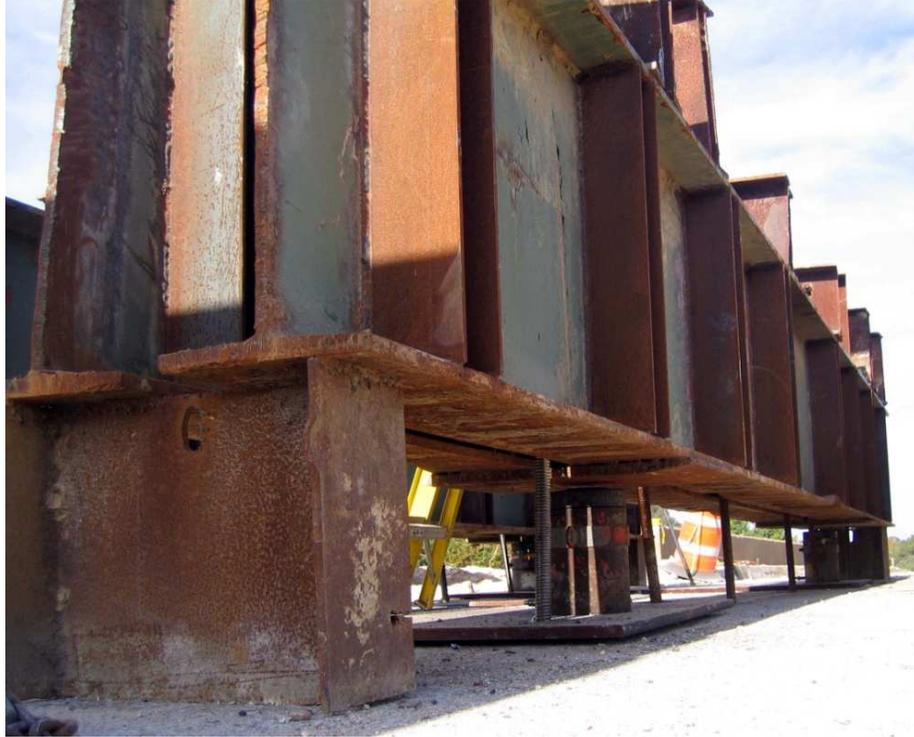
Figure 3.4 Photo of Loading Mechanism from Bridge Deck

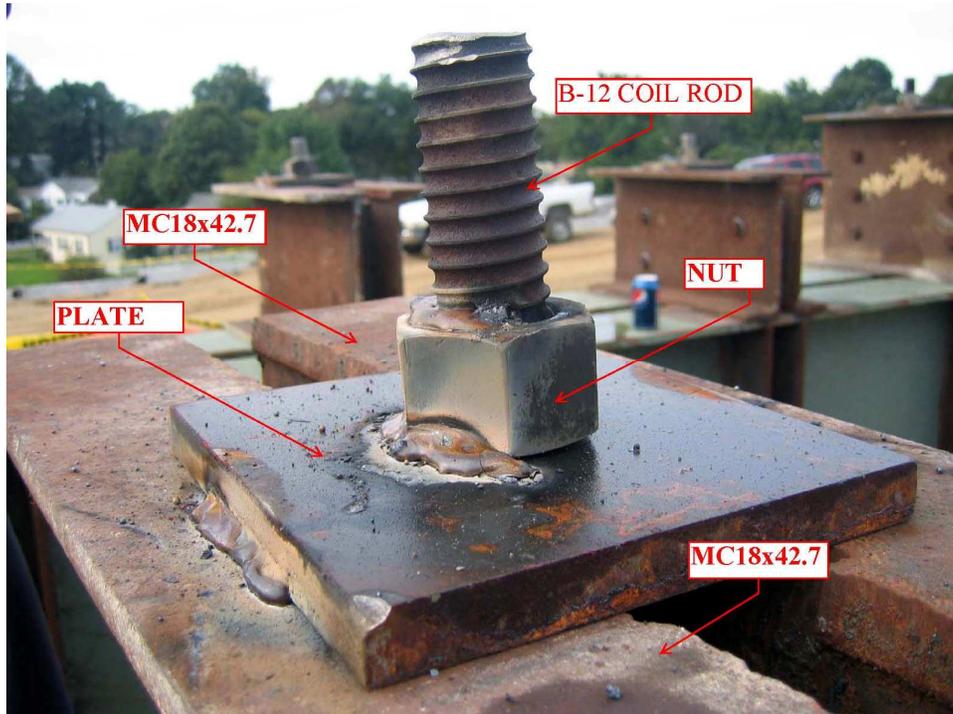
Holes of 3 in. diameter were drilled through the concrete deck and load plate (where applicable) to allow the passage of the 1 1/2 in. diameter B-12 Dayton Richmond coil rods that passed through the bridge deck. The coil rods passed between the two stiffened wide flange beams and the two MC18x42.7, which were bolted to one another. At the top of each MC18x42.7 pair, the coil rods also passed through a steel plate with a hole drilled through its middle to allow the coil rods through. A nut was tightened against this plate. Welds were placed between: the plate and MC18x42.7 pair, the plate and nut, as well as the nut and B-12 coil rod. Whether this was necessary or advisable or not was a source of debate between the project participants. Figure 3.5 shows one of the twenty coil rod and bolt connections.

Figure 3.5 Close Up Photo of Coil Rod on Loading Mechanism

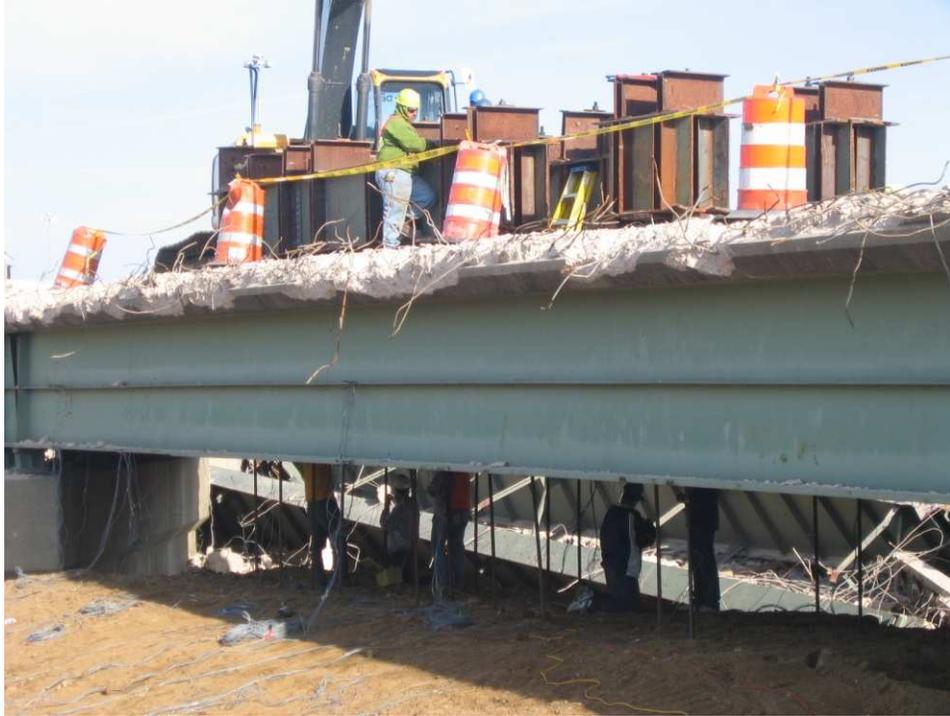
Figure 3.6 Photo of Bridge 7R, Facing North

As shown in Figure 3.2, the B-12 rods were first vertically embedded into concrete, 14.5 ft below the bridge, where Baylor Boulevard formerly crossed under the bridge. The coil rods were not long enough to reach the necessary height above the bridge deck. Therefore, each B-12 coil rod was individually spliced onto additional coil rods using Dayton Superior's D-110 US/MC-SAE coupler splice system. Before the bottom coil rods were spliced to the additional coil rods, the bottom coil rods were nearly covered to the top with backfill. More back fill was used to cover the next set of coil rods and then spliced together with additional coil rods. The process continued until the backfill reached approximately 3-4 ft. away from the bottom of the bridge and the coil rods were approximately 5-6 ft. above the bridge deck. Figure 3.6 displays a photo of the structure (looking north), where the backfill height and coil rods below the bridge can be seen.

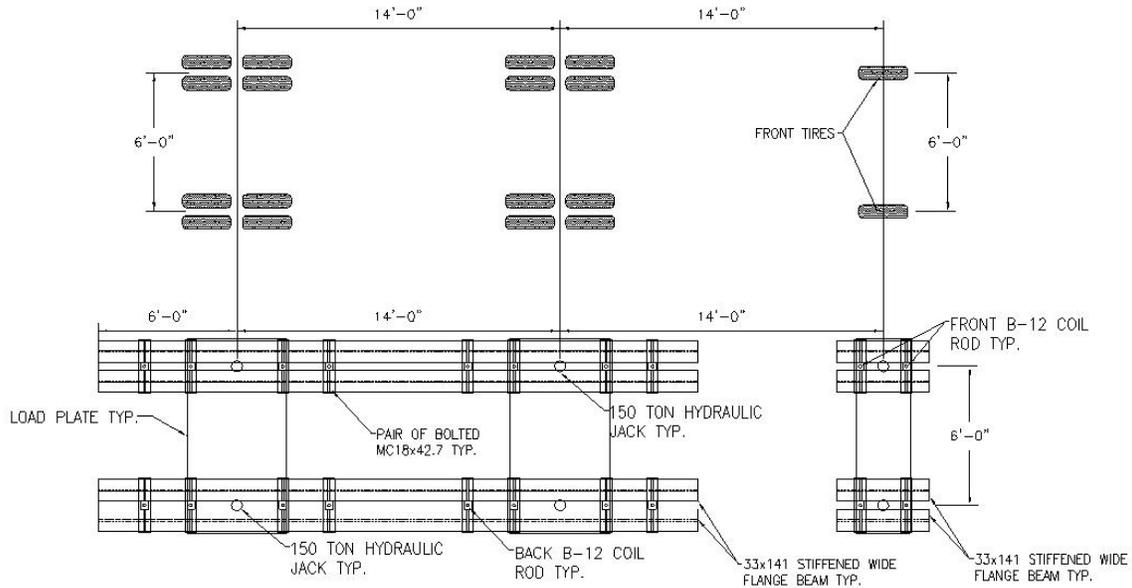
Figure 3.7 displays a plan view of an HS-20 truck (at the top portion of the figure) and the loading mechanism that was used during the bridge test (at the bottom portion of the figure). As shown in the figure, the dimensions of the truck and loading mechanism are the same. The HS-20 truck transverse distance between wheels is 6 ft. and the longitudinal distances between each axle are a minimum of 14 ft, which would cause the worst-case scenario for the subject structure. The transverse distance between the centerline of the hydraulic jacks was 6 ft. and the longitudinal distance between the hydraulic jacks were 14 ft. The use of four coil rods at each back wheel location was based on the amount needed to resist HS-20 load increments. The load at each front wheel location is resisted by two coil rods in order to resist the force from the jack symmetrically, despite the fact that only one rod would be needed based on the anticipated forces.

Figure 3.7 Plain Views of HS-20 Truck and Loading Mechanism

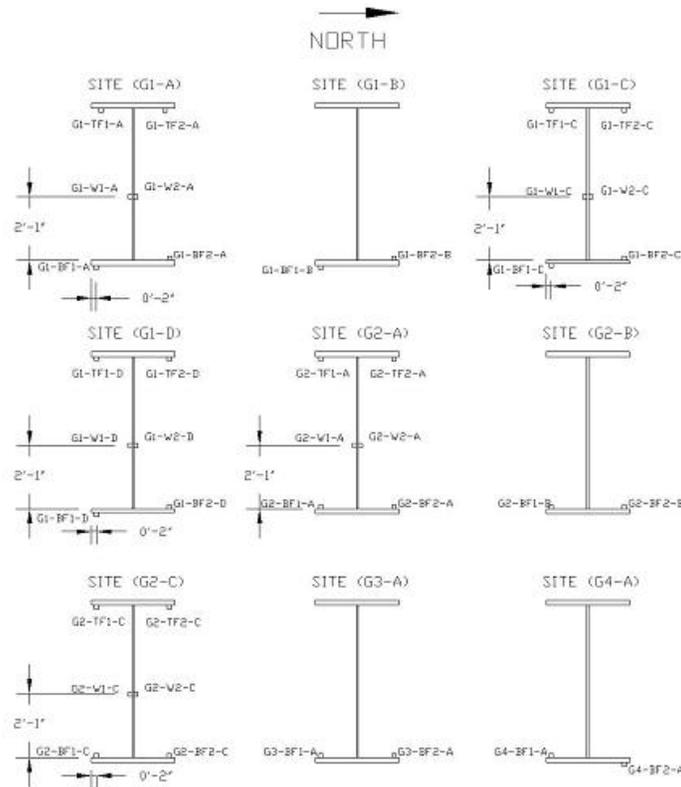
Gauge groupings G1-B, G2-B, G3-A, and G4-A had a pair of gauges that were generally attached to the top of the bottom flanges’ fascia, 2 in. away from the outer edges of the flanges. However, the south gauge in gauge grouping G1-B (Gauge G1-BF1-B) and the north gauge in gauge grouping G4-A (Gauge G4-BF2-A) are attached 2 in. away from the outer edge of the bottom fascia of the bottom flange. This was done in order to avoid potential damage to the gauges when the parapets were removed.

The remaining gauge groupings have three pairs of strain gauges, for a total of six per grouping. One pair of gauges in these groupings is located in a similar manner as previously mentioned, on top of the bottom flange fascia, 2 in. from each girder edge. However, the south gauges for Gauge G1-A (Gauge G1-BF1-A), G1-C (Gauge G1-BF1-

Figure 4.3 Girder Instrumentation Layout

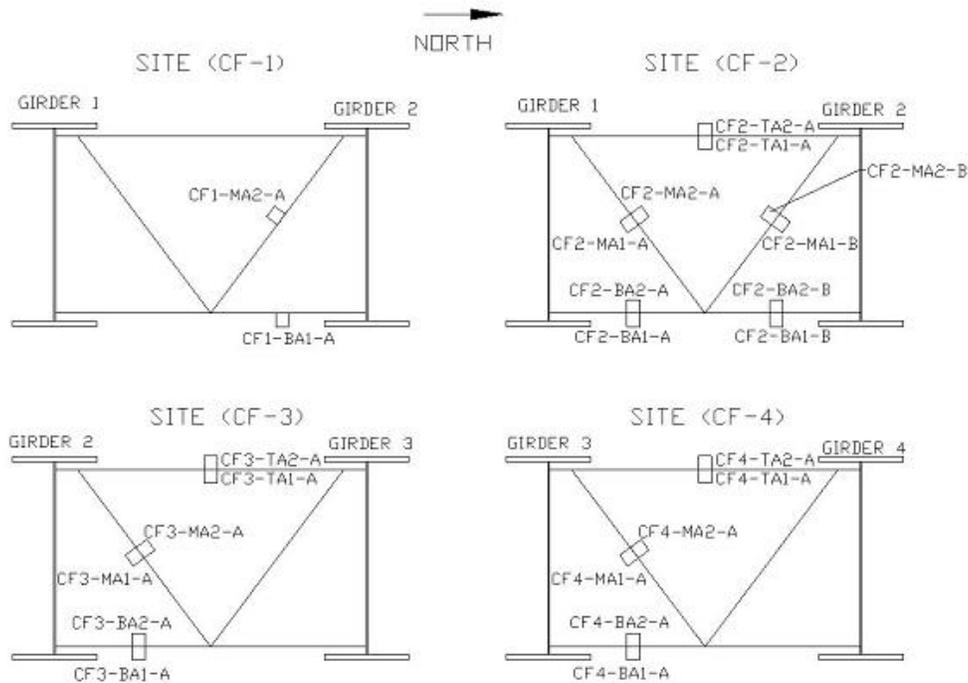
Cross frame grouping CF-2 had the most strain gauges with five pairs, totaling ten gauges. This cross frame had the most strain gauges due to the fact that the FEA predicted this cross frame to have the greatest amount of stress compared to the other cross frames.

Figure 4.4 Cross Frame Instrumentation Layout

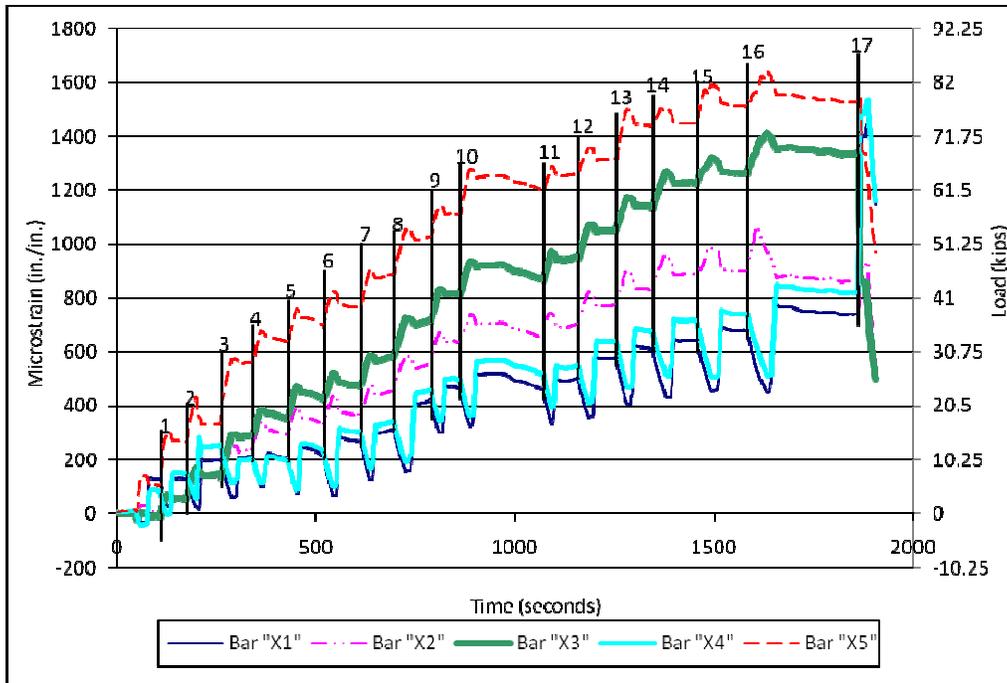
Figure 4.5 displays the microstrain vs. time (in seconds) graph from the coil rod gauges. The forces in the bars are also included, in the secondary y-axis of the figure. The recorded strains at the coil rods were converted to a force by multiplying the strain values to the elastic modulus and area of the bars.

Figure 4.5 Coil Rods Time History Graph

The back bars (X2, X3, and X5) exhibit a similar pattern in the graph in that the strain values increase and decrease at the same times. Bar X5 experiences the highest strain values followed by Bar X3 and then Bar X2, throughout the graph. The fact that the Bar X5 and Bar X3 forces are higher than the X2 forces is expected as the former bars are closer to load jacks (see Figure 4.1). Also as expected, the back bars have higher strain values than the front bars (X1 and X4) since the jack force at the front bar locations is intended to be one-fourth that at the back bar locations, but half the number of coil rods exist at the front bar locations compared to the back bar locations. Not only do the front bars follow a similar pattern to one another, but the strain values of these two bars are closer to one another than any combination of the back bars.

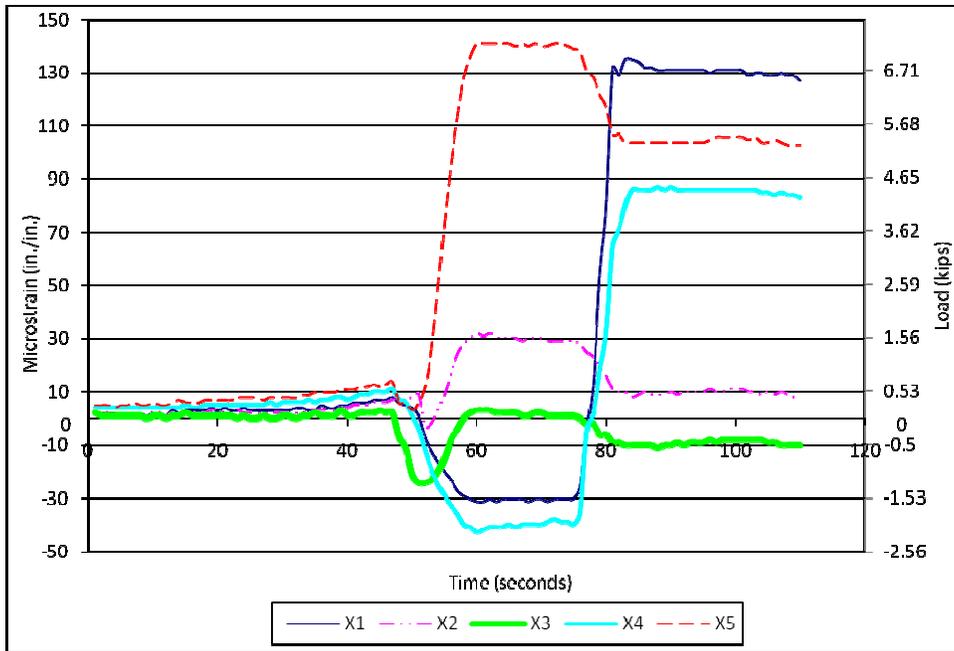
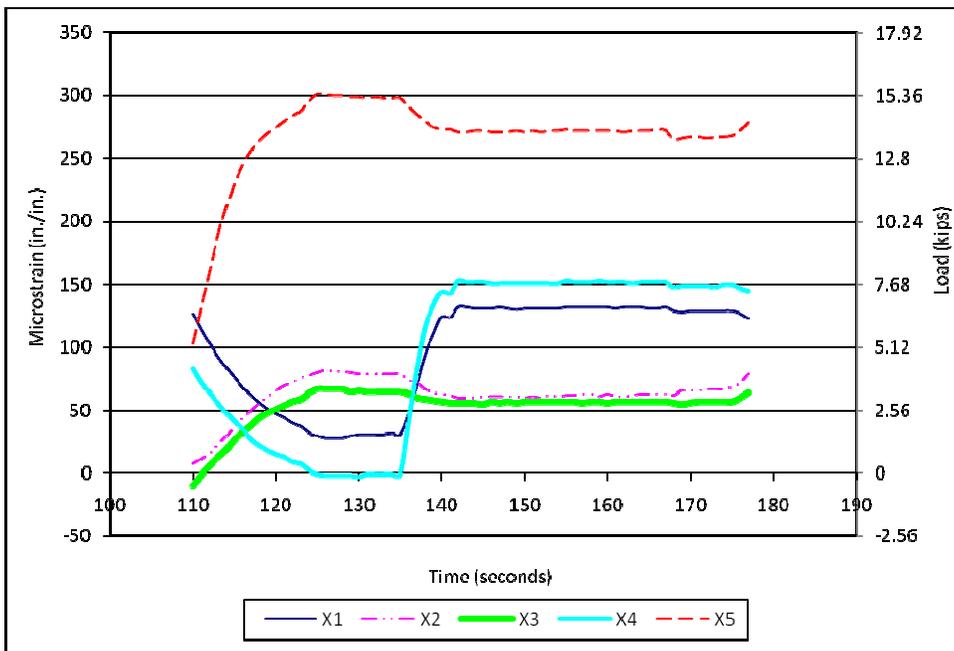
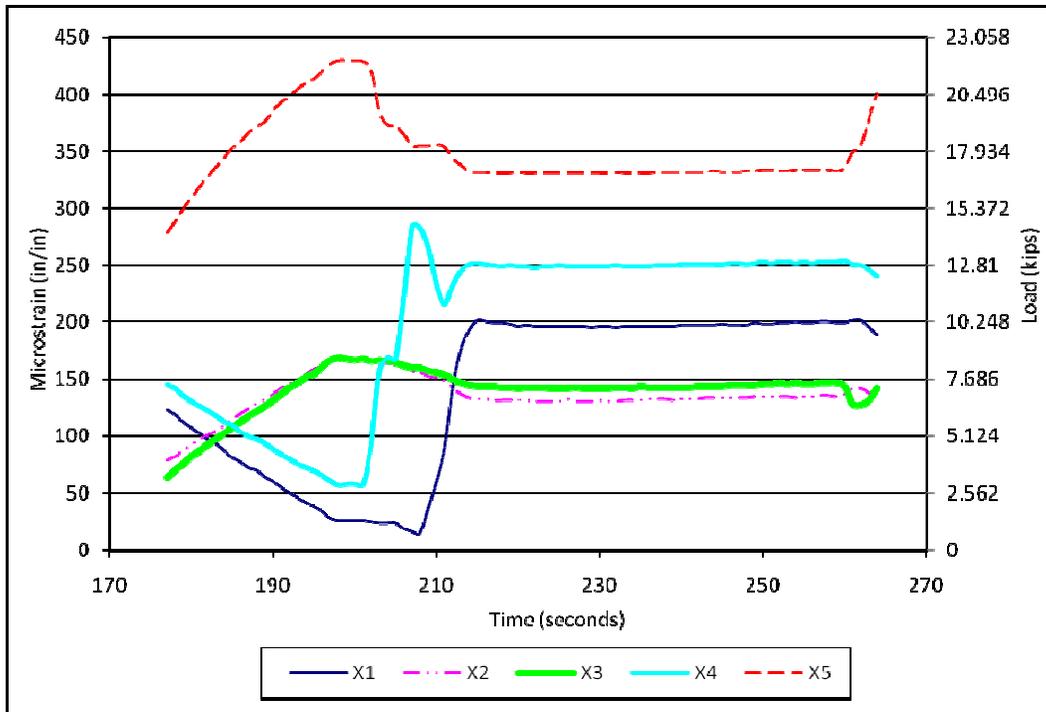
Figures 4.6, 4.7, and 4.8 show these detailed graphs of increments 1, 2, and 3, respectively. Similar graphs of increments 4 through 17 can be found in Appendix B. The fact that the front and back bars were not jacked simultaneously during the test is evident in these graphs. Specifically, the back bars (X2, X3, and X5) were jacked first at every increment, which can be seen due to these strain values increasing first. These bars generally begin to increase due to the applied loadings at the beginning of each increment. The shift in the centroid of the loading that occurred between when the front and back bars were jacked caused the front bar strains to decrease at the start of each increment. However, later in each increment there is generally a net increase in force in these bars after the jacking force is applied to them.

After the jacking sequence is completed, the strains decrease and then plateau as the load stabilizes (denoted at the horizontal portions on the graph). The end of an increment is defined as when a significant change in microstrain is observed in the data used to create Figure 4.5. Engineering judgment was used to determine what constituted a significant change based on the trends in the strain data in a specific gauge at a specific time; this corresponds to a difference of 4 to 13 microstrains from one time stamp to the next second at a given gauge. Time stamps are consistently used to report gauge readings for all gauges at the respective increments. The data was also evaluated to assess when significant changes in slope occurred; at the last time stamp for a given truck increment, the slope over the previous five seconds of data ranged between negative

Figure 4.6 Increment 1, Time History Graph

Figure 4.7 Increment 2, Time History Graph

Figure 4.8 Increment 3, Time History Graph

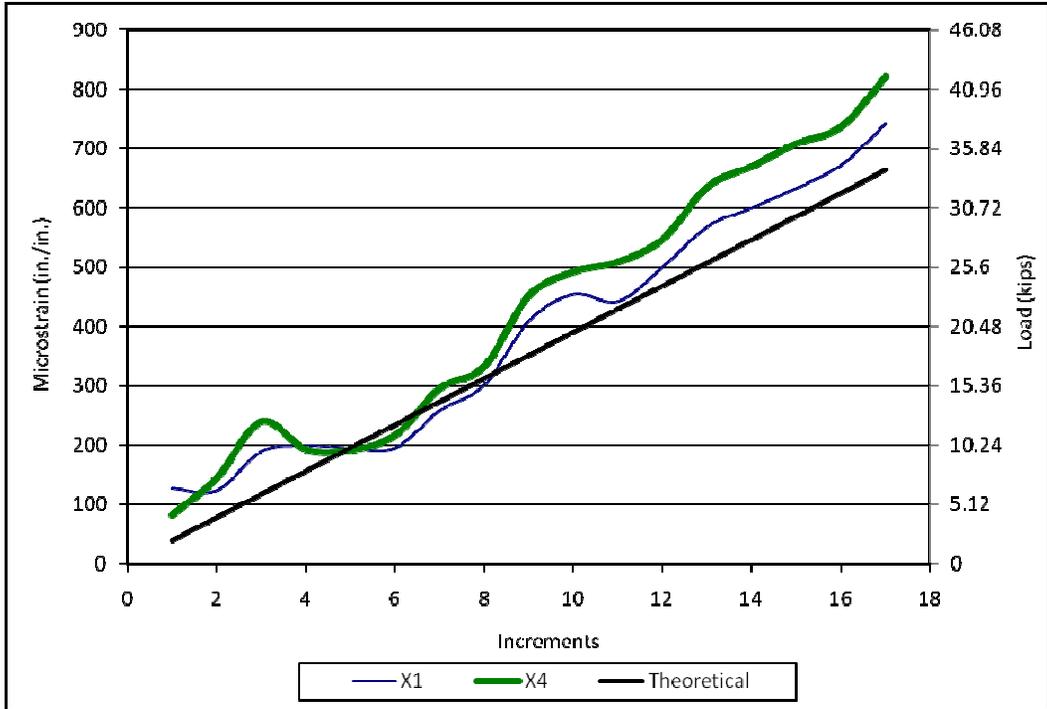
coils rod forces to the theoretical HS-20 truck loadings that were targeted. Specifically, Figure 4.9 compares the theoretical loading of 2 kips of force (or 39 microstrains) per increment to the actual front coil rod forces. Figure 4.10 compares the theoretical loading of 4 kips of force (or 78 microstrains) per increment to the actual back coil rod forces. Figure 4.11 compares the total theoretical loadings of 16 kips of force (or 312 microstrains) per increment and total actual forces from two previous figures. The total theoretical loading is the targeted sum of the five bars (two front bars and three back bars) during each increment.

Figure 4.9 Theoretical vs. Actual Front Coil Rods

It may also be noteworthy that the strains plotted in Figure 4.9 show that the strain is increasing very little in the front bars between increments 4 and 7, with almost no increase between increments 4 and 6. This may have also played a role in the issues related to the variable neutral axis position and changes in girder strain that were observed during these increments that will be discussed in the following section.

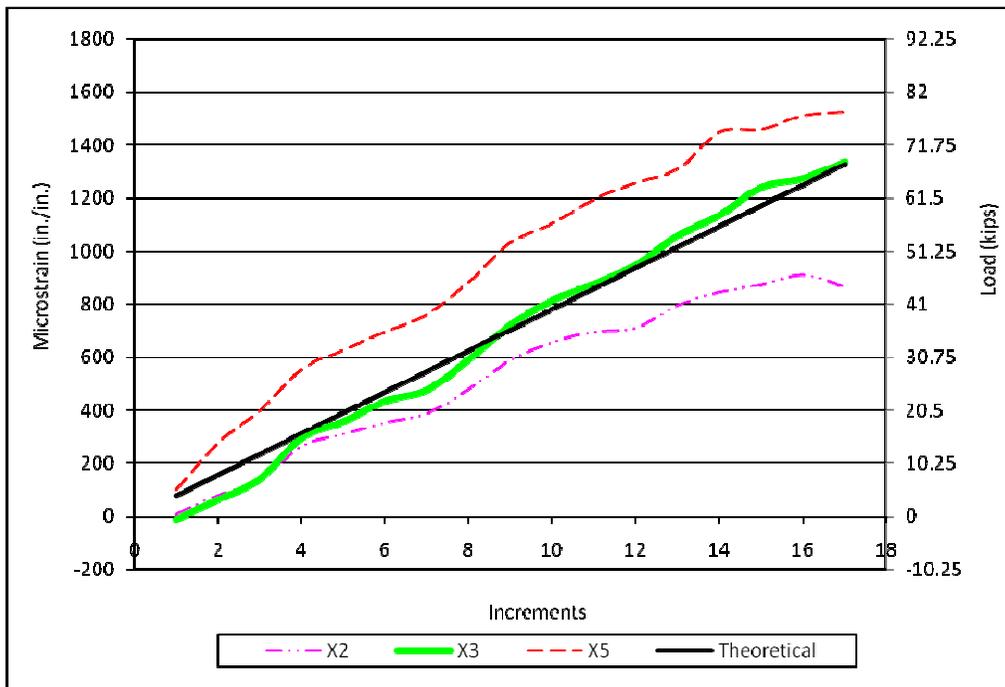
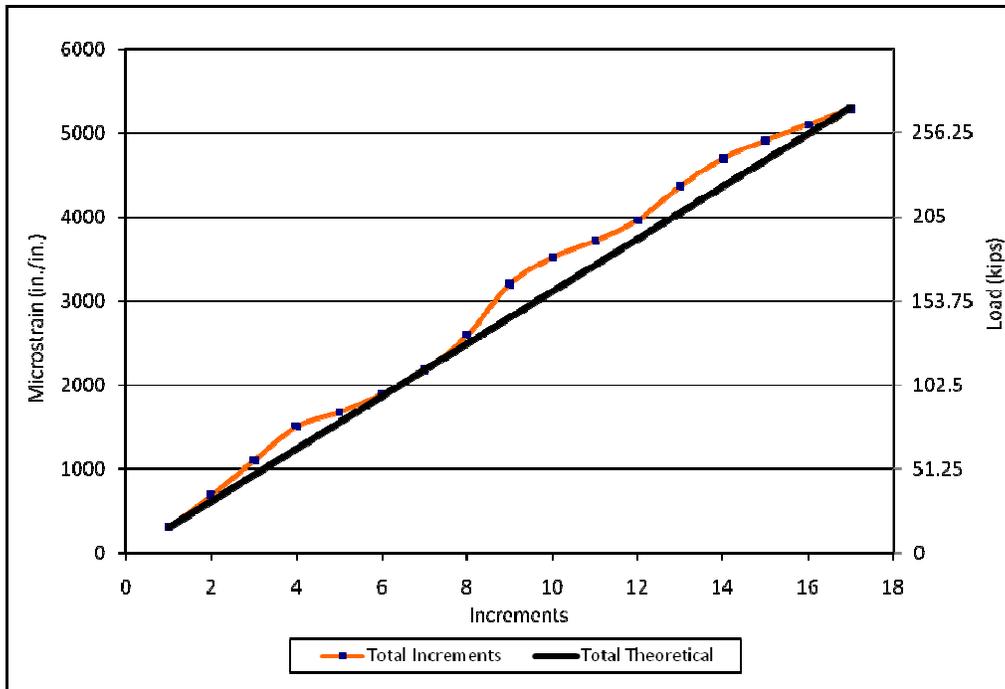
Figure 4.10 Theoretical vs. Actual Back Coil Rods

Figure 4.11 Theoretical vs. Actual Total Coil Rods

instrumented back bars show much better correlation, differing from the targeted loadings by only 10% on average. However, the average percent difference for the sum of the five bars was very consistent with the theoretical loadings, differing by an average of only 7%. The percent differences were calculated by taking the absolute difference between the actual loads and theoretical loads, then dividing by the theoretical loads.

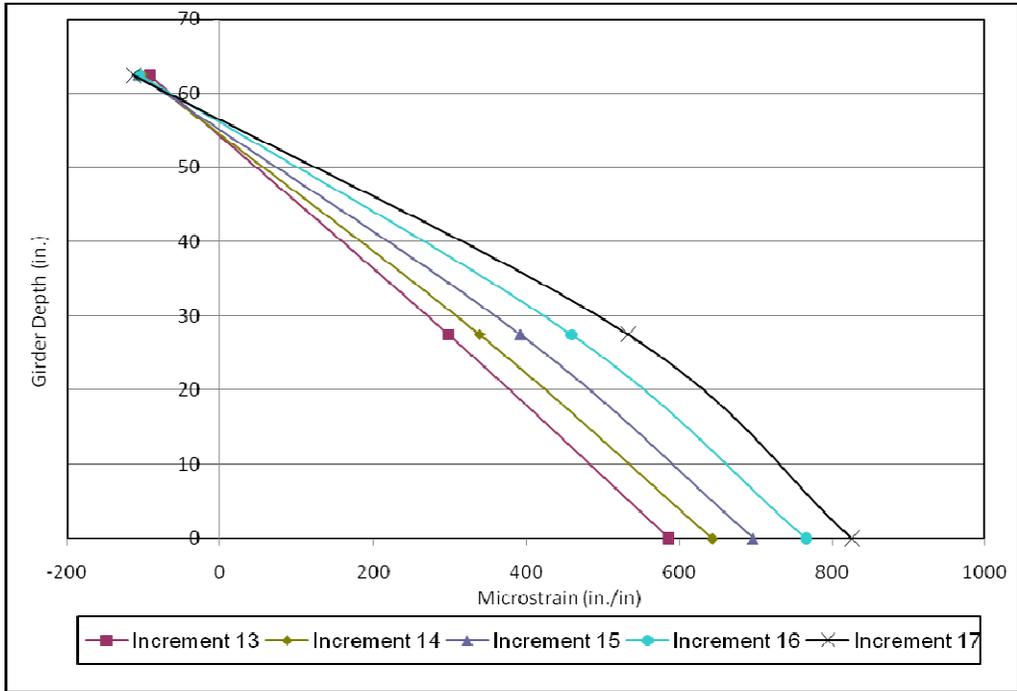
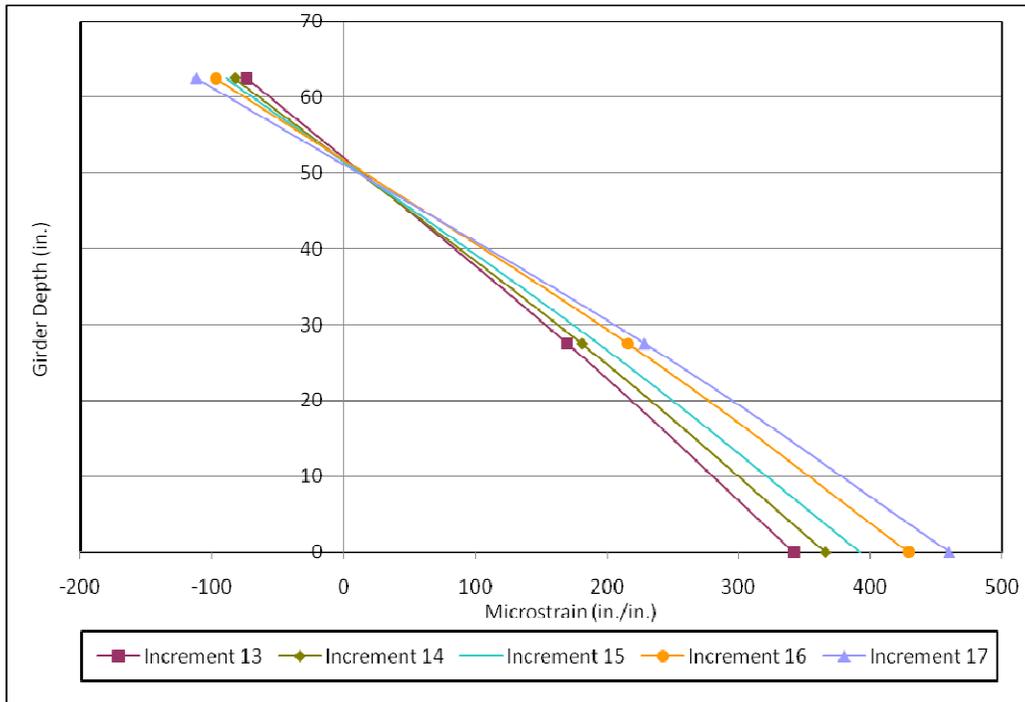
The cross-sectional strains in Figures 4.12 and 4.13 generally indicate an ideal elastic flexural response through the cross-section in that the strains at the top flange, web, and bottom flanges proportionately increase as more load is applied to the structure. Between increments 13 and 17 at gauge grouping G2-A (Figure 4.12), increment 13 had the lowest neutral axis location at 54 in. from the base of the bottom flange and increment 17 had the highest neutral axis location at 57 in. At gauge grouping G2-C (Figure 4.13), increment 17 had the lowest neutral axis location at 51 in. from the base of the bottom flange and increment 13 had the largest neutral axis location at 52 in. These neutral axis locations were quantified based on visually observing where the trend lines (generated using Microsoft Excel's smooth line feature) in the figures above crossed the vertical axis. As mentioned in Section 2.2.3, the estimated neutral axis location from the diagnostic test for the interior girders of the bridge was 54.4 in. from the base of the

Figure 4.12 Gauge G2-A Cross-Section Strain Increments 13-17

Figure 4.13 Gauge G2-C Cross-Section Strain Increments 13-17

bottom flange. The calculated value is 51 in. (based on the effective concrete width of 96 in., concrete density of 150 pcf, and concrete compressive strength of 9,000 psi). Thus, these results (particularly at G2-C) are generally consistent with expectations based on the previous predictions. The fact that the neutral axis is relatively high at gauge grouping G2-A at increment 17 suggests that the bottom flange may be beginning to yield at this location; this is also suggested when visually comparing the linearity of increment 16 versus 17 in Figure 4.12. This potential yielding is discussed in more detail in the following section.

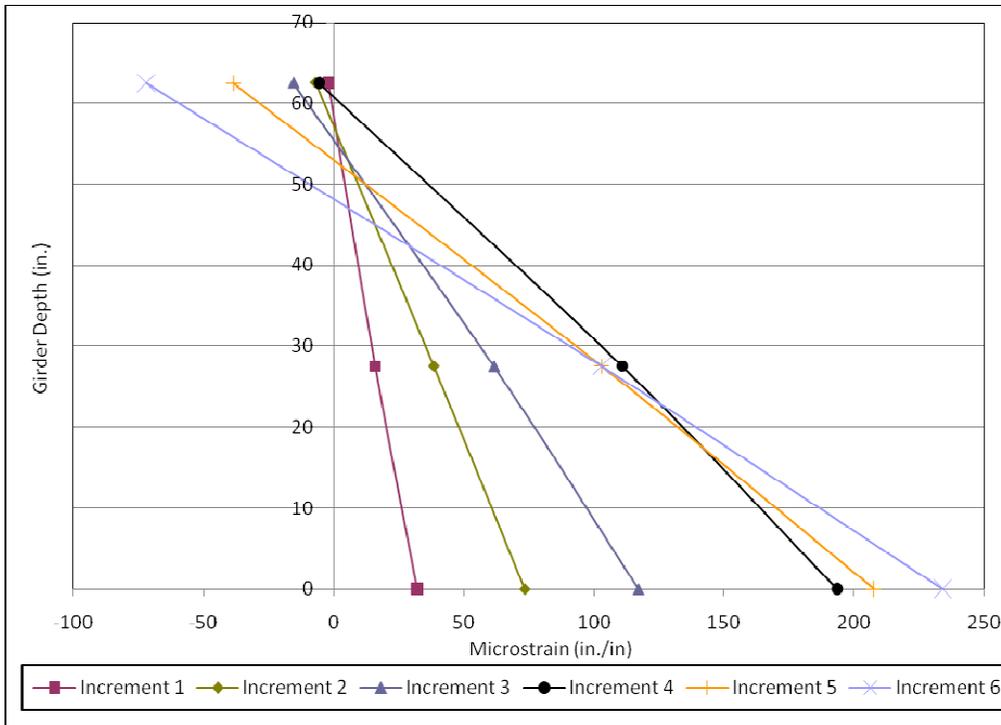
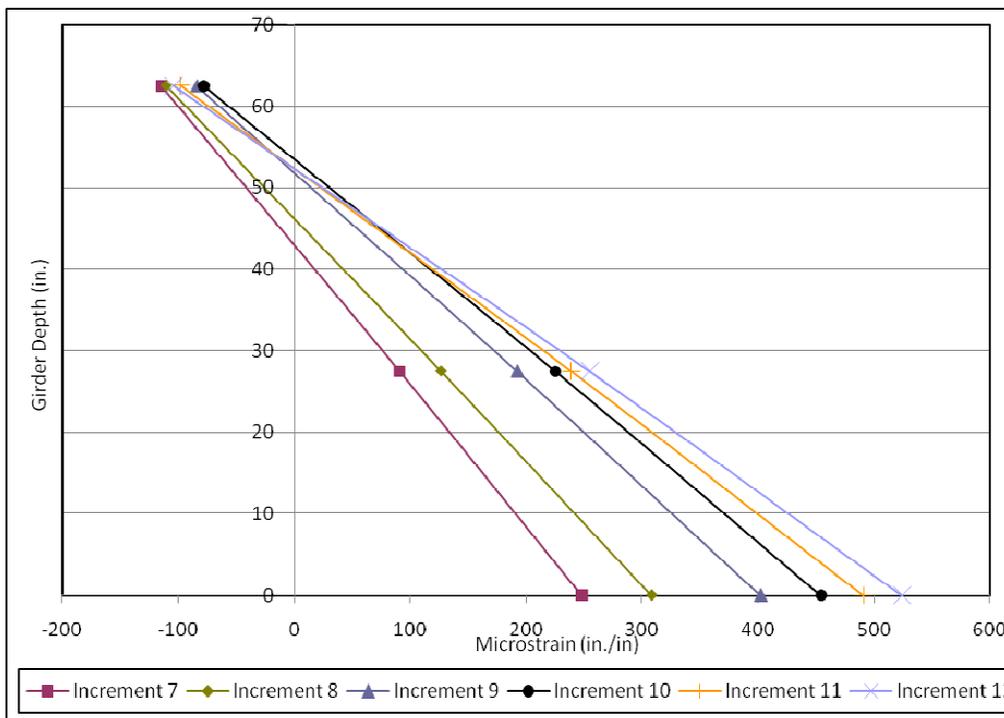
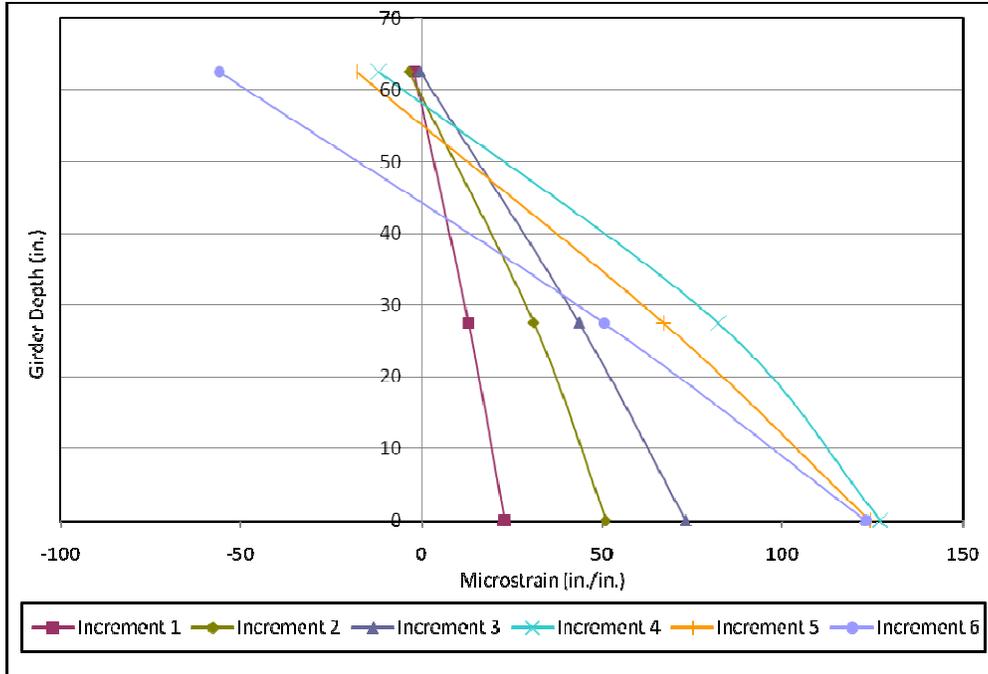
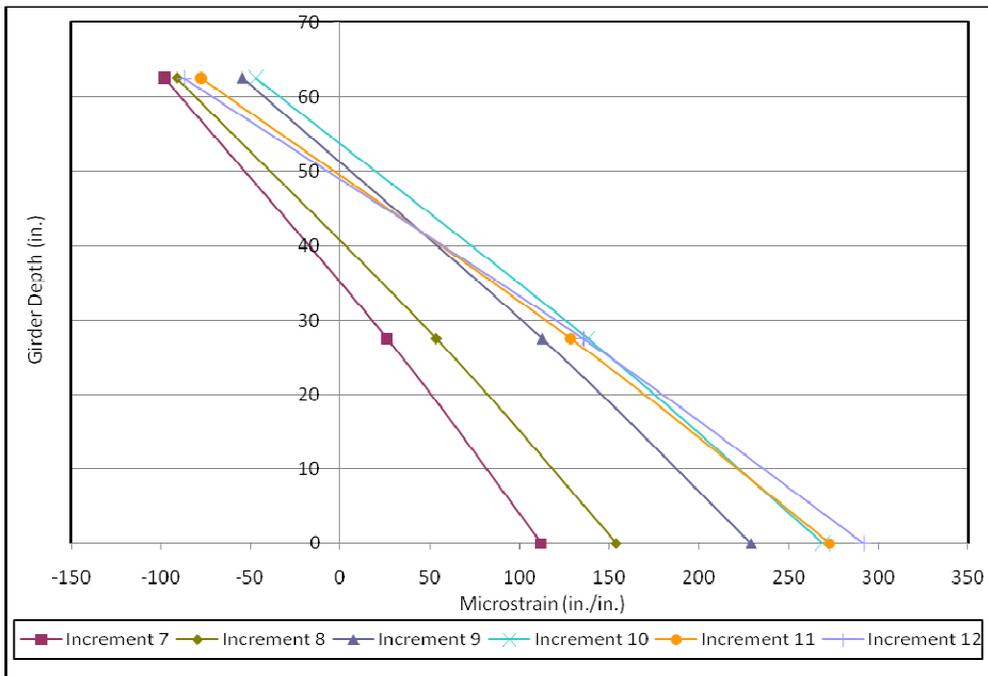
Figures 4.14 and 4.15 are graphs of the cross-sectional strains between increments 1 through 6 and 7 through 12 (respectively) for gauge grouping G2-A. During increments 9 through 12 the neutral axis locations were all within 3 in. of the calculated value of 50.8 in. At increments 4, 6, 7, and 8 the neutral axis locations were greater than 3 in. away from the calculated neutral axis value. Figures 4.16 and 4.17 are similar graphs for gauge grouping G2-C. Increments 9-12 were within 2 in. of the calculated value. Increment 3 shows a neutral axis position 10 in. higher than the theoretical value; however, this position is sensitive to the decreasing magnitude of a small strain value recorded in the top flange at this increment. Increments 6, 7, and 8 show neutral axis locations at least 7 in. lower than the theoretical value. It is assumed from Figures 4.14 through 4.17 that there was some loss of composite action between increments 4 and 8 caused by the close proximity of the concentrated loads to the gauge locations. The more consistent neutral axis position displayed from increments 9 to 17 was then perhaps due to the friction between the slab and the girder.

Figure 4.14 Gauge G2-A Cross-Section Strain Increments 1-6

Figure 4.15 Gauge G2-A Cross-Section Strain Increments 7-12

Figure 4.16 Gauge G2-C Cross-Section Strain Increments 1-6

Figure 4.17 Gauge G2-C Cross-Section Strain Increments 7-12

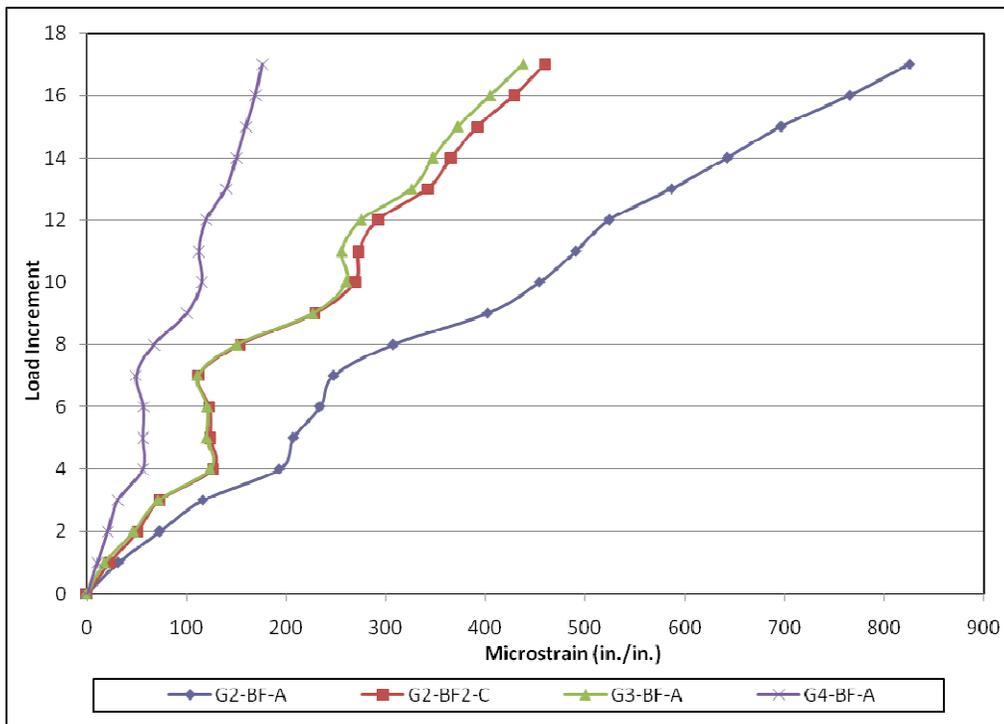
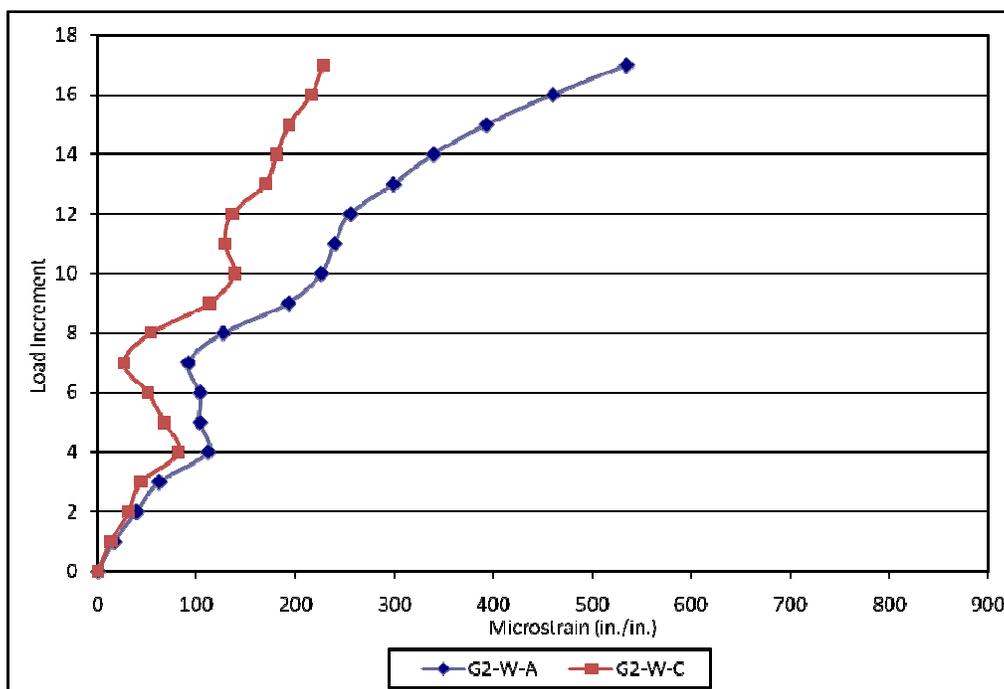
Figures 4.18 through 4.20 display graphs of the load increment vs. average microstrains in the bottom flanges, web and top flanges, respectively. These three graphs are plotted with consistent x and y-axis scales for better comparison between the three graphs. In general, these graphs report the average of the north and south gauges on each component of each cross-section with the exception that the average between G2-BF1-C

Figure 4.18 Field test bottom flange data

Figure 4.19 Field test web data

The gauge locations in Figures 4.18 and 4.19 (bottom flange and web locations) display an unusual trend generally between increments 4 and 7. The strain values increase from increments 1 to 3, but from increments 4 to 7, the strain values stay the same or in some instances decrease. This would suggest that the structure has infinite or negative rigidity, which is not possible. This odd trend is hypothesized to be a result of the lost composite action between increments 4 and 7 that was previously discussed in Section 4.3.1. As expected due to the neutral axis position, the top flange strain values

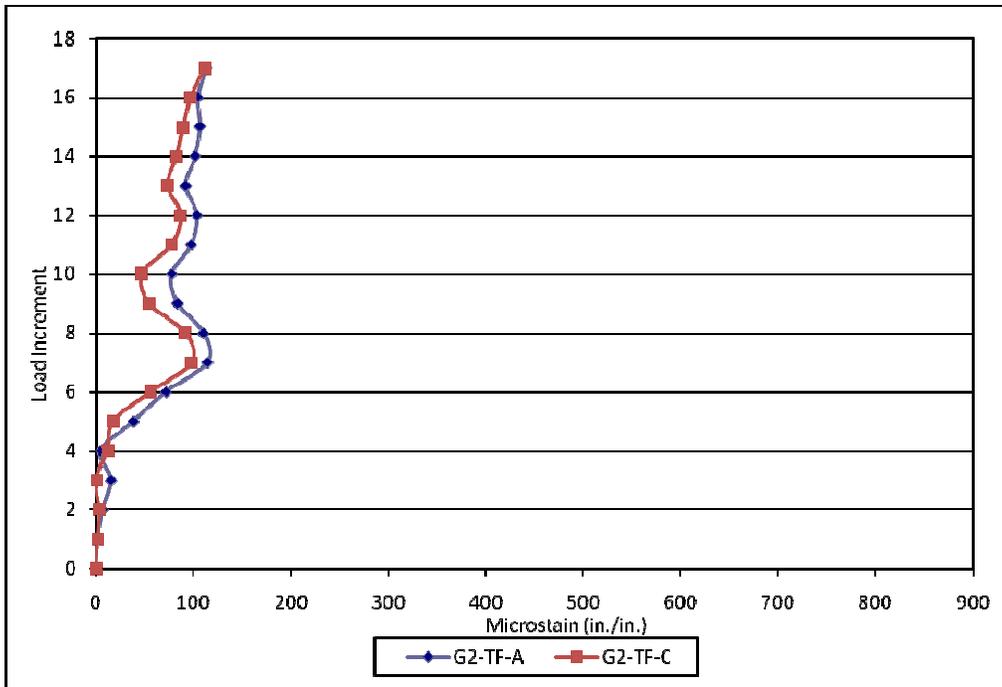
Figure 4.20 Field test top flange data (compression)

displayed in Figure 4.20 were relatively low. These strain values also show nonlinear increases in strain indicating potential changes in the degree of composite action in Girder 2.
