**EVALUATING RESERVE BRIDGE CAPACITY
THROUGH DESTRUCTIVE TESTING
OF A DECOMMISSIONED BRIDGE**

A thesis submitted to the Faculty of the University of Delaware in partial fulfillment of the requirements for the degree of Master of Civil Engineering

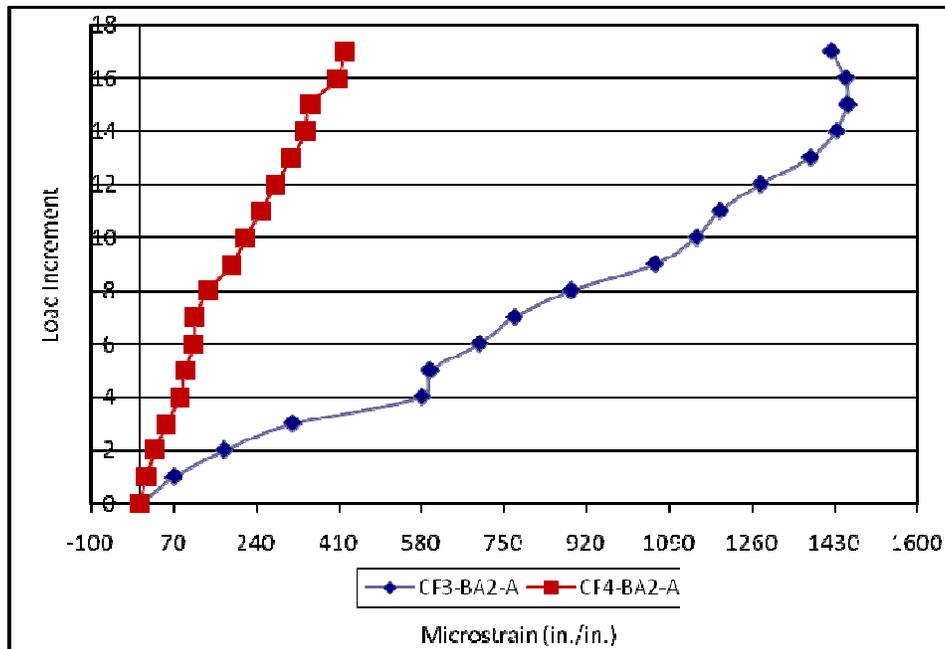
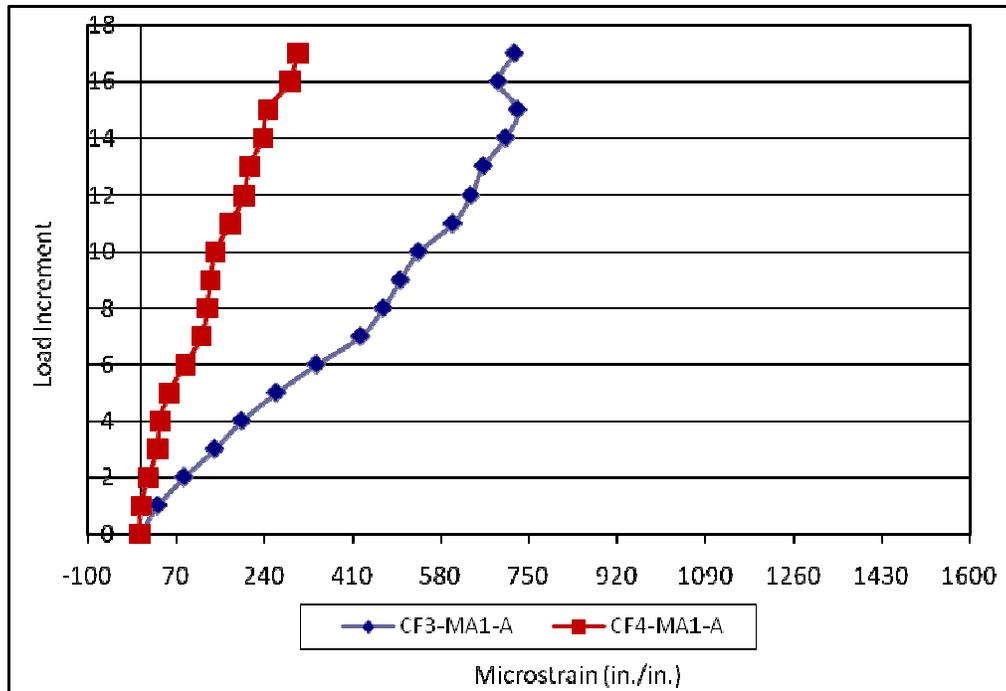
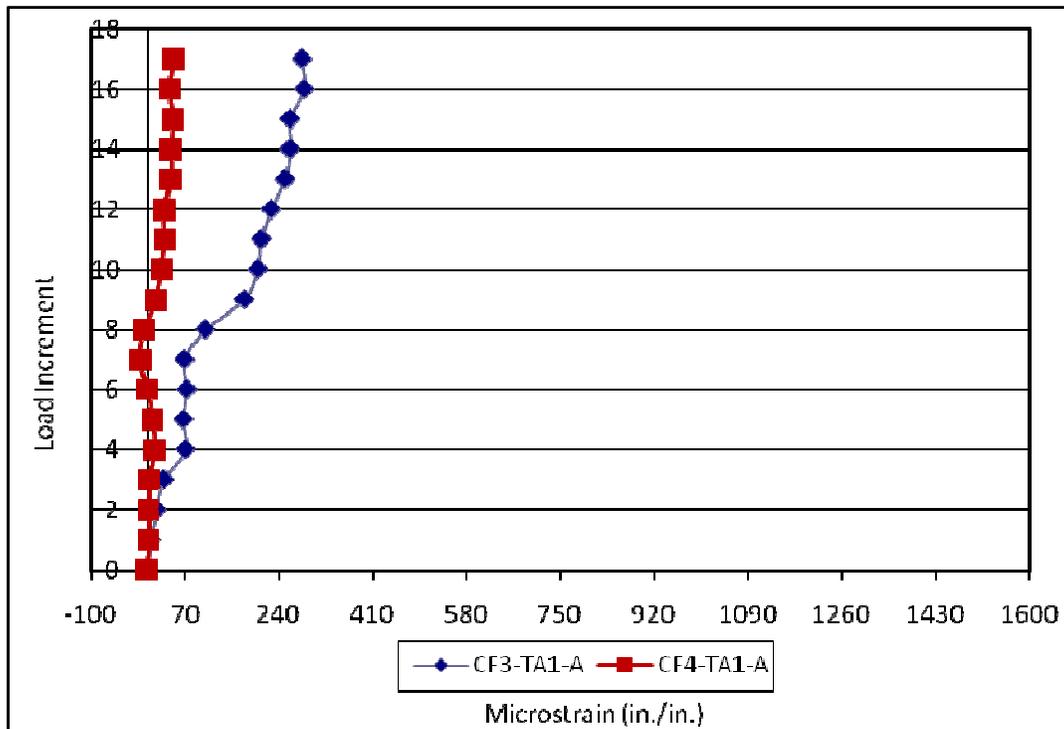
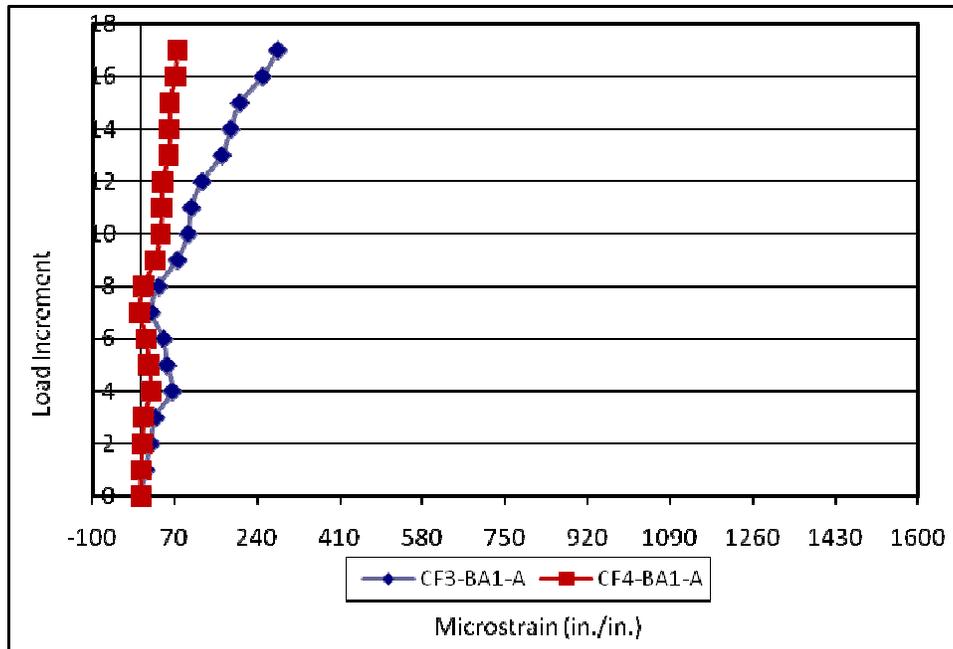
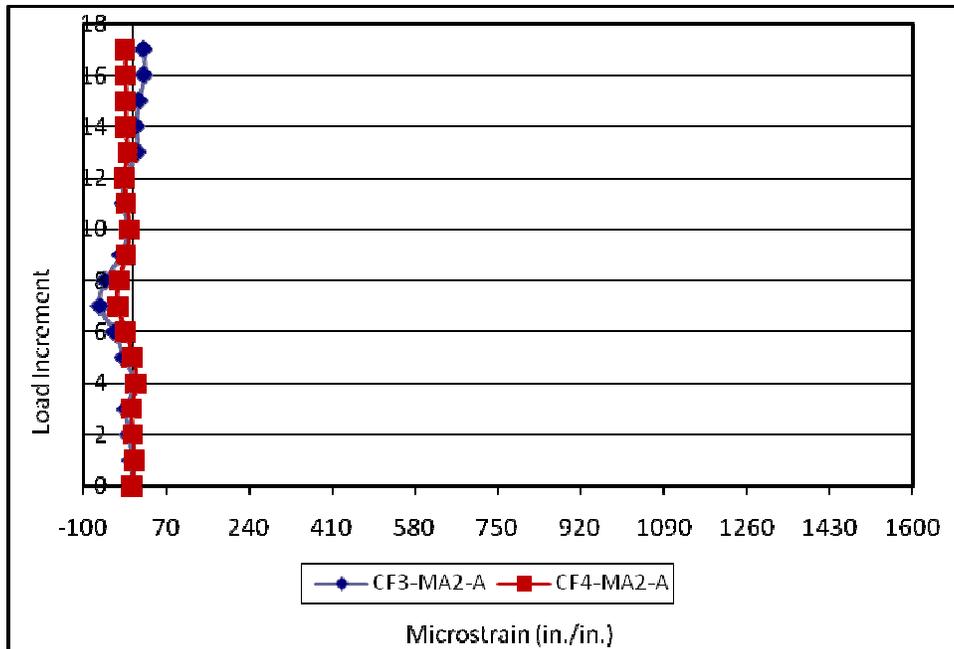
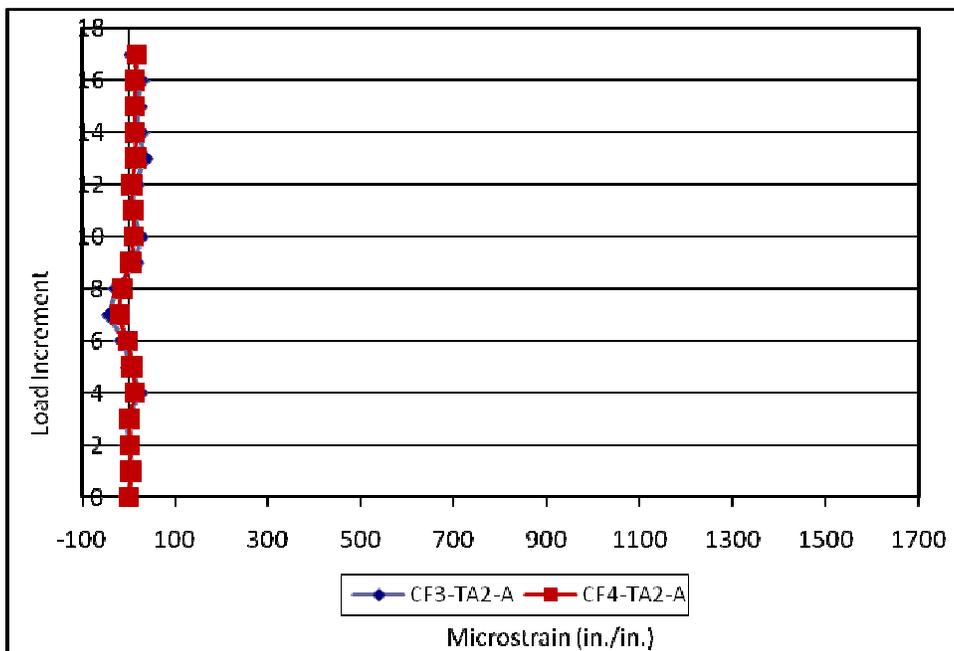
Several general trends can be observed from Figures 4.21 through 4.26. First, it is seen that the strains generally increase with increasing applied load. In comparing the relative magnitudes of the different gauges it is shown that, as expected, the concentric legs have much higher strain values than the eccentric legs, which typically have strains less than 100 microstrains (the only exception being gauge CF3-BA1-A), including fluctuations between tension and compression. It is also shown that

Figure 4.21 Field Test Concentric Leg Bottom Angle Data (tension is positive)

Figure 4.22 Field Test Concentric Leg Middle Angle Data (compression is positive)

Figure 4.23 Field Test Concentric Leg Top Angle Data (tension is positive)

Figure 4.24 Field Test Eccentric Leg Bottom Angle Data (tension is positive)

Figure 4.25 Field Test Eccentric Leg middle Angle Data (compression is positive)

Figure 4.26 Field Test Eccentric Leg Top Angle Data (tension is positive)

The strain values for the gauges that were attached to concentric legs of Cross Frame 3 also give some insight into the system response of the bridge. As discussed above, it is estimated that the bottom angle of this cross frame began to yield at increment 10. In looking at the data from all of the concentric leg gauge readings on this cross frame (CF3-BA2-A, CF3-MA1-A, and CF3-TA1-A), the strain began to decrease or stays the same (CF3-TA1-1) at increment 15 or 16 in all three cases. The strain also began to decrease in two (CF3-MA1-1 and CF2-TA1-1) of the three eccentric legs at

increment 16 (although this is less meaningful due to the more significant fluctuations in these gauge readings). This suggests a potential change in the load distribution characteristics of the bridge in that less load is being transmitted through Cross Frame 3. This may have been caused by the high magnitude of loading.

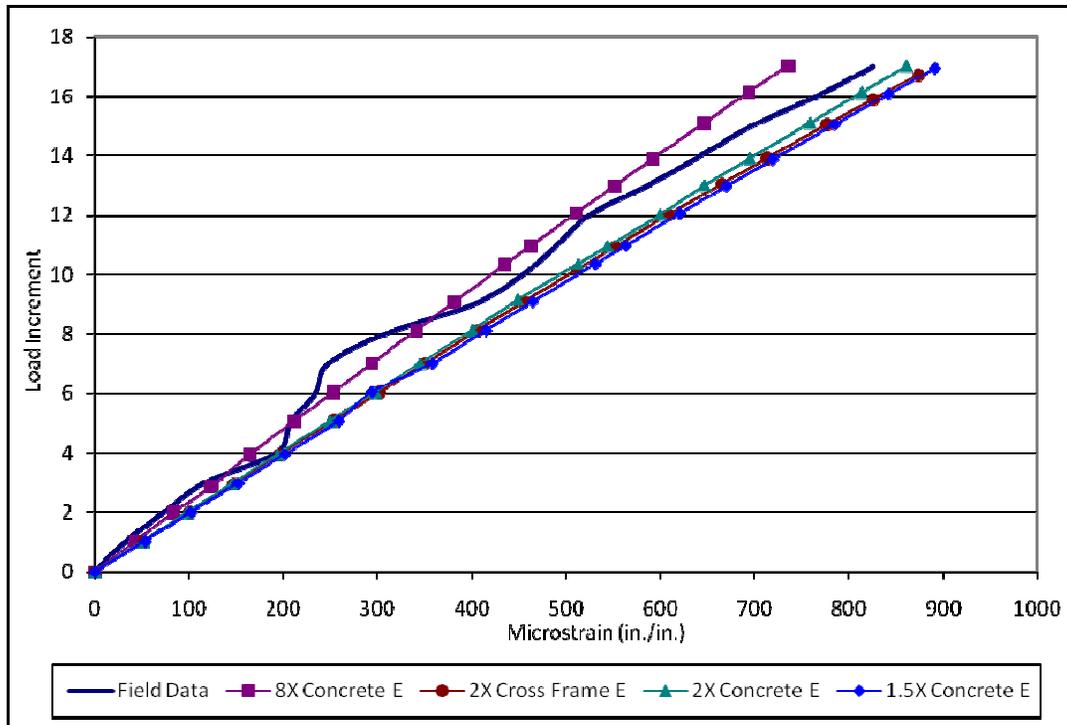
Not only were the slopes over the entire loading range (increments 1 through 17) compared, but the slopes between increments 1 through 4 were also separately calculated. This was done because of the hypothesized change in composite action that

Figure 5.1 Gauge G2-A Increased E FEM

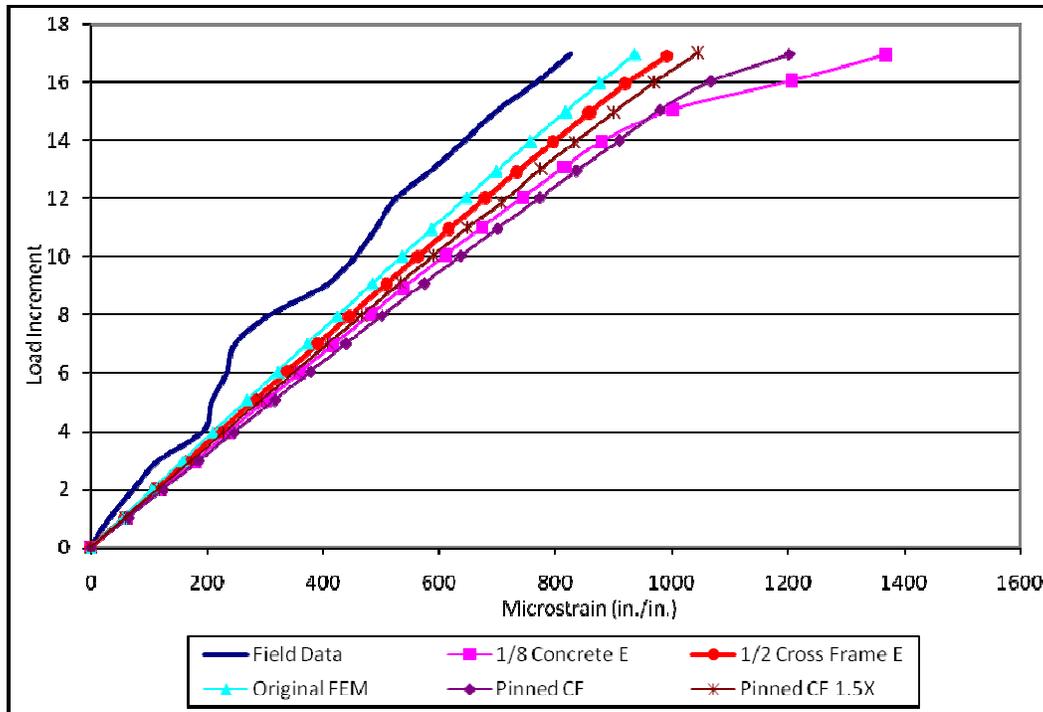
Figure 5.2 Gauge G2-A Remaining FEM

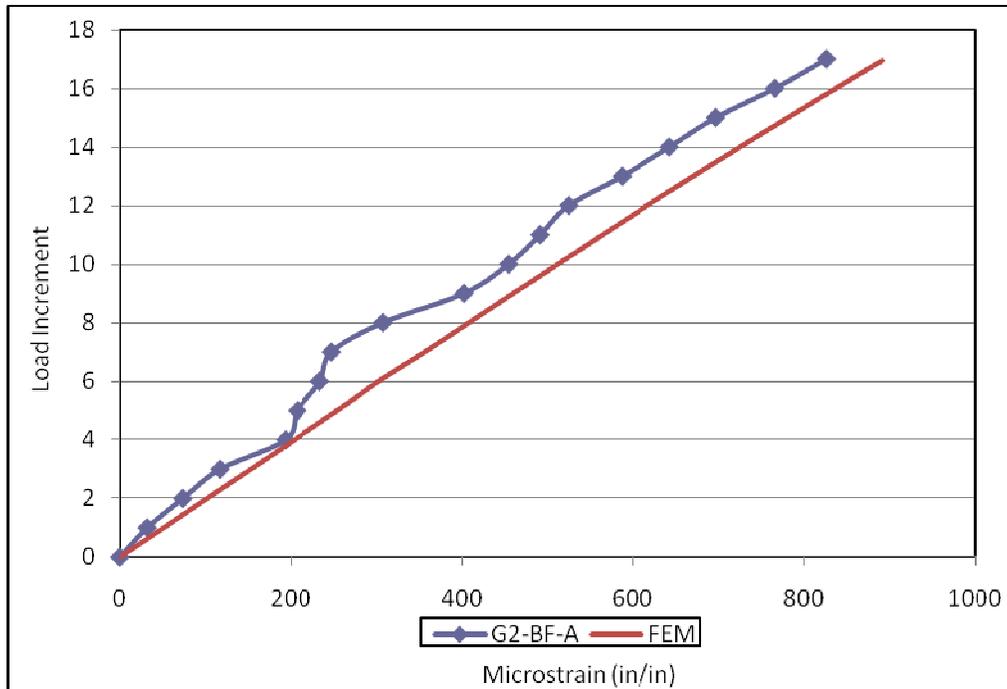
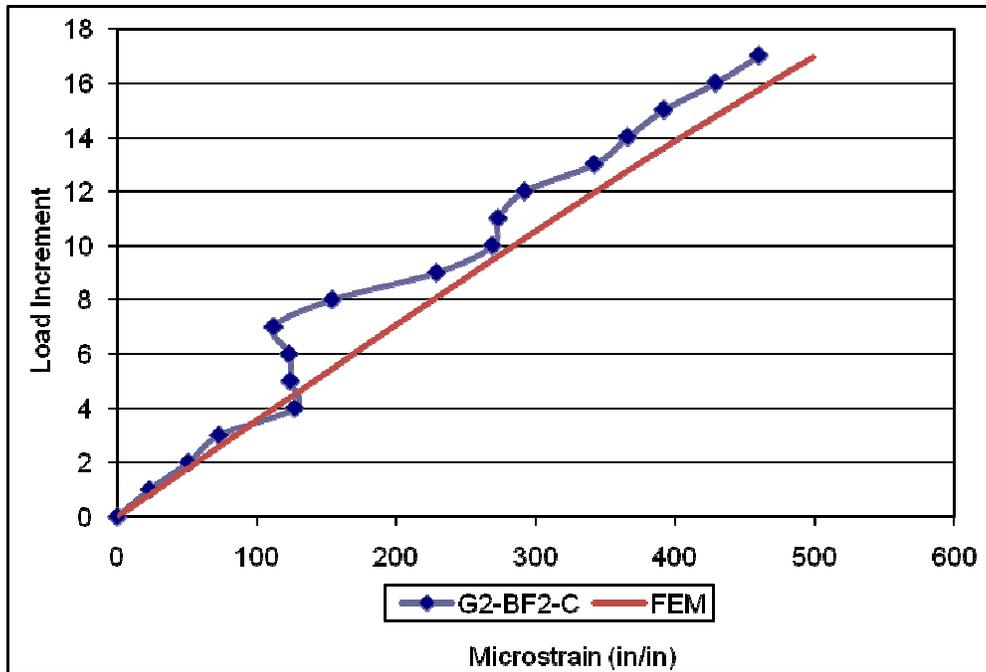
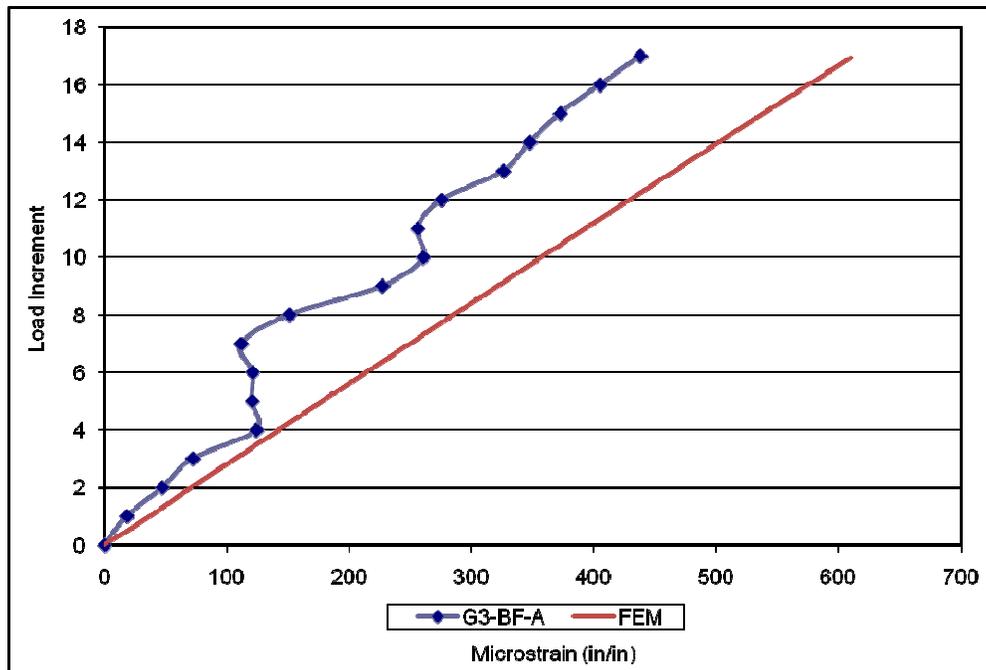
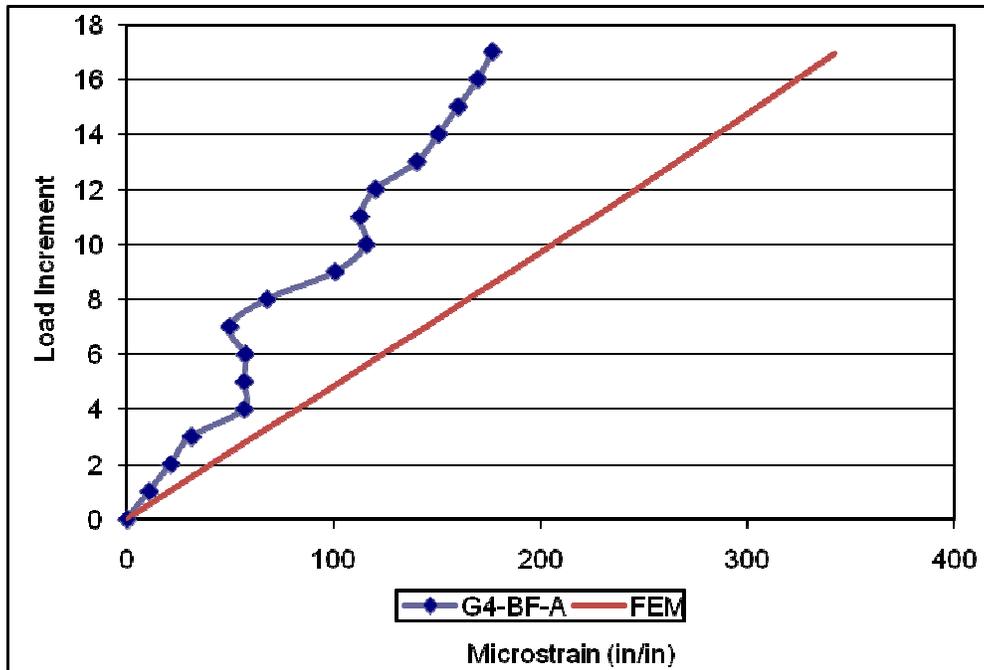
Figure 5.3 Gauge G2-BF-A Field Data and Calibrated FEM Results

The primary purpose of creating the FEA was to predict the post-elastic response of the bridge in order to better understand the system behavior of this common bridge configuration. It was determined through the FEA that the ultimate capacity of this structure was 30 HS-20 trucks. The purpose of this section is to investigate the response of the bridge up to this level of loading.

Figure 5.4 Gauge G2-BF2-C Field Data and Calibrated FEM Results

Figure 5.5 Gauge G3-BF-A Field Data and Calibrated FEM Results

Figure 5.6 Gauge G4-BF-A Field Data and Calibrated FEM Results

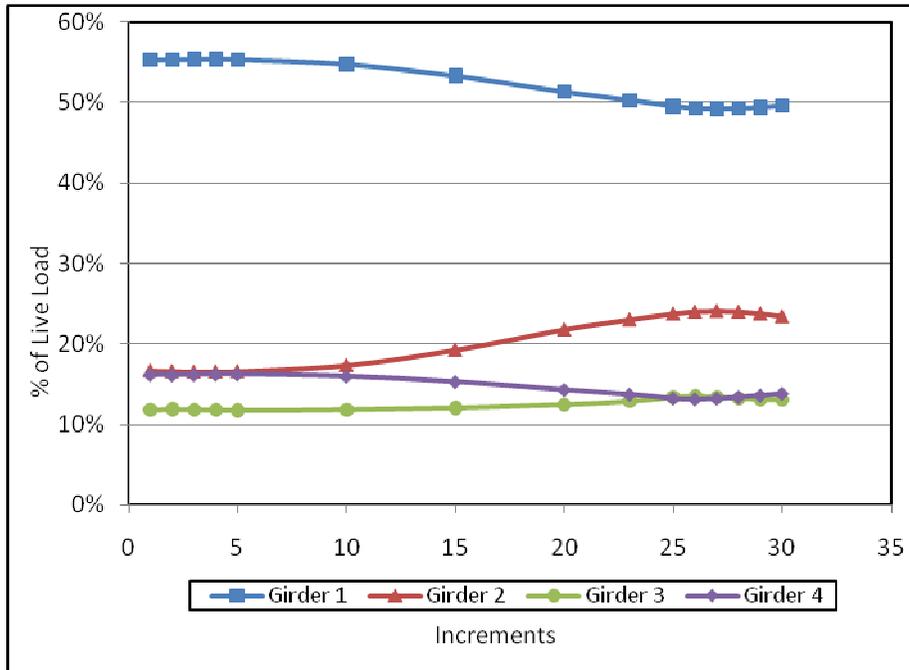
Figure 5.8 Percent of Loading Carried at each Girder Reaction

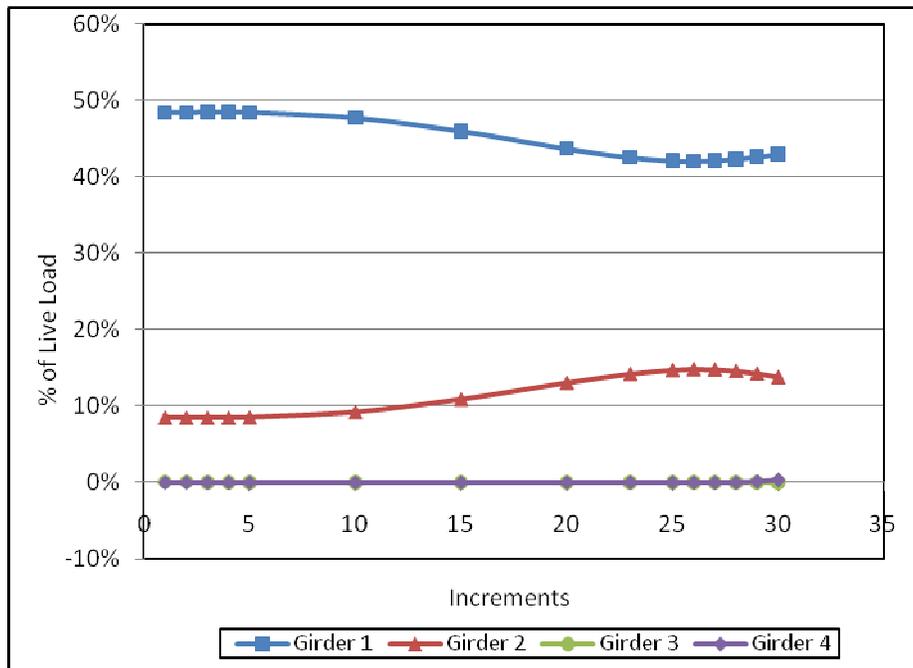
Figures 5.9 and 5.10 show graphs similar to the percent of live load vs. truck increment graph in Figures 5.8 except these graphs consider the reactions at each end of each girder. Specifically, Figure 5.9 graphs the west reactions at each girder and Figure 5.10 graphs the east reactions at each girder. These show that the west support of Girder 1 carried the majority of the live loads, by over a 29% margin, during each increment.

Figure 5.9 Percent of Loading Carried by West Supports

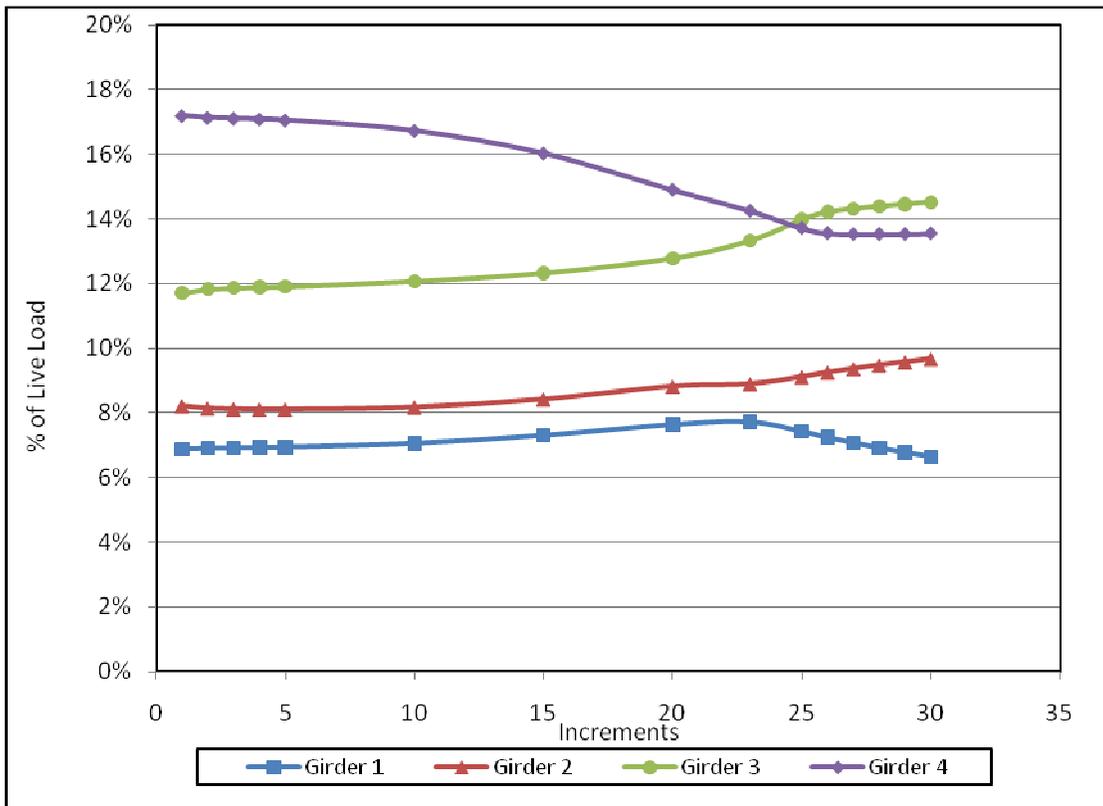
As shown in Figure 5.10, the loading is distributed between the east girder reactions much more evenly compared to the west girder reactions. This is attributed to the fact that the east supports that are closest to the centroid of the loading also require the greatest transverse distribution of loading, making these supports (at Girders 3 and 4)

Figure 5.10 Percent of Loading Carried by East Supports

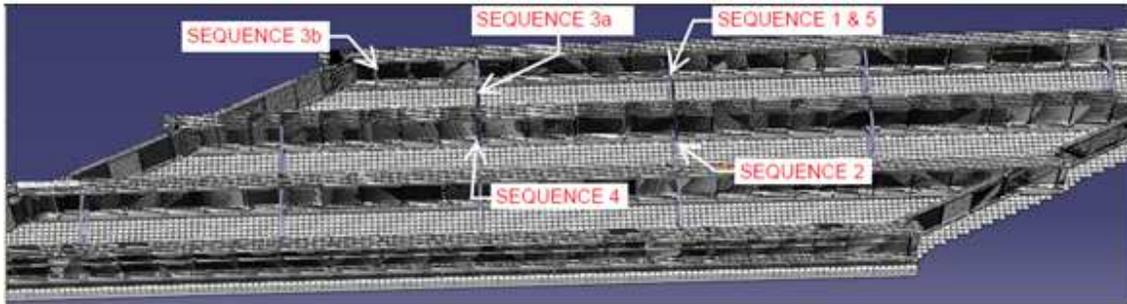
in several of the elements thought to be experiencing shear yielding and it was found that the shear stress comprised at least 84% of the total stress (summing the two in-plane stresses and the shear stresses) in these elements. The yielding that occurred at the bottom flanges over the supports was neglected when compiling the data in Table 5.11 and Figures 5.11 through 5.13 because this yielding is fairly isolated (never extending through the web depth). However, the shear yielding at the end of one girder that is mentioned above is included because this yielding is much more significant, extending through the full depth of the web and beyond the 22.5 ft distance between the support and the nearest cross frame location (as will be shown below). Figures 5.11 through 5.13 present an upside-down view of Bridge 7R from the FEA. Thus, Girder 1 is at the top of the figures and Girder 4 is at the bottom of the figures and the bottom flanges are towards the top of the figures and the top flanges are towards the bottoms of the figures. The

Figure 5.11 16 HS-20 Truck Yielding Pattern

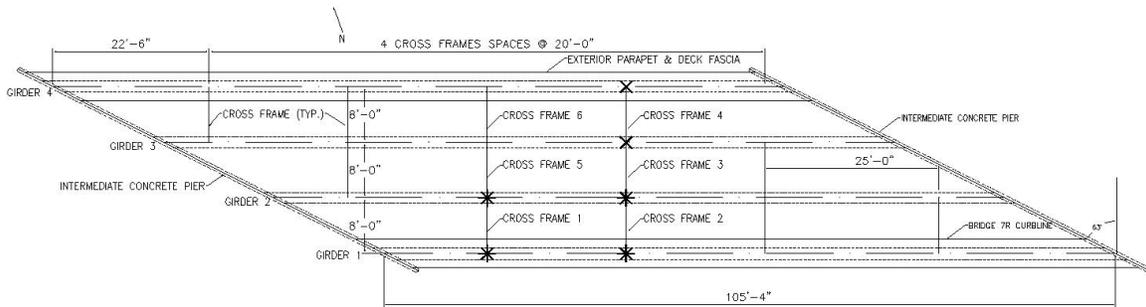
Each of the ends of the cross frame members was connected to a node on the girders, which are in turn surrounded by four elements. The progression of yielding in these elements was analyzed based on the premise that the more elements adjacent to the cross frame connection that yield, the less loading that will be transferred to the cross frame. The summary of this analysis is presented in Table 5.12. Overall elements surrounding 14 connection points between the cross frames and girders had yielded. The location of each of these cross frames can be seen in Figure 5.14. It should be noted that, because of the way the cross frames are connected directly to the girders in the model, adjacent cross frames in the same bridge cross-section will share a common connecting node (for example the chords of Cross Frames 1 and 5 both connect to the same nodes on Girder 2). The entries in the table are organized by cross frame members but since two cross frames can connect to a girder, the yielding maybe shown at a different cross frame. The three columns to the right of the table display the truck increment at which the given

Figure 5.14 Cross Frame Locations

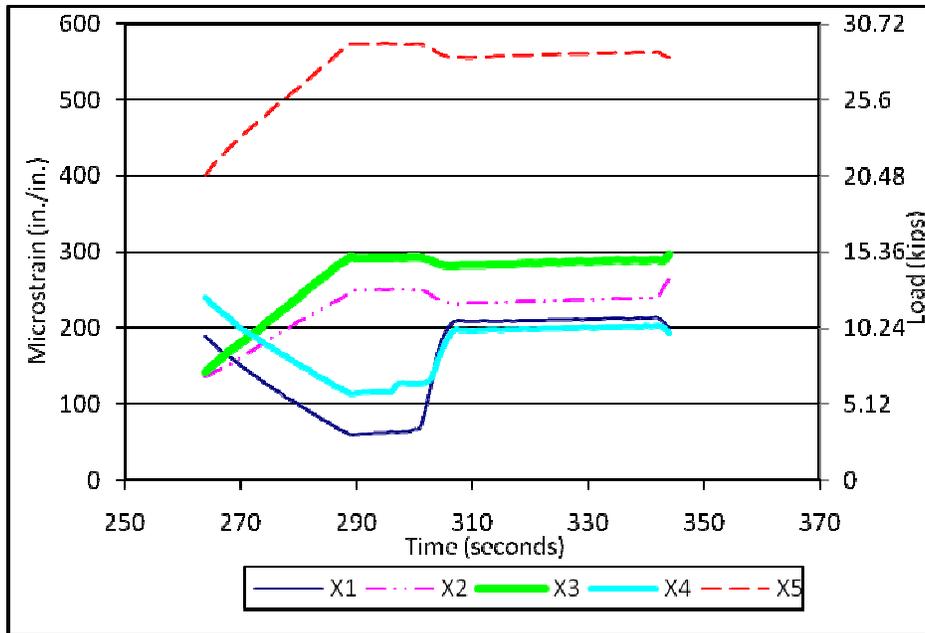
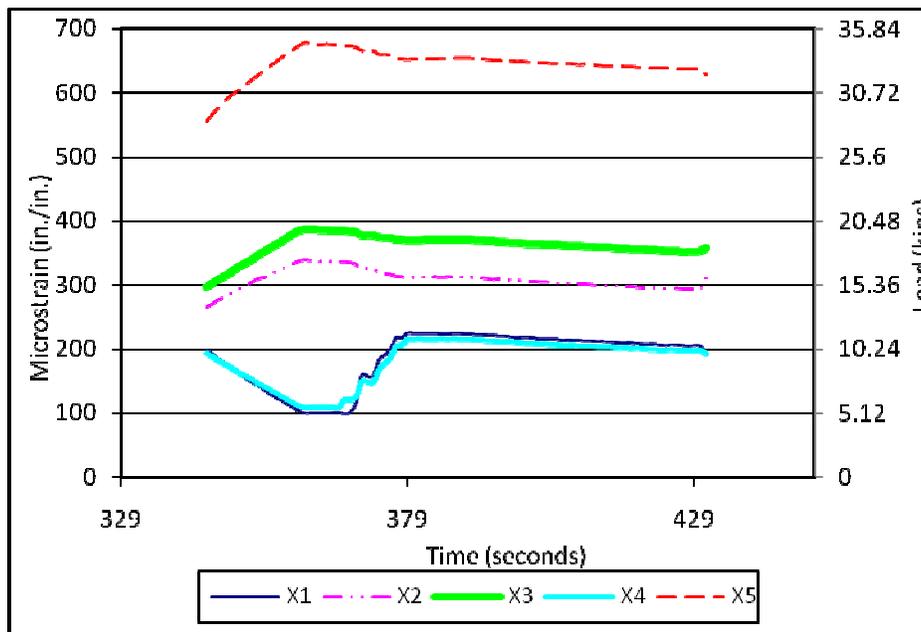
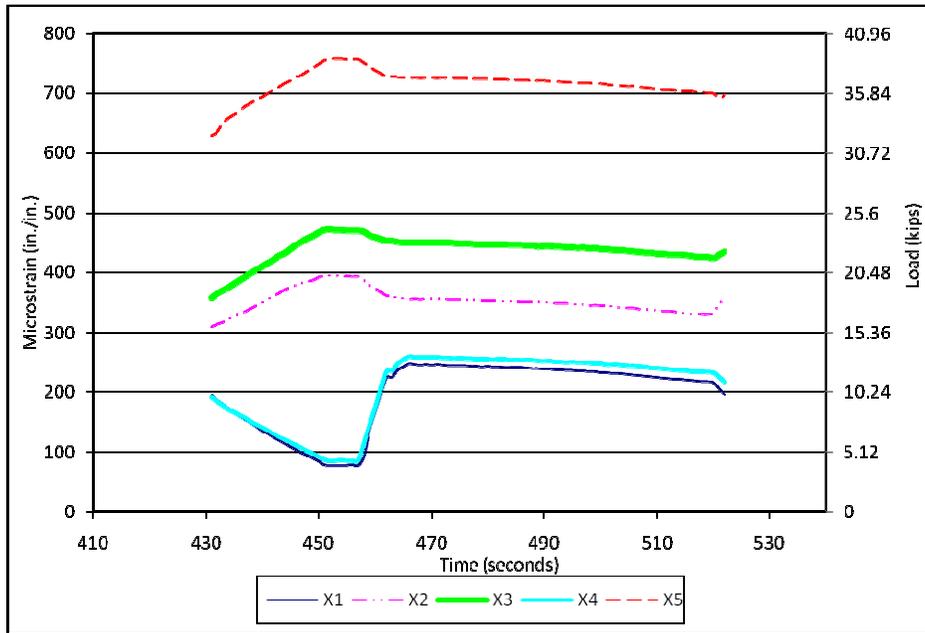
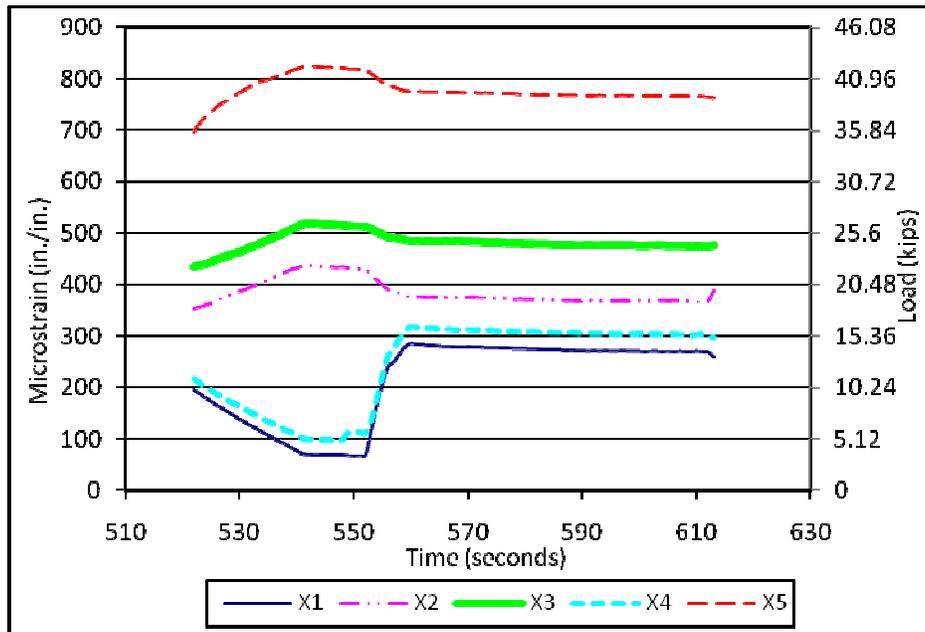
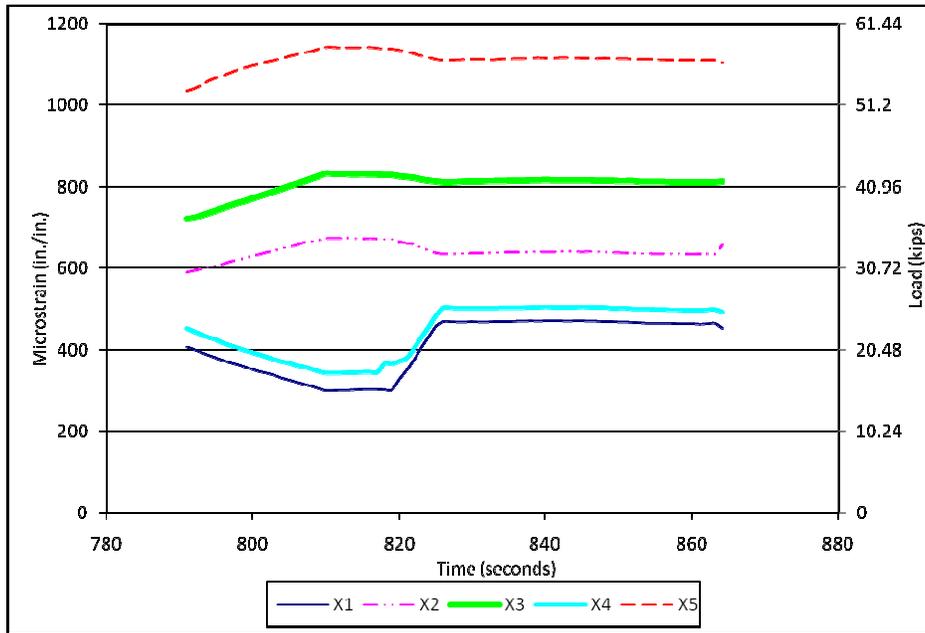
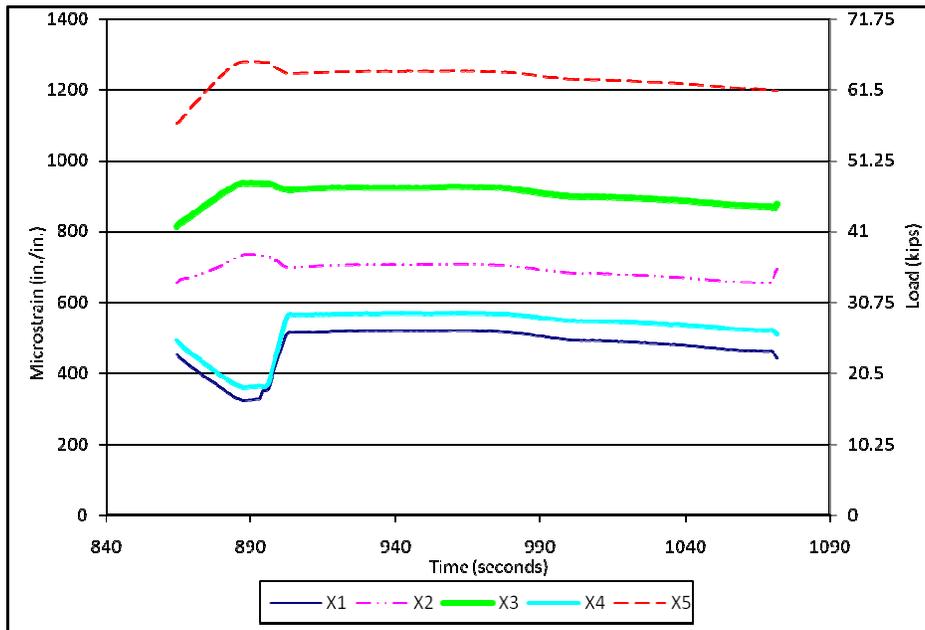
Section 4.2 graphed the strains in each of the five coil rods versus time for increments 1-3. The contents in this appendix contain similar strain graphs from increments 4-17. The increments of loading are discussed in Section 3.1.

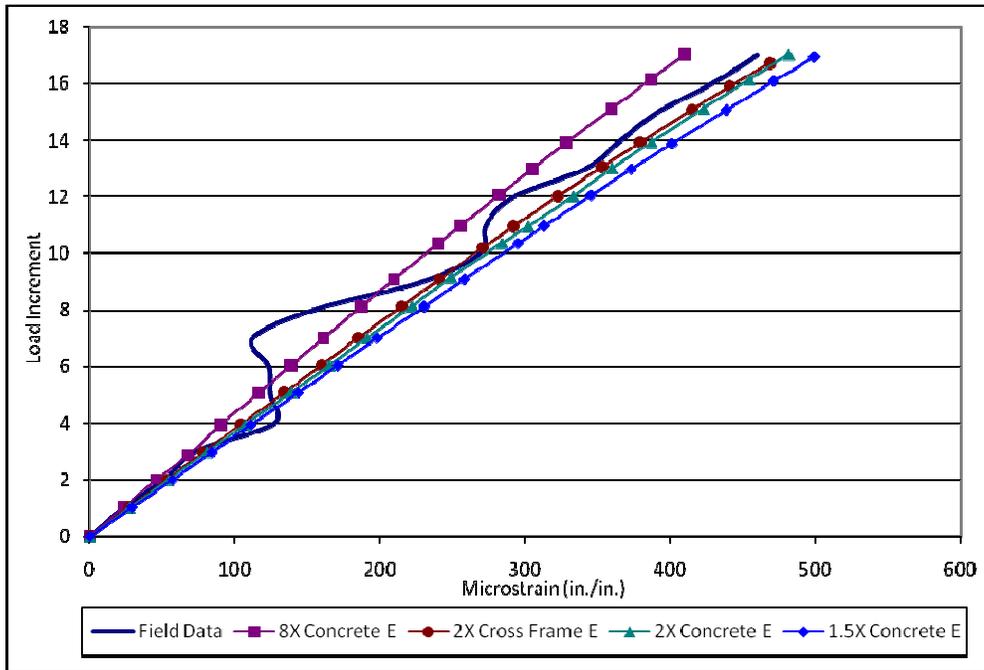
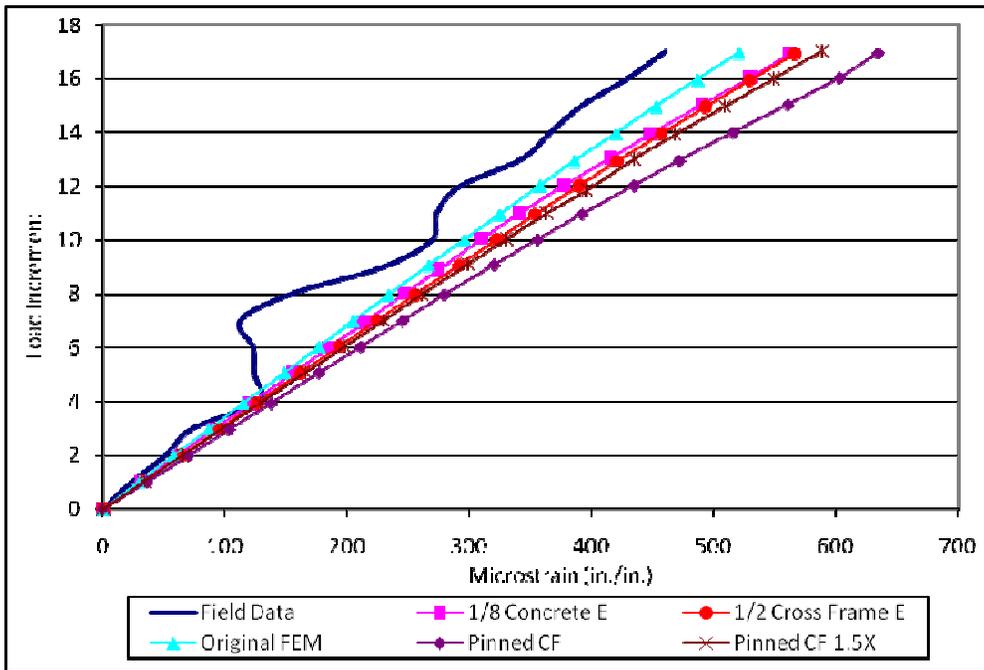
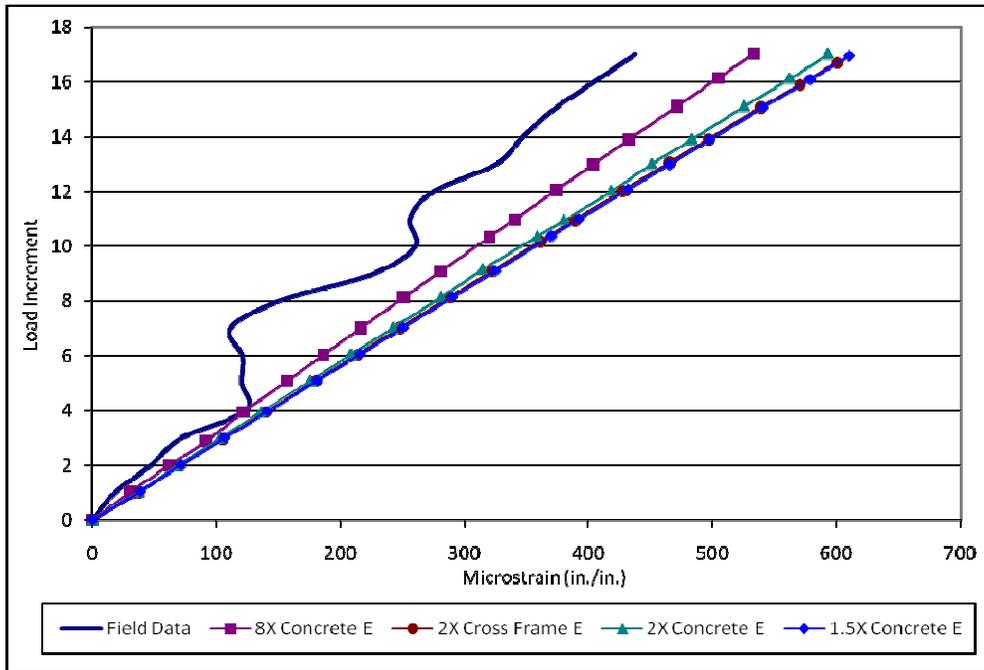
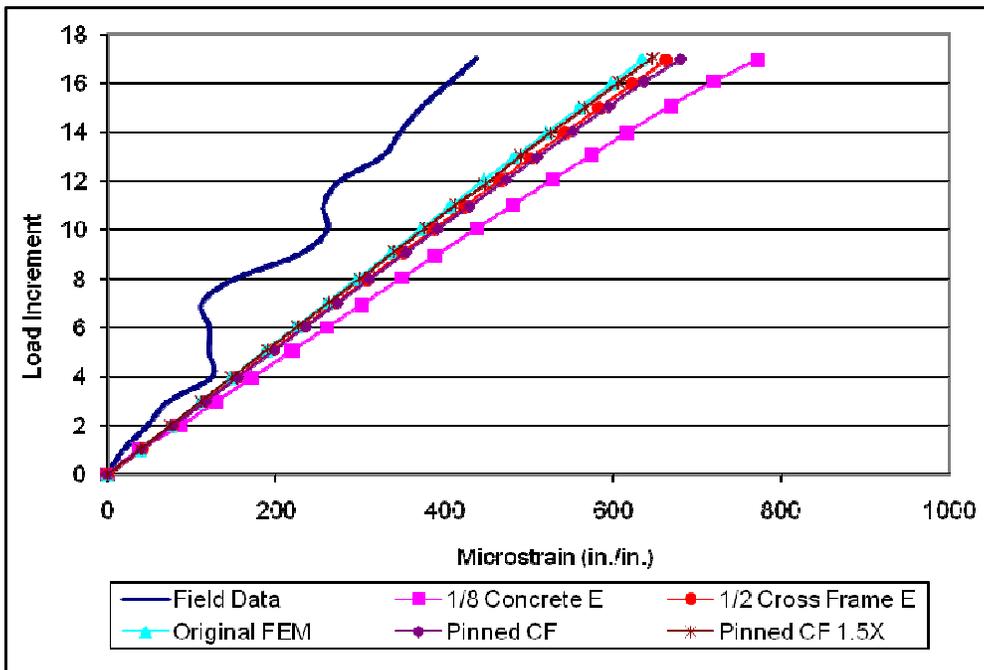
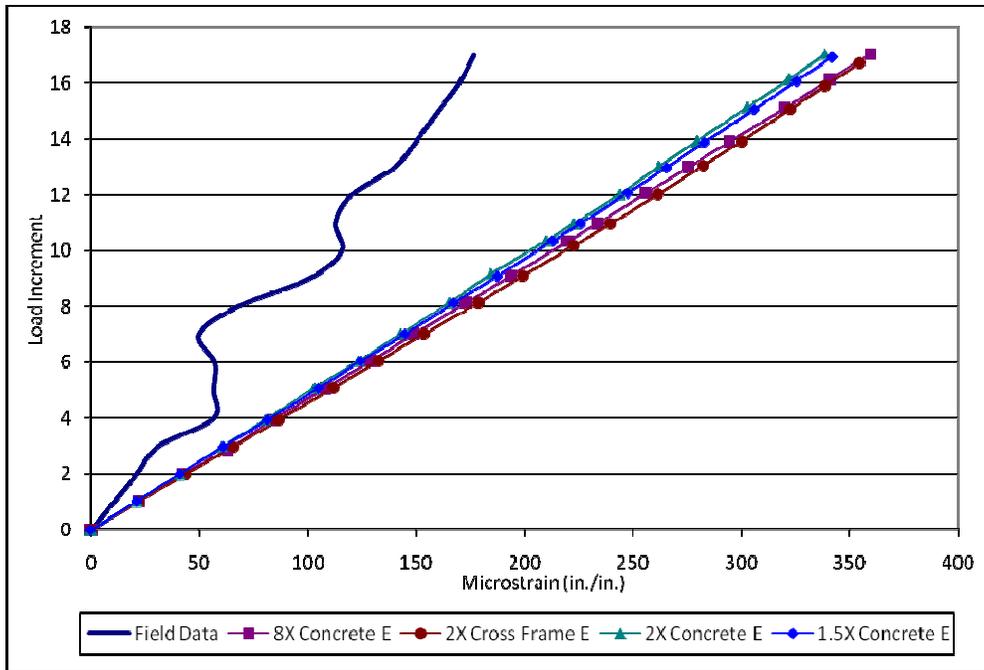
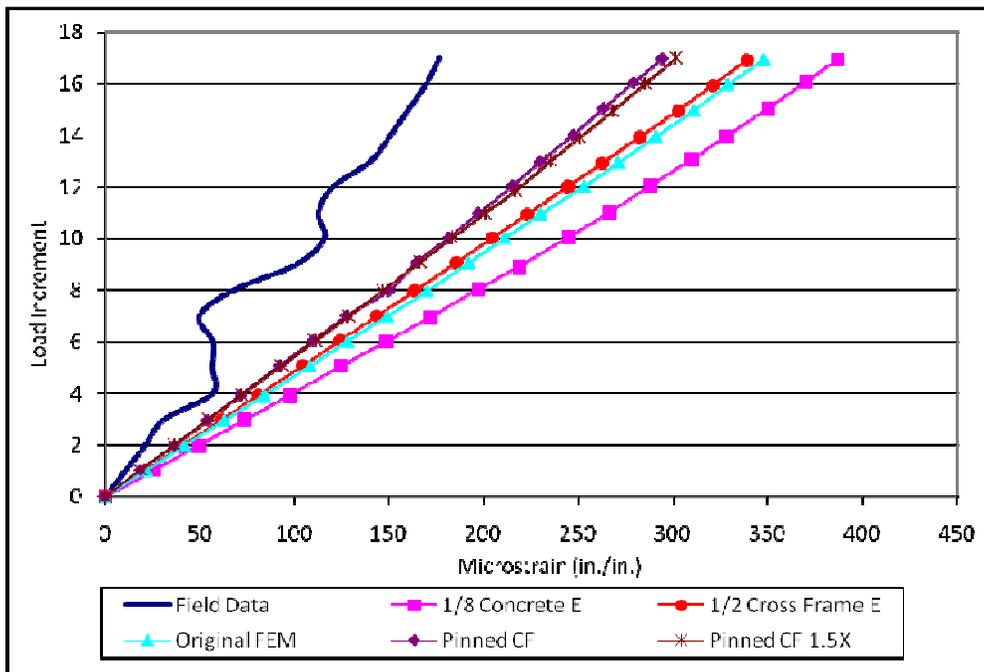
Figures C-1 through C-6 graph truck increments versus microstrains resulting from the FEA and field testing. This is the data used to calculate the slope values presented in Tables 5.1 through 5.4. The data at each gauge location is plotted on two different graphs due to the large number of data generated at each gauge. Here one graph shows the series that involved increasing the elastic modulus in the model and the other graph shows all other analyses. The field data is shown in all graphs for comparison purposes. Specifically, Figures C-1 to C-2, C-3 to C-4, and C-5 to C-6 are graphs of Gauges G2-BF2-C, G3-A, and G4-A respectively. Figures C-1, C-3, and C-5 are graphs of field data results along with the models that had the elastic modulus of the concrete or cross frames increased. Figures C-2, C-4, and C-6 are graphs of the field test data, 1/8 elastic modulus of concrete, 1/2 elastic modulus of the cross frames, the original model, and both the pinned cross frame connection models.
