**EVALUATING RESERVE BRIDGE CAPACITY
THROUGH DESTRUCTIVE TESTING
OF A DECOMMISSIONED BRIDGE**

A thesis submitted to the Faculty of the University of Delaware in partial fulfillment of the requirements for the degree of Master of Civil Engineering

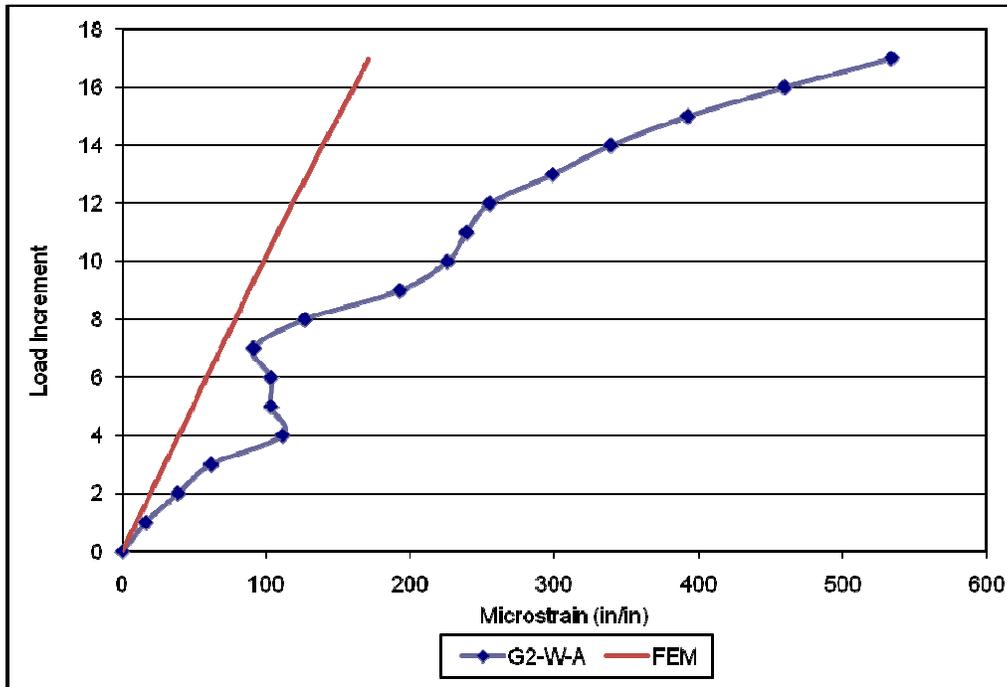
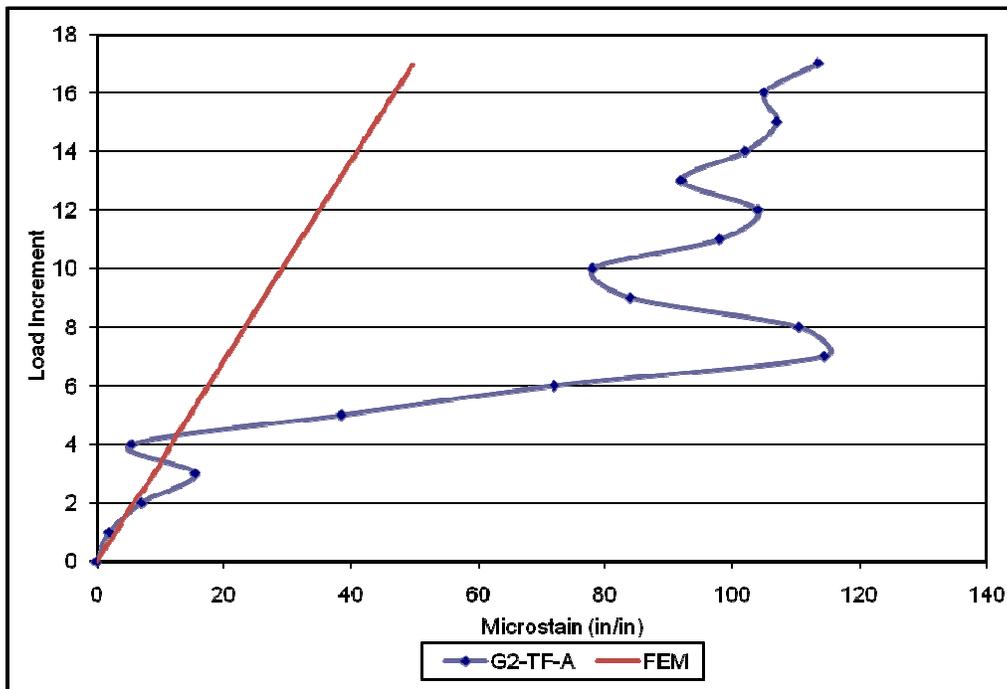
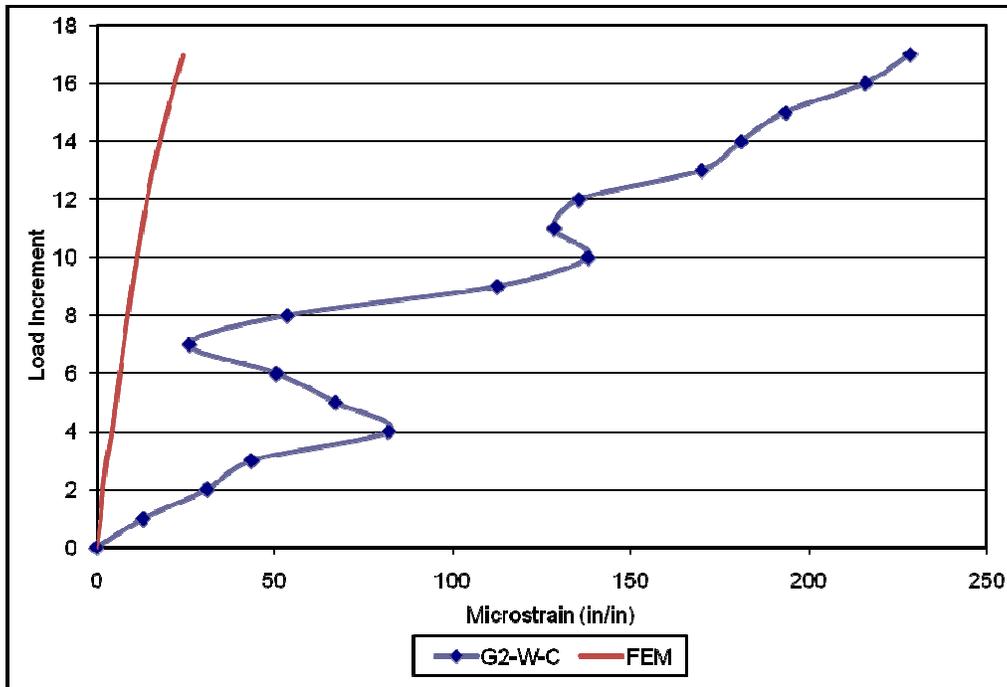
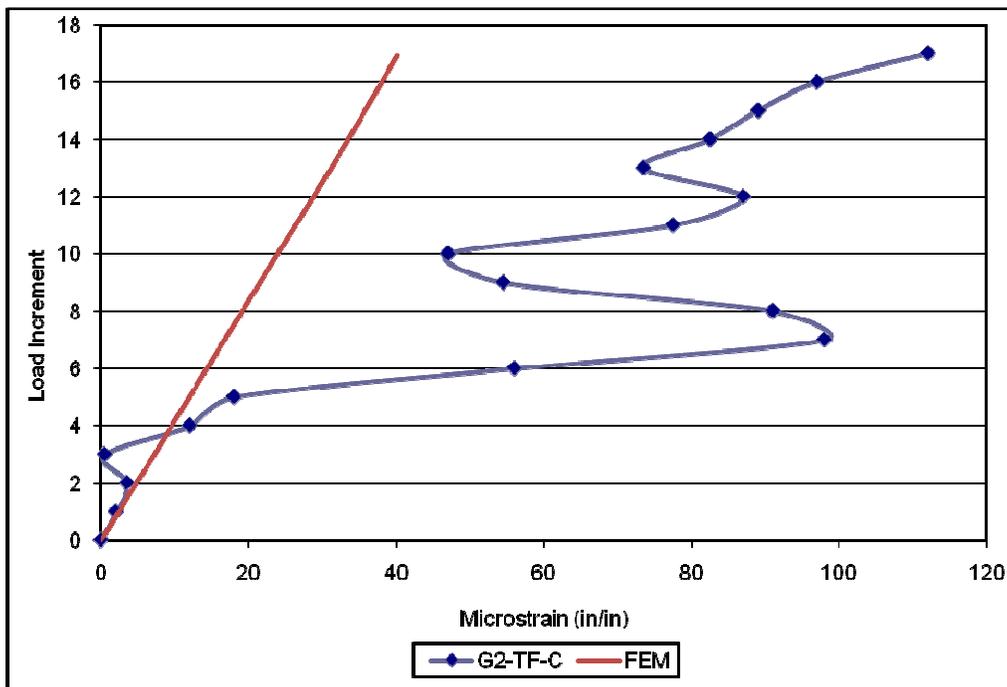
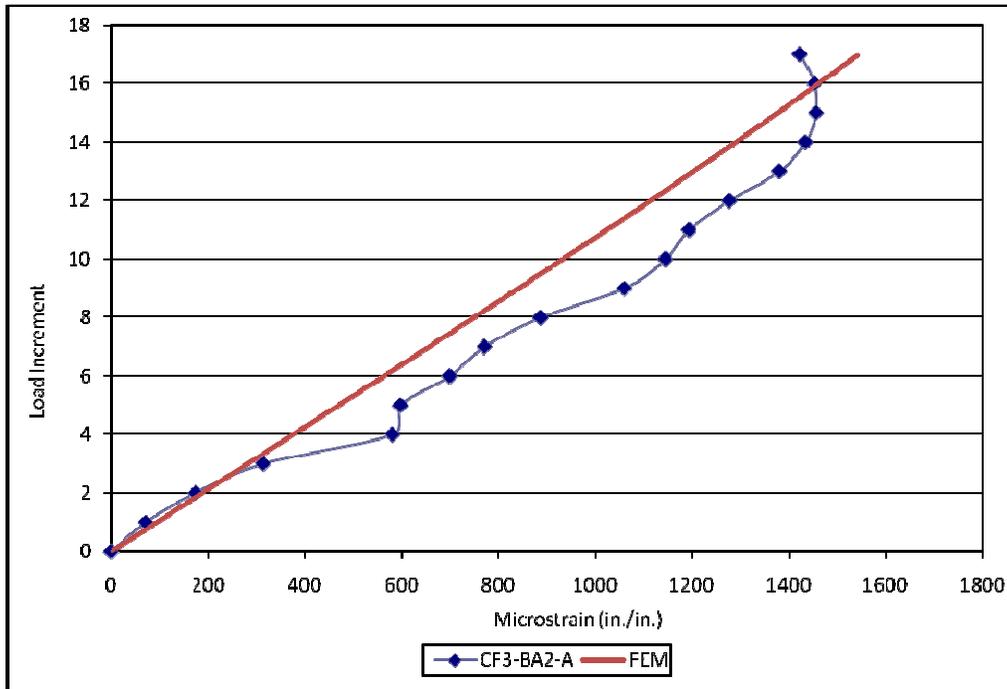
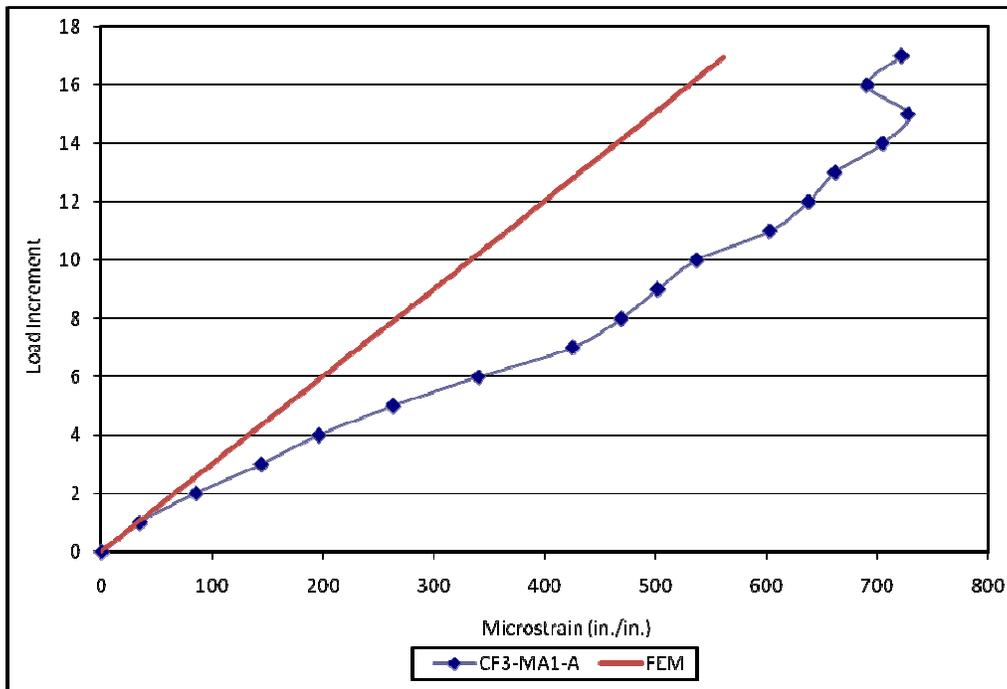
The graphs in Appendix D are graphs of the load increments vs. microstrains from the field test data and the calibrated FEA, which increased the elastic modulus of the concrete by 150% compared to the original model. The webs, top flanges, and Cross Frame 3 graphs (Figures D-1 to D-7) from the FEA predict greater strains than the field test at the majority of increments. The Cross Frame 4 graphs (Figures D-8 to D-10) are similar to the bottom flange comparisons of the field data and calibrated model (shown in Figures 5.1-5.4) in that the field data strains are greater than the FEA strains at the majority of the increments. The comparison between the field data and calibrated model shown in this appendix is only included for completeness. Due to the difficulty in achieving correlation between the bottom flange strains in the model and field data, no attempt was made to achieve consistency between the FEA results shown in this appendix and the field data.
