**Field Report**

**Plan for Rocky Run Environmental Protection (PRREP)**

Draft April 15 2015

The Nature Conservancy: Delaware Chapter  
Wilmington, Del.

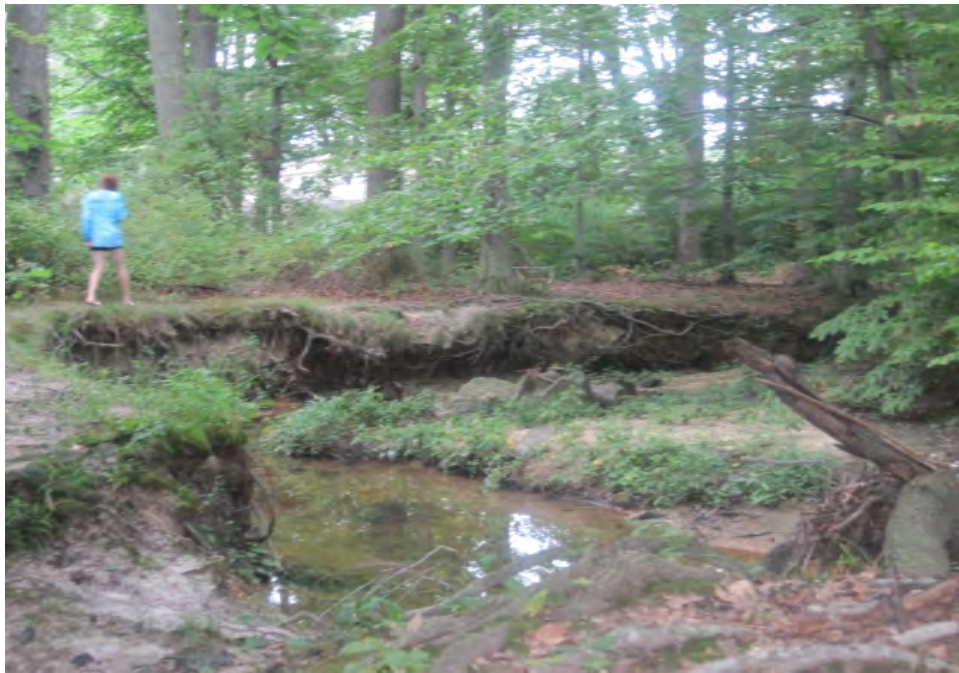
**Figure 3.1.** Residential greenway site (R3) along Rocky Run

**Residential Greenway (R3):** Located in a residential area near Devonshire Park behind the Concord Mall in subwatershed R3, this is the most upstream site in Upper Rocky Run. In this section of the stream, Rocky Run is a meandering creek following the typical riffle-run-pool sequence with highly eroded and undercut banks (Figure 3.1). On both side of the stream is a narrow forested buffer and in some areas there is evidence of ephemeral washes and small pipes that likely drain nearby residential yards and roadways.

**Habitat/Physical Assessment:** This reach of the Rocky Run scored a total 117 of 200 in the EPA rapid habitat assessment, a score that measures on the low end of the suboptimal range. Scores for the subcategories in this assessment show suboptimal conditions for epifaunal substrate and available cover, pool substrate characterization, pool variability, sediment deposition, channel flow status, and channel alteration. Channel sinuosity was rated as marginal, owing largely to

Biological Assessment: Two hundred and nine organisms were collected from this site. Of those macro invertebrates, 158 fell into the pollution tolerant category. The most abundant taxa collected were flat worms and worms at 90 and 40 sites, respectively. Because the majority of organisms identified in this survey were highly pollution tolerant, this site was given a VASOS index of 6, which indicates that the water quality in the Residential Greenway is in an unacceptable ecological condition to support healthy, diverse aquatic life.

**Structural Recommendations:** The primary recommendation to restore the impaired waterways in the Upper Rocky Run subwatershed is to remove the trapezoidal concrete channel that stretches from the north end of the Concord Mall to the Route 202 overpass. The previous chapter details the negative impacts on ecology and habitat associated with stream channelization, and the best way to improve this section of the stream is to remove the concrete channel and restore natural benthic and stream bank conditions. However, this method would likely be a costly venture that would require a significant financial commitment from interested parties as well as the cooperation of the local landowner (Concord Mall Management). Regardless, it may be worth the effort to complete a feasibility study on channel removal.

Because channel removal may be cost prohibitive, other structural techniques ought to be considered in the reaches of the stream around the Concord Mall. In this area behind the restaurant Red Lobster, there is a large stormwater retention basin that is meant to capture some of the water from an adjacent strip mall before it enters the stream. The researchers recommend studying the feasibility of retrofitting stormwater basins along the Concord Pike commercial corridor to increase its water storage and infiltration capacity to mitigate the effects of large

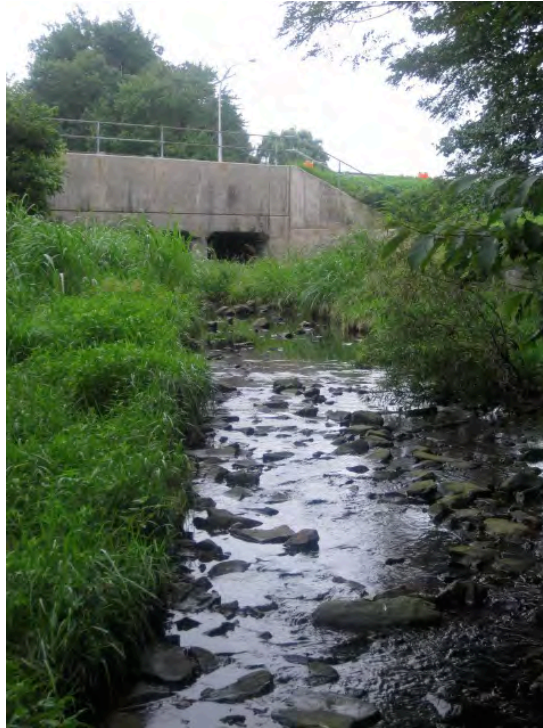
**Figure 3.2.** Route 202 overpass along Rocky Run

**Route 202 Overpass:** Route 202 crosses Rocky Run as a six-lane highway surrounded by stores, strip malls, and hotels. This particular stretch of Rocky Run is located just downstream of the Route 202 overpass. This site is at the end of a mile long concrete channel through which the stream flows. Some areas of that channel are in serious disrepair, and natural stream conditions begin to reemerge. In other areas, the channel remains eroded and impaired, supporting minimal or no aquatic flora and fauna. At this site there was a noticeable amount of litter, which is likely related to the site’s proximity to the highway as well as a major strip mall and two large hotels.

Habitat/Physical Assessment: The EPA rapid habitat assessment results in this section of Rocky Run led to a suboptimal habitat rating with a score of 125/200. Suboptimal scores were given for the epifaunal substrate/available cover, pool substrate characterization, pool variability, sediment deposition, bank stability, and vegetative protection along this reach. Channel sinuosity was found to be marginal, given that this site location is just downstream of Rocky Run’s concrete

channelized reach. Riparian vegetative protection was found to be poor, as a major strip mall and two hotels are located within approximately 30 feet of the stream at this location. Undercutting of the stream banks was observed. However, most of the undercutting was observed on one side of the stream rather than both sides in the cross section measurements.

**Biological Assessment:** As in Site #1, there was minimal biodiversity at site #2 and the majority of the organisms represented in the sample were pollution-tolerant flatworms (141 out of a total of 169 organisms). The second most abundant organisms were midges (16 identified individuals). Though the goal of this biological assessment is to collect and document 200 individual organisms, researchers completed the four kicknet samples (the maximum number allowed by this protocol) and were still no able to reach the desired sample size. With a Va. SOS index of 4, the water quality at Route 202 was labeled as being in an unacceptable ecological condition to support healthy, diverse aquatic life.

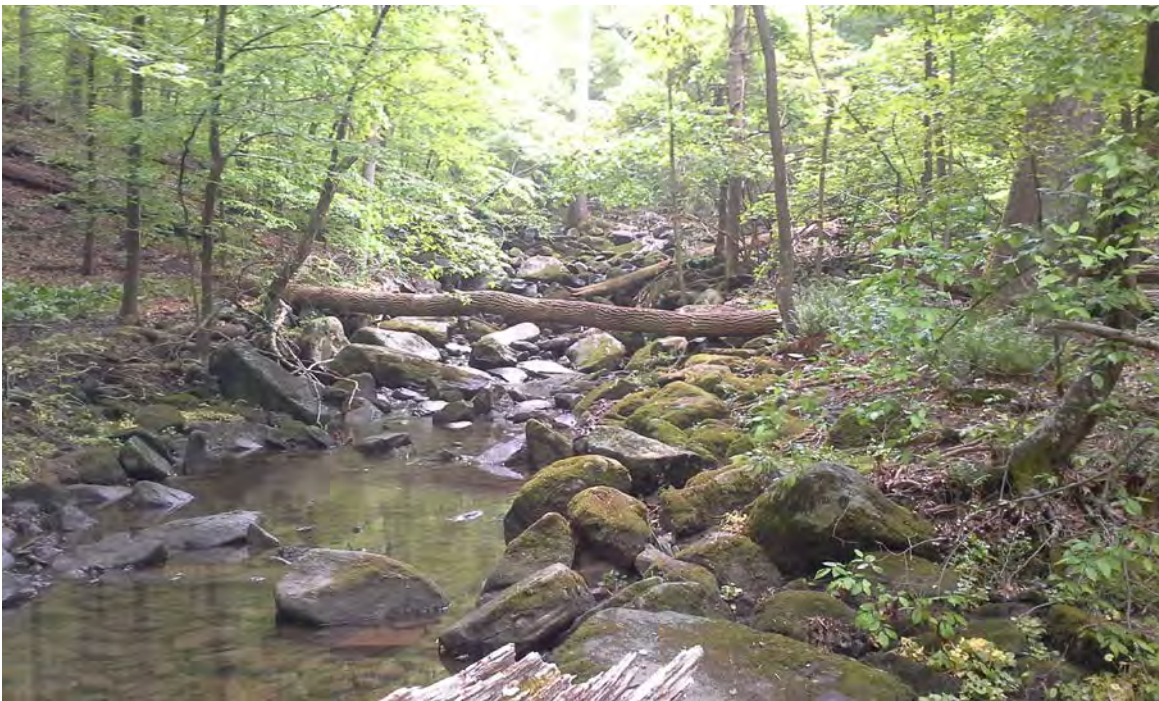
**Figure 3.3.** Hurricane Run confluence in R6

**Hurricane Run Confluence:** Site #3 is located just upstream of Upper Rocky Run’s confluence with Hurricane Run. Below this point the two streams merge to form the Rocky Run main stem. This segment of the stream is characterized by a large boulder field, both within the stream channel and along the banks. So numerous were the boulders that it was difficult to discern the boundaries of the stream banks. A wide forested riparian buffer lines both sides of the stream in this area. Some street litter was found among the boulders at this site, and the researchers believe it is likely that this litter was washed downstream from the more urbanized headwaters during storm/flooding events.

**Habitat/Physical Assessment:** This study site received an overall rating of 146 of 200 using the EPA rapid habitat assessment method. This value is in the high end of the suboptimal range and

**Biological Assessment:** Because of the large number of boulders located within this site, there were few stream riffles in which the researchers could collect samples of macro invertebrates. From 4 kicknet samples (the maximum allowed in under the Va. SOS protocol), only 10 organisms were collected: 4 caddisflies, 3 common net-spinners, 2 crane-flies, and 1 sowbug. These numbers indicate a proportionally high number of pollution intolerant species and rendered a Va. SOS index of 9, meeting acceptable ecological conditions. It should be noted that the small number of macro invertebrates collected is less indicative of the quality of the natural habitat at this site and more indicative of the difficulty that the site presented for sampling techniques. Maneuvering the kicknets around the boulder system and finding riffle sections of the stream to survey was hampered by the dense boulder system. However, the researchers believe that the Va. SOS findings, despite being based on a small sample size, are accurate in their description of the overall quality of the ecological habitat at this site given the types of organisms collected.

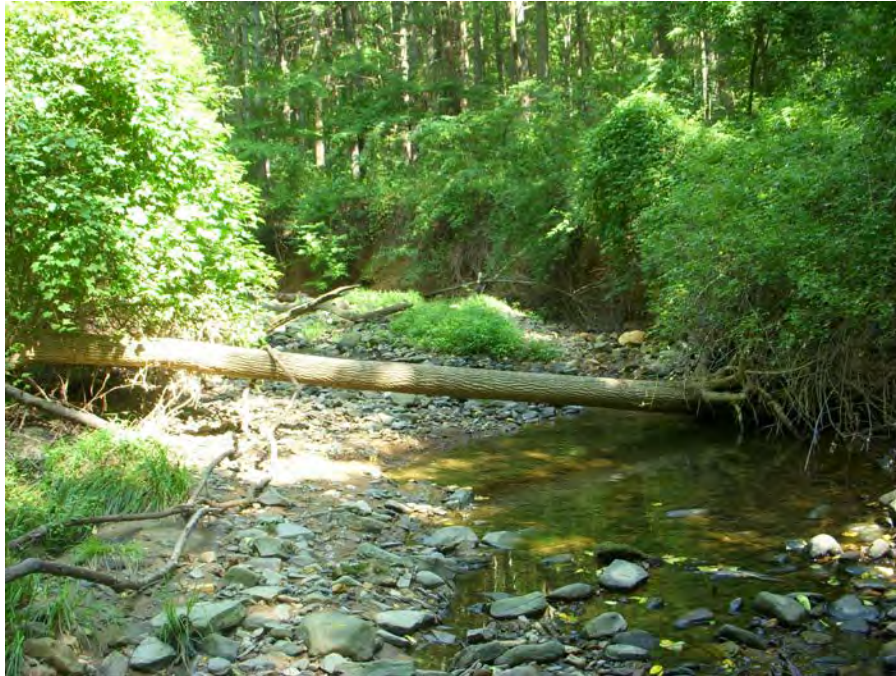
**Figure 3.4.** Lower Hurricane Run in H1

**Lower Hurricane Run:** The Lower Hurricane Run site is located within a heavily forested area of the Hurricane Run subwatershed. With its extensive trail system, hikers, runners and horseback riders often utilize this area. Much of this stream segment has eroded and undercut banks but perhaps the most defining characteristic is the large step-like topography of the underlying bedrock.

**Habitat/Physical Assessment:** The Lower Hurricane Run study site received a rating of 147.6/200 using the EPA rapid habitat assessment method, a value which is just below the minimum score (150/200) needed for an optimal rating. Score reductions were the result of erosion and undercutting along the stream's right bank (which yielded low suboptimal observations for bank stability) and lack of channel sinuosity (which produced only marginal ratings in this category). Lower Hurricane Run's epifaunal substrate/available cover, pool substrate characterization, pool variability, and channel alteration were all found to be optimal. Sediment deposition, channel flow status, vegetative protection, riparian vegetative zone width were all rated on the high end of the suboptimal range. As in Sites #1 and #2, the Lower Hurricane Run site also had noticeably steep and undercut riverbanks.

Biological Assessment: Only 36 organisms were collected in the four kicknet samples taken, which is likely because there were more runs and pools at this specific site than riffles (the ideal sampling condition). However, of those 36 individuals, 26 were caddisflies, stoneflies, and mayflies at 18, 5, and 3, respectively. These organisms are highly intolerant of pollution and their presence indicates good quality habitat. As such, with a Va. SOS index of 10, Lower Hurricane Run was at an acceptable ecological condition. It should also be noted that Hurricane Run is not listed as an impaired waterway on the 303(d) list put forth by DNREC and the EPA.

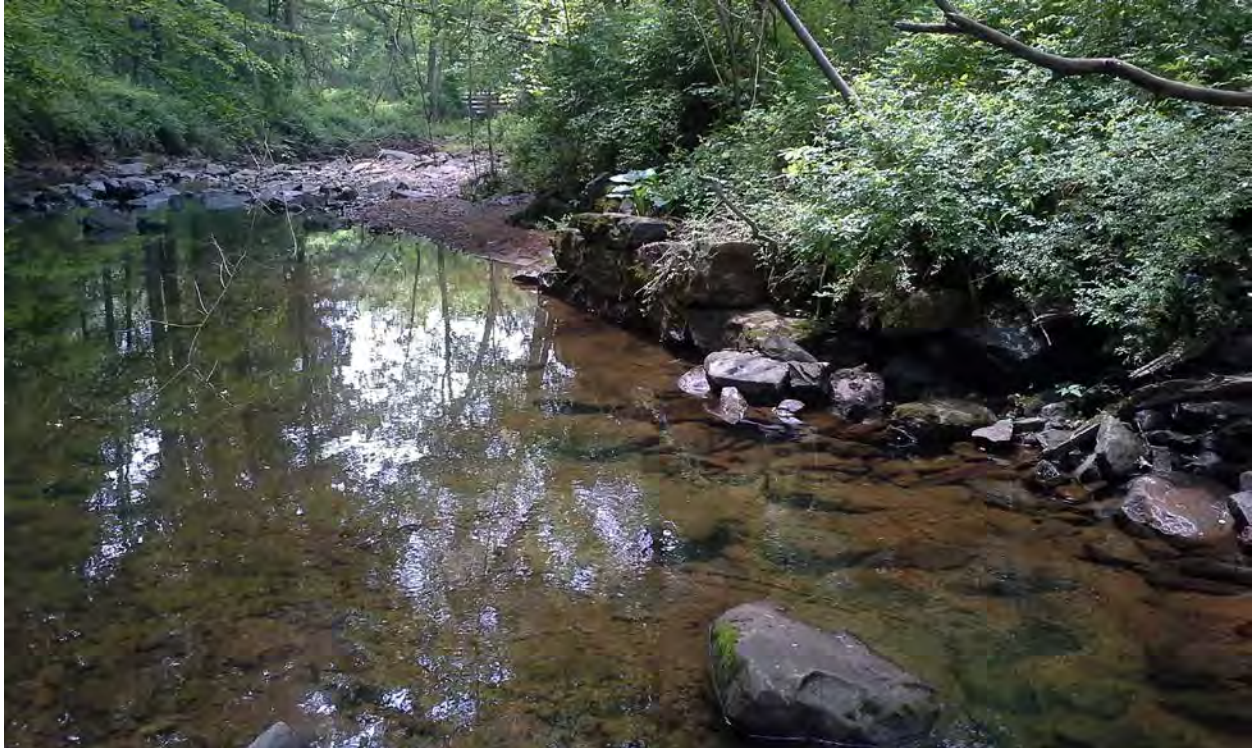
**Figure 3.5.** The Brandywine confluence with Rocky Run in R7

**Brandywine Confluence:** The fifth site just above the confluence of the Brandywine Creek and the Rocky Run main stem was reached by a trail through the Brandywine Creek State Park. This segment of Rocky Run also contained a great number of boulders and stones, but not to the magnitude of Site #3. There were also what appeared to be the remnants of a stone dam or mill located on the western stream bank at this site.

Habitat/Physical Assessment: The Rocky Run at Brandywine Creek confluence study site received an overall rating of 153/200, which is considered to be optimal. This was the highest ranking received of the five study sites. The high rating is the result of the optimal ratings given for the subcategories of epifaunal substrate/available cover, pool substrate characterization, pool variability, channel flow status, and channel alteration. Both sediment deposition and riparian vegetative zone width were ranked on the high end of the suboptimal range. Channel sinuosity and bank stability were rated as suboptimal along this reach of the river. As in some of the upstream sites, Site #5 showed signs of bank undercutting and steepness.

Biological Assessment: Site #5 was particularly notable for the great number of caddisflies present. So numerous were the caddisflies that one could see them resting on the rocks without having to pick them up. Of the total 146 organisms sampled, 116 were caddisflies. These organisms are highly pollution intolerant and can only survive, especially in such large populations, in high quality habitats with minimal contamination. Thus, the Va. SOS index was 10, meeting acceptable ecological conditions.

Some areas of the Rocky Run Main Stem display significant erosion and undercutting. Researchers recommend that a feasibility study be conducted on the potential to use bioengineering techniques to restructure and reposition the natural boulder system that exists within the stream to stabilize heavily eroded portions of the stream bank.
