FINAL PROJECT REPORT #56

SAN BRUNO CALIFORNIA,  
SEPTEMBER 9, 2010  
GAS PIPELINE EXPLOSION AND FIRE

**Disaster Research Center Final Project Report  
University of Delaware, Newark DE**

**August 2011  
(revised May 2012)**

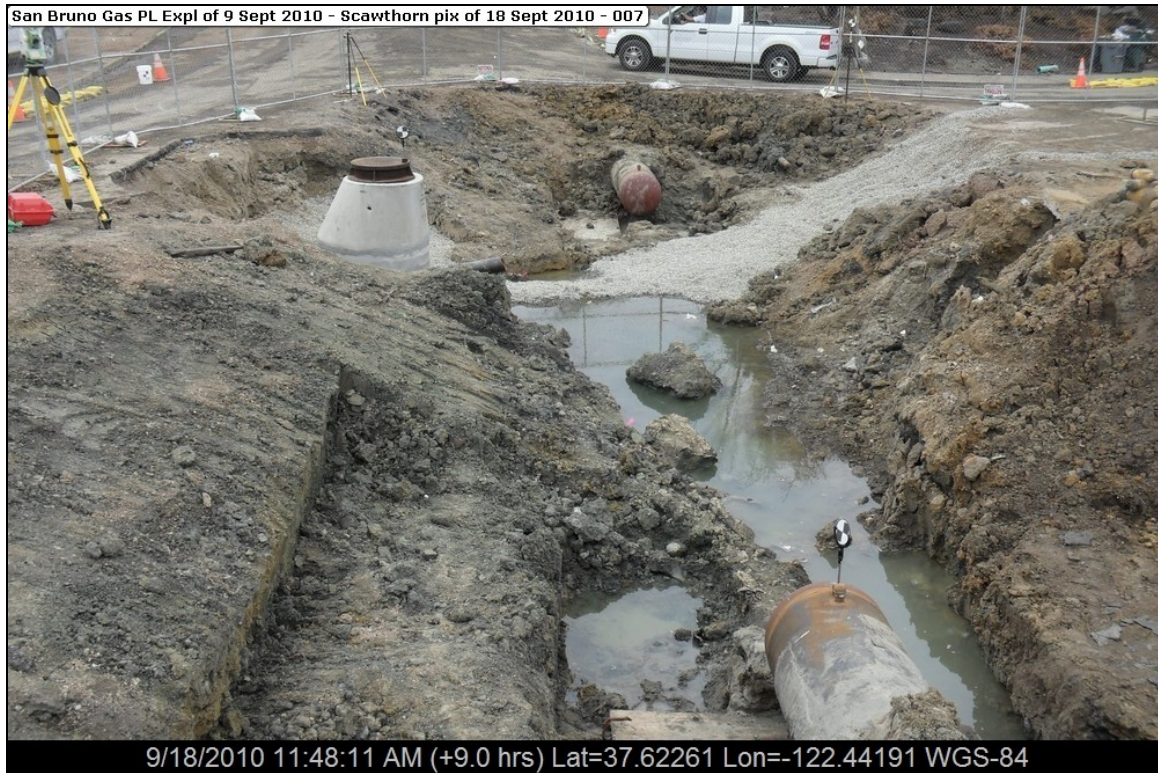
The rupture created a crater approximately 22 m (72 ft) long by 8 m (26 ft) wide at the intersection of Earl Avenue and Glenview Drive (Figure 3, and Figure 8). A pipe segment approximately 8.5 m (28 ft) long was found about 30.5 m (100 ft) south of the crater. PG&E estimated that 1.35 million m<sup>3</sup> (47.6 million standard cubic ft) of natural gas were released as a result of the rupture. Nearby damaged utilities included a 0.152 m (6 in) cast iron water main, a 0.254 m (10 in) sanitary sewer line and 0.102 m (4 inch) gas distribution line (NTSB 2011b).

Figure 2 Gas explosion crater (C. Scawthorn)

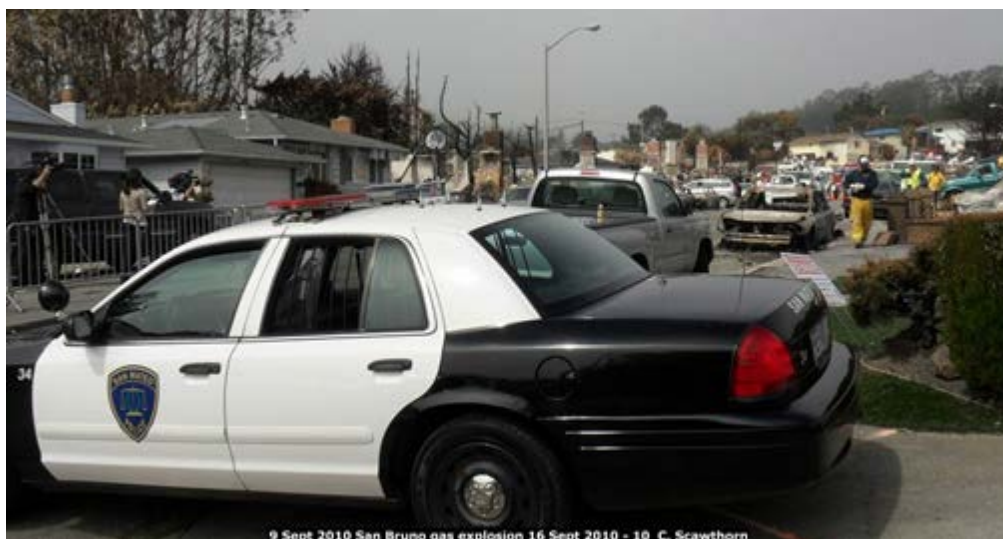
Figure 23 Police fenced cordon, 16 Sept 2010 (Photo: C. Scawthorn)

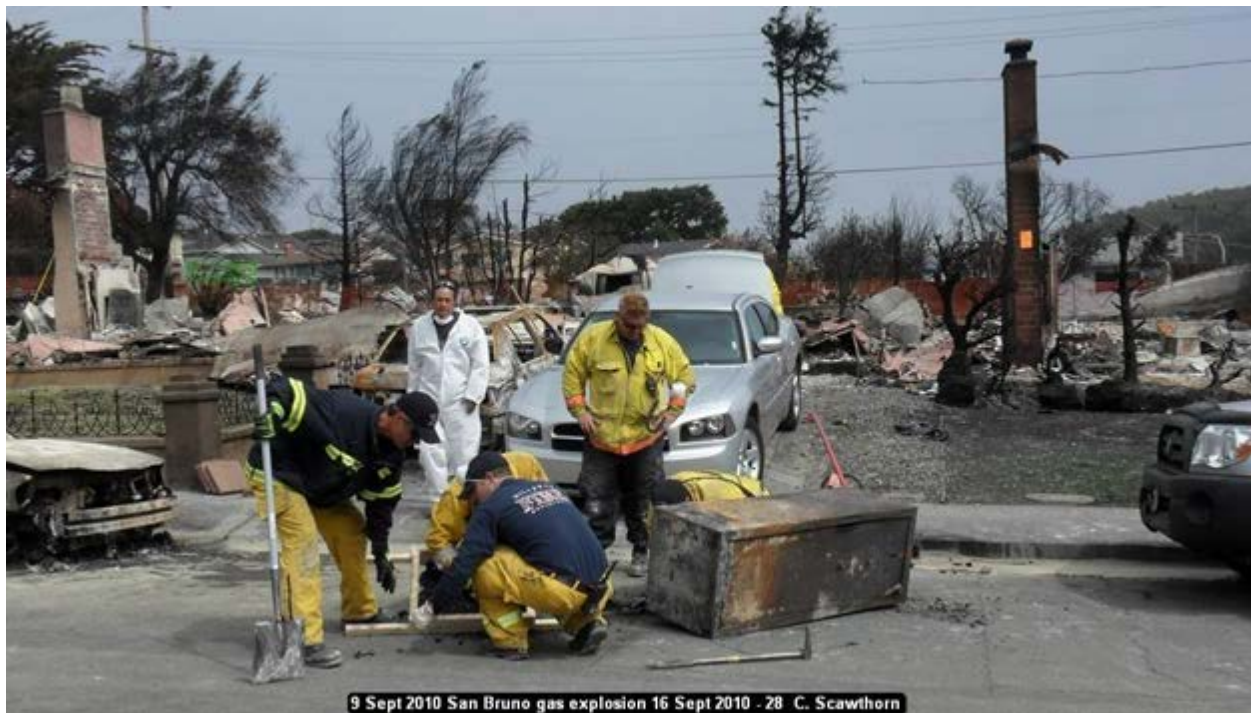
Figure 24 Firefighters sifting homeowner (in white Tyvek suit) property recovered from safe (box on right) (Photo: C. Scawthorn)

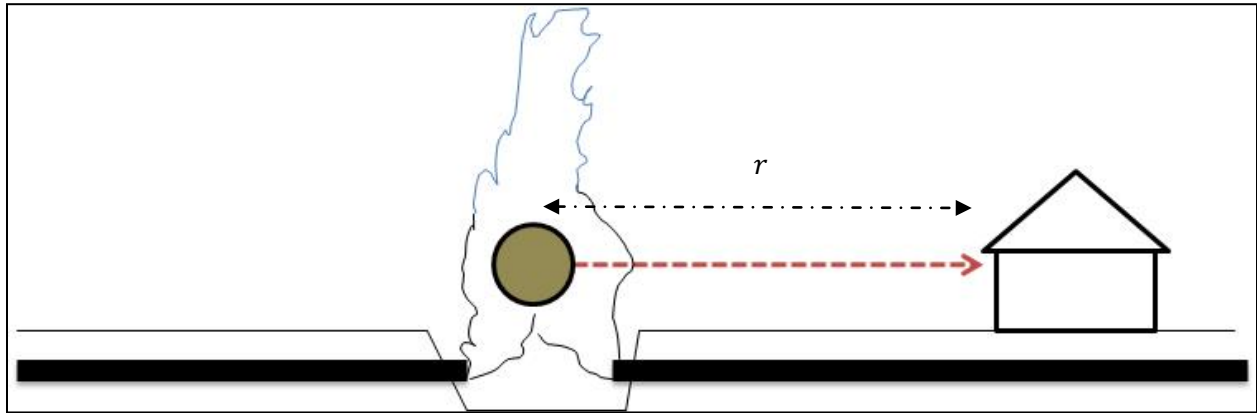
Figure 26 . Point source fire model

Stephens (2000) and Jo and Ahn (2002) adopt a similar assumption that considers the actual jet flame to be a point source (Figure 26) that emits thermal radiation at the ground level. The equation for the radiation heat flux  $I$  in  $\text{kW/m}^2$  at a horizontal distance of  $r$  (in m) from the fire center is (Eq. 2.1 in Stephens (2000), based on API RP 521 (1990):

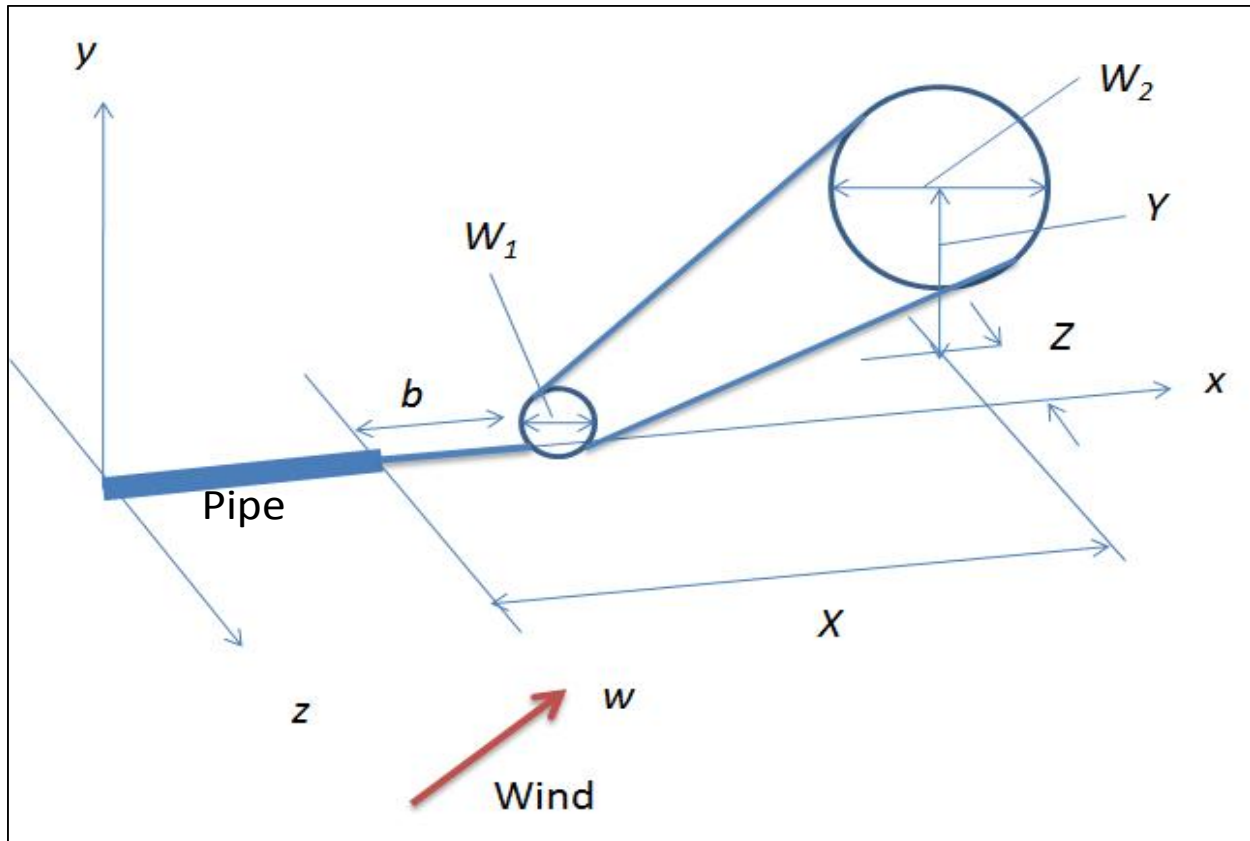
Figure 27 Horizontal release flame shape model (Redrawn from Johnson et al. 1994)

Equation 3 describes a relatively simple and conservative method to estimate the hazardous area for a gas jet fire. It does not, however, consider the effects of flame geometry and wind. Johnson et al. (1994) provides correlations to predict flame shape and thermal radiation. In Johnson et al. (1994), the flame is modeled as a truncated frustum of a cone (Figure 27). The variables defining the shapes are the coordinates ( $x, y, z$ ) of the center of the end of the frustum in m, the maximum flame width  $W_2$  in m, the minimum flame width  $W_1$  in m, and the flame lift-off  $b$  in m, as shown in Figure 27. Johnson et al. (1994) require the following inputs to calculate these dimensions: (1) Wind speed and direction, (2) gas release rate from pipe, and (3) physical properties of gas.

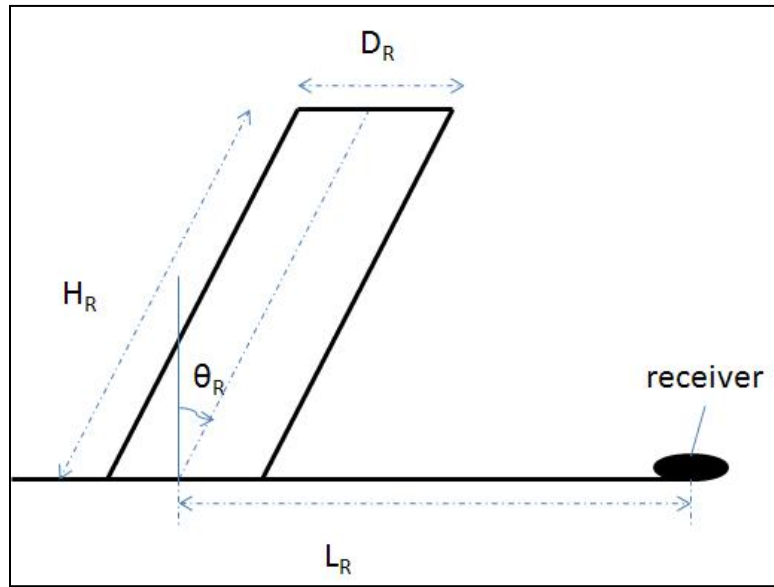
Figure 28 Assumed geometry for tilted cylinder for flame (Mudan 1984)

Johnson et al. (1994) use a numerical contour integration technique (Brian and Bagster 1989) to calculate the view factor of the end and side of the flame. In this analysis, to simplify the calculation of the view factor, we instead assume the flame shape to be a tilted cylinder and use the Mudan (1984) view factor equations (Figure 28). The cylinder geometry is estimated from

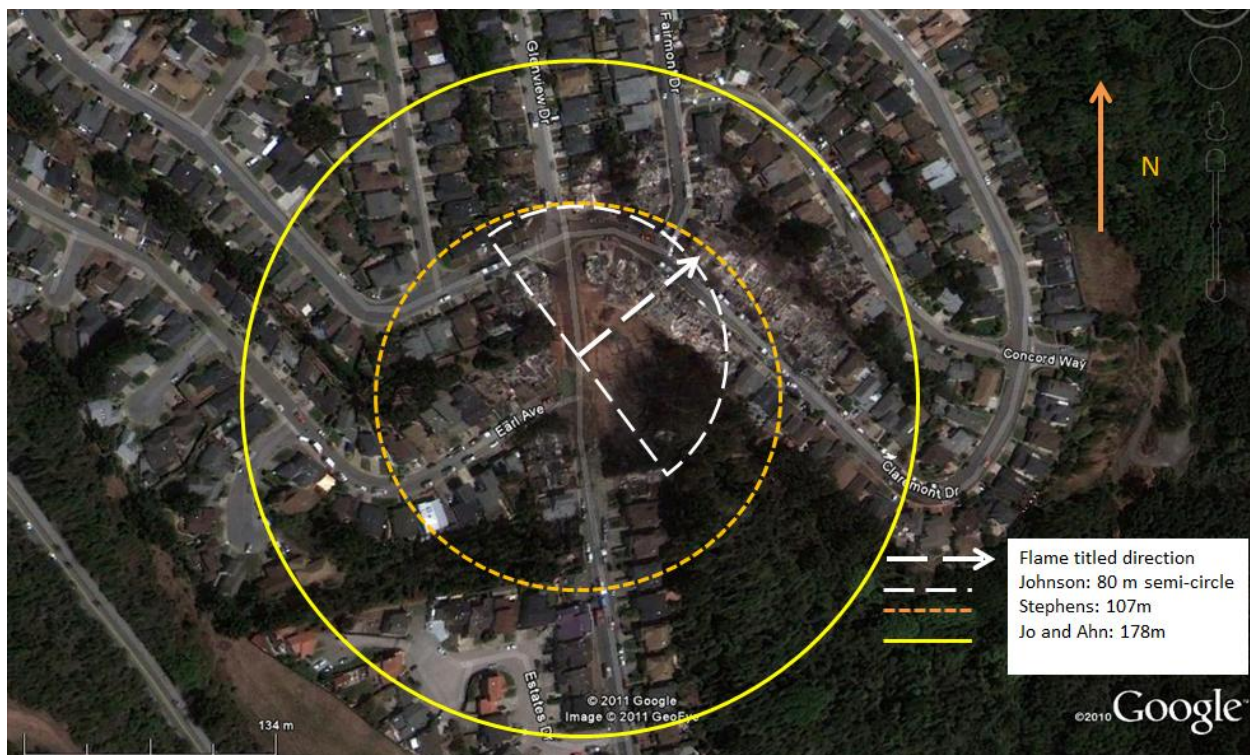
Figure 29 Hazard area when gas pressure was 289.9 psi

To estimate the hazardous area, we assume a threshold radiation flux value and use the fire models in Step 2 to determine the distance within which that threshold is exceeded. For people, the thermal radiation threshold is represented as that at which people outdoors at the time of failure would be exposed to a finite but low chance of fatality (1%). For a typical wooden property, the threshold is the value below which the property would not be burned. Stephens (2000) adopted  $15.77 \text{ kW/m}^2$ , Jo and Ahn (2002) used  $15 \text{ kW/m}^2$ , and Lee and Davidson (2010) used  $12.5 \text{ kW/m}^2$  as the thermal radiation threshold values used to define a hazardous area for damage to both people and property. For this analysis, we use  $15 \text{ kW/m}^2$ . Table 8 summarizes the resulting hazard areas for all three models. Figure 29 and Figure 30 show maps of the resulting estimated hazardous areas.

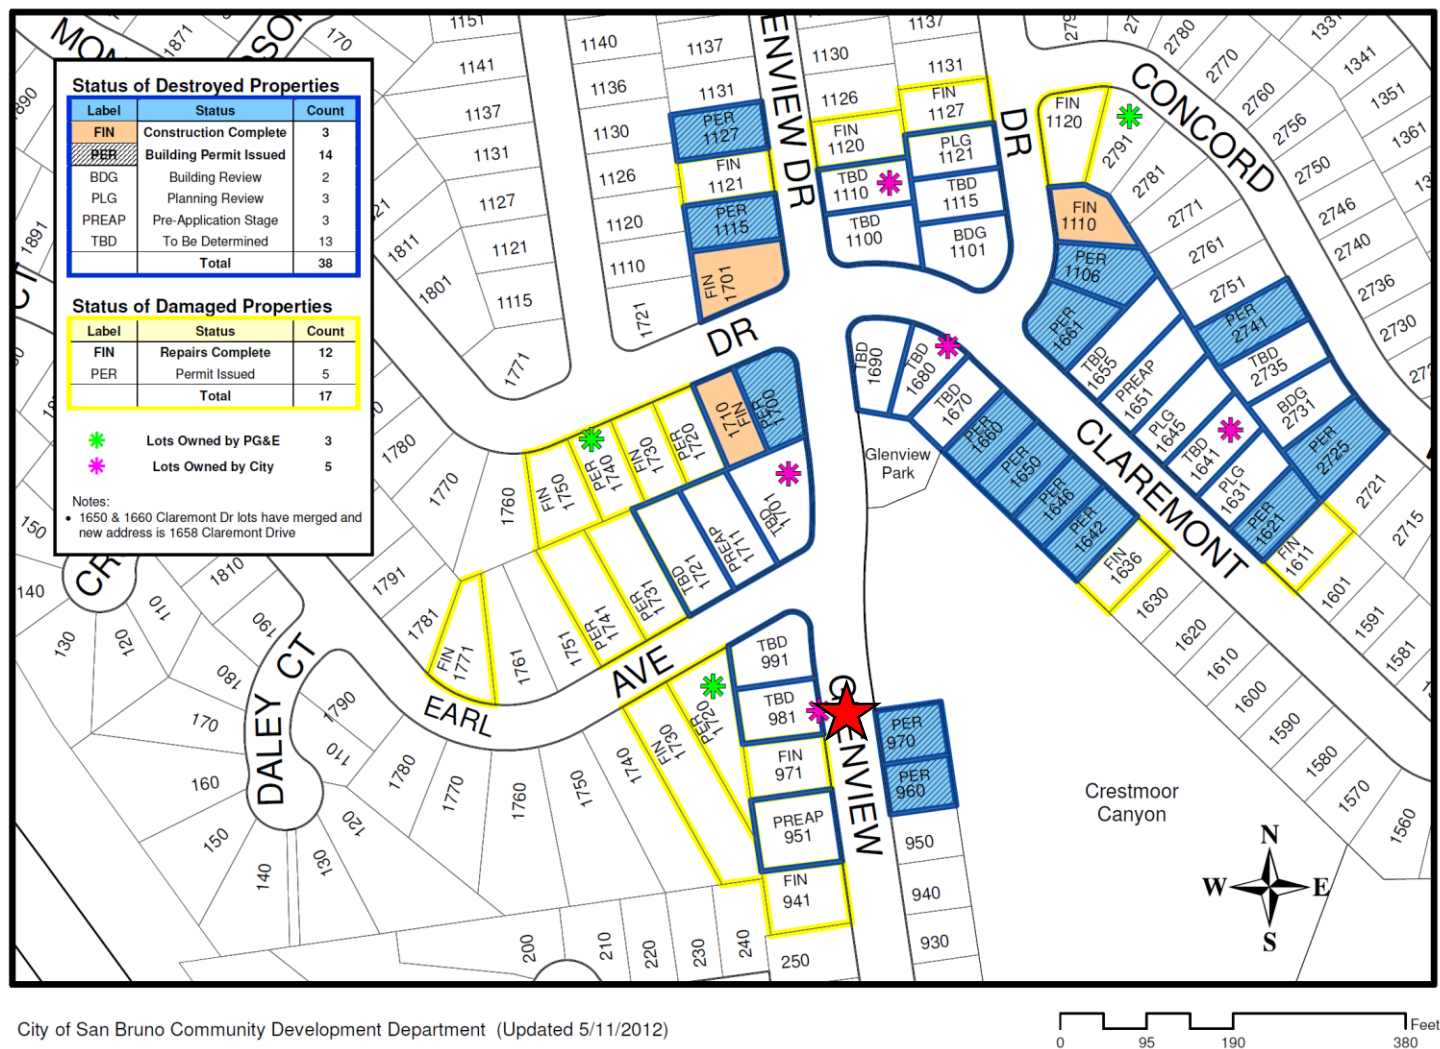
Figure 32 Crestmoor rebuild map as of May 2012  
 (Source: SBCDD 2012; [http://www.rebuildcrestmoor.org/app\\_pages/view/30](http://www.rebuildcrestmoor.org/app_pages/view/30))

Figure 32 and Table 10 summarize the status of home rebuilding as of May 2012, according to the City of San Bruno Community Development Department (SBCDD 2012). Of the 63 damaged and destroyed homes, after 20 months, rebuilding of 8% of the destroyed homes has been completed, 37% are under construction, 21% are in various stages leading to construction, and 34% are unclear. Damaged homes have been repaired more quickly, with 71% (12/17) already complete. Eight lots are now owned by PG&E or the City and may take longer to be rebuilt.
