BANK BARNS IN MILL CREEK HUNDRED, DELAWARE

Hubert F. Jicha, III

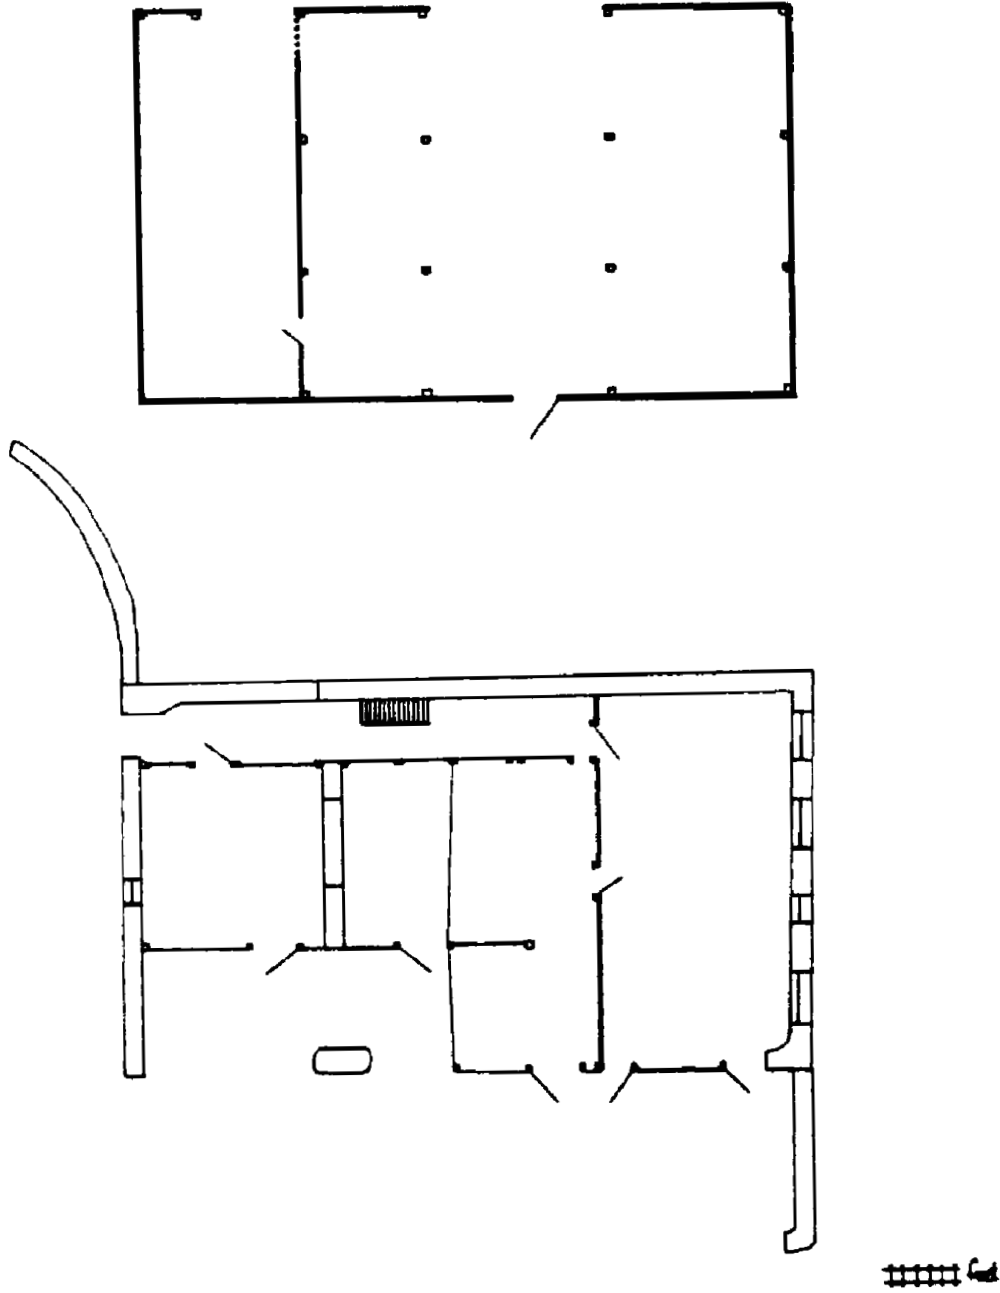
Robert Gore Barn, Ebenezer Church Road.  
a) Upper Level. b) Lower Level.

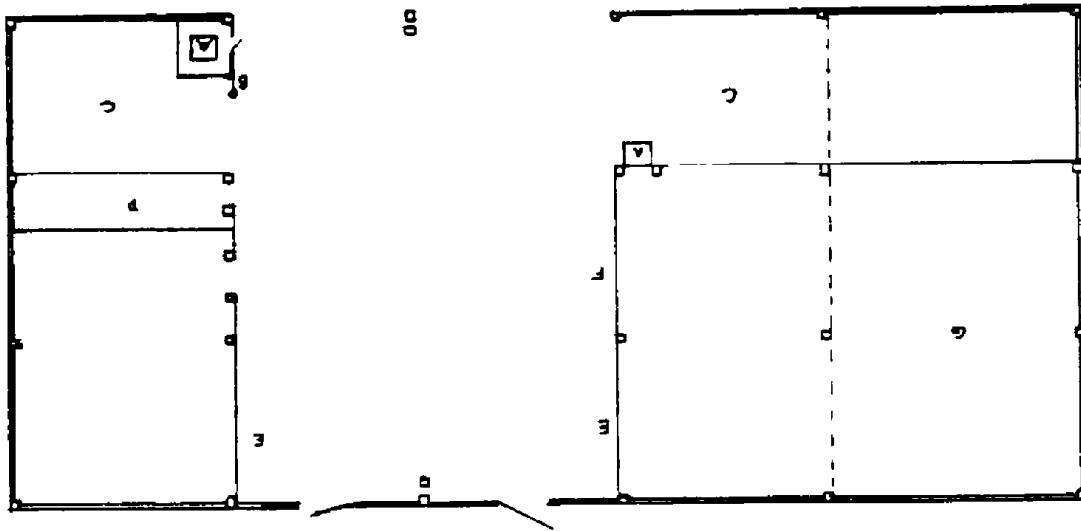
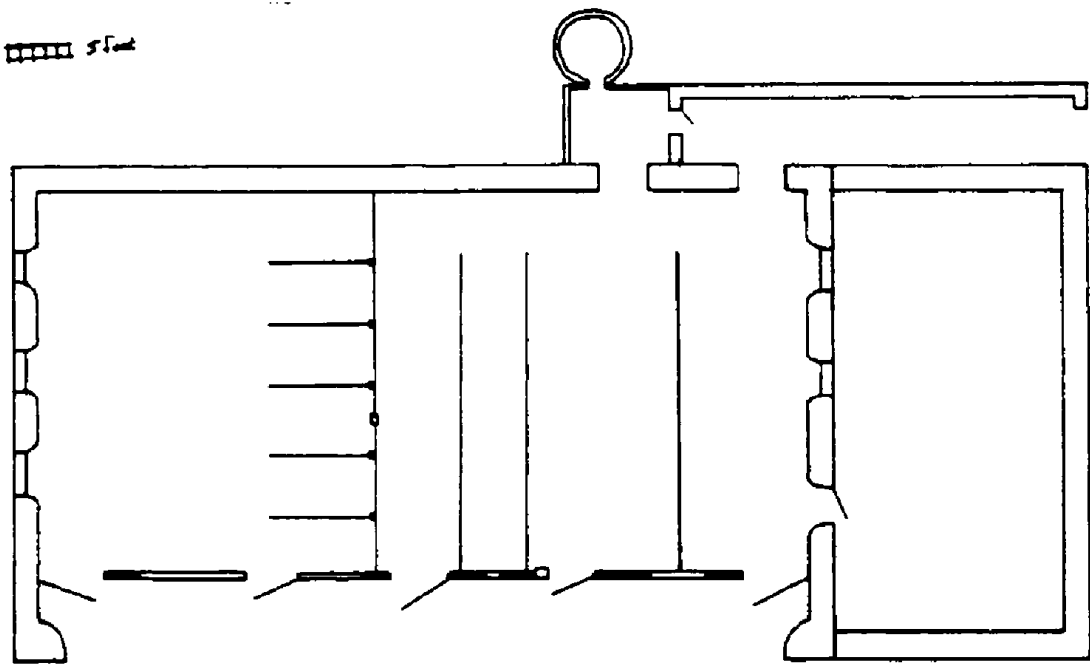
Kellig Bank Barn, Old Paper Mill Road.  
a) Upper Level. b) Lower Level.

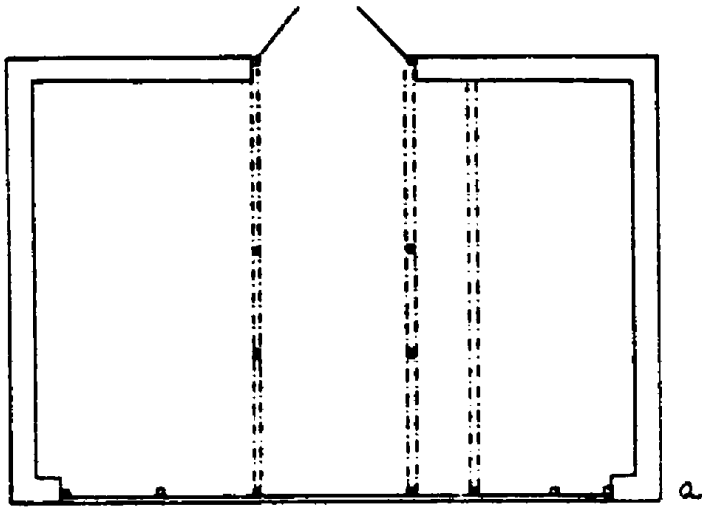
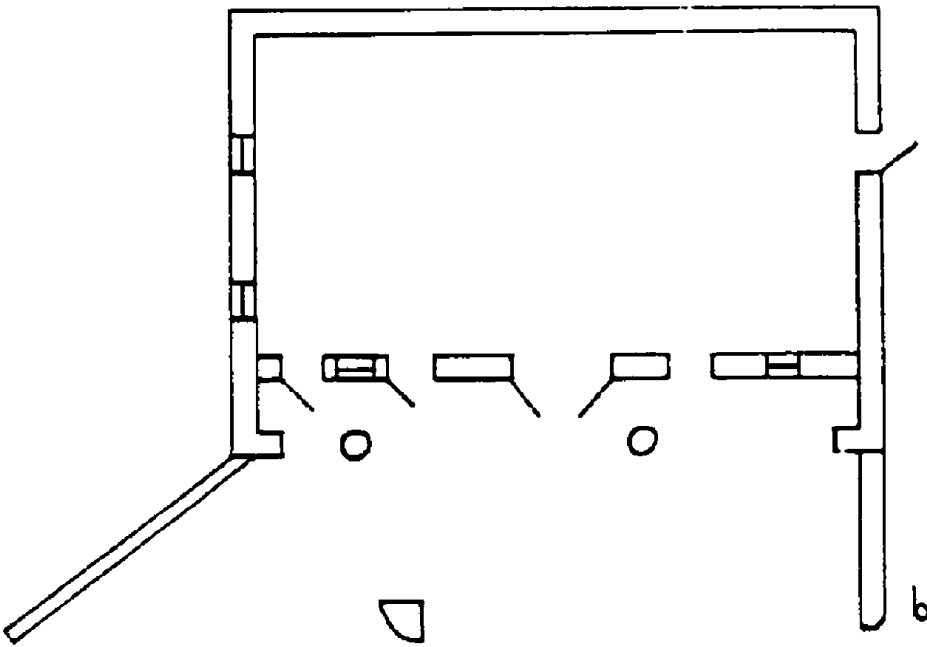
Wm. Bell Bank Barn, Pleasant Hill Rd.  
a) Upper Level. b) Lower Level.

Additions were built onto virtually every barn. Some barns were altered a little, others so much that the original barn is buried. The Wm. Bell barn (c.1810) on

Pleasant Hill Road near Corner Ketch was only altered by the addition of a shed roof to shelter the sheep being raised in the 1930's. The R. Fitzsimmons barn near Milford Crossroads (c.1850), a frame barn with recessed stable wall, has not been altered at all. On the other hand, the F. Thompson barn on the old Wilmington-Landenburg Road is a rather ugly compendium of additions on a large double decker barn soon to be destroyed. These are the exceptions. Most additions were added so regularly that some later barns incorporated them into the original structure when building.

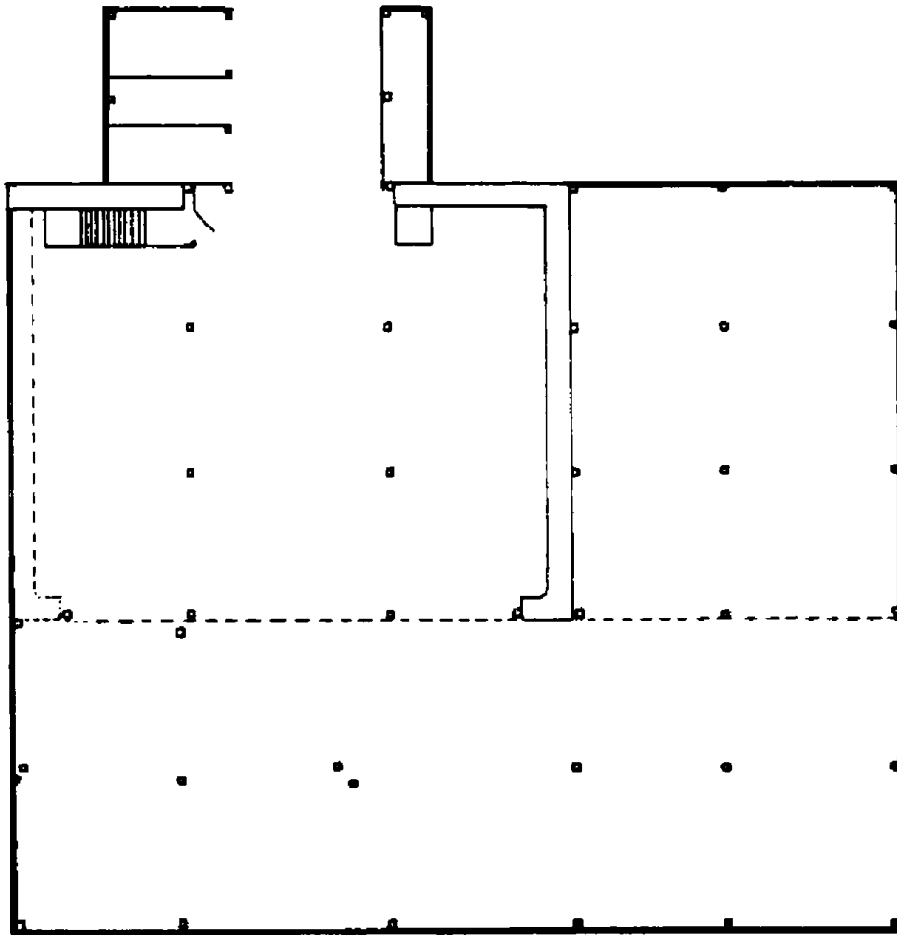
D. Eastburn Bank Barn, Corner Ketch Hill Rd.  
Upper Level with Bridge and Additions.

in Switzerland which is often seen at the gable end and bridges a gap between the ramp and barn. The Mill Creek Hundred bridge house had a variety of functions. Certainly it was used for implement or wagon storage when the center bay was full or being used. The bridge house nearly always contains corn cribs on each long wall, incorporated into the structure. Beneath the bridge house a number of activities took place. On double decker barns, a central doorway is in the long wall which opens to the area beneath the driveway. This door is often set at wagon height so that different things, especially bags of grain, could be loaded and unloaded easily. A barn does not have to be a double decker to have this feature as several two level barns have bridge houses with a space beneath it for various activities. The D. Eastburn barn and the J. Stinson barn, both on Corner Ketch Road, have a bridge house with corn cribs and space beneath although they are only two levels. The R. Peters barn has a bridge house that was added on. It appears to have been added quite early but apparently the farmer needed the extra space conveniently next to the threshing floor. This bridge house has a corn crib on one side and is situated flat on the ground.

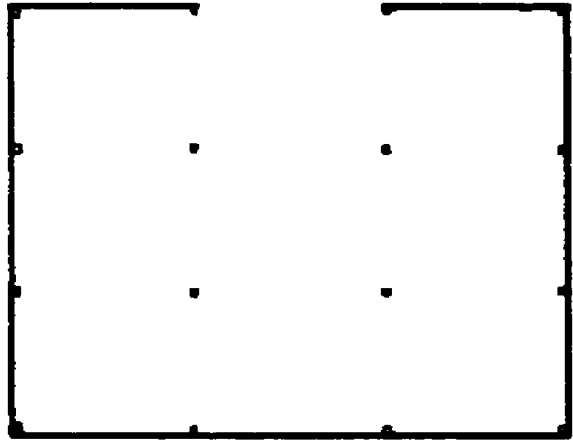
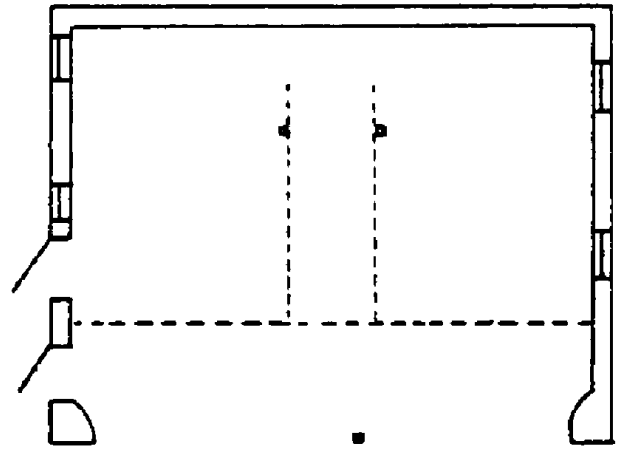
FIGURE 1

R. Fitzsimmons, Polly Drummond Hill Rd.  
a) Upper Level. b) Lower Level.

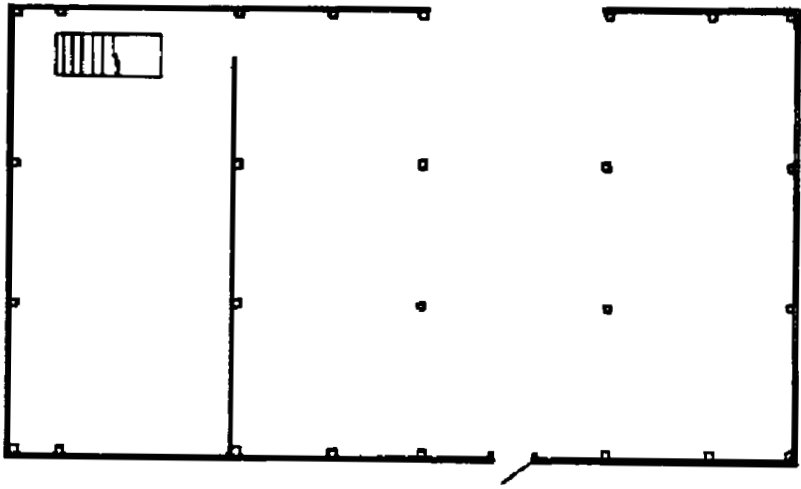
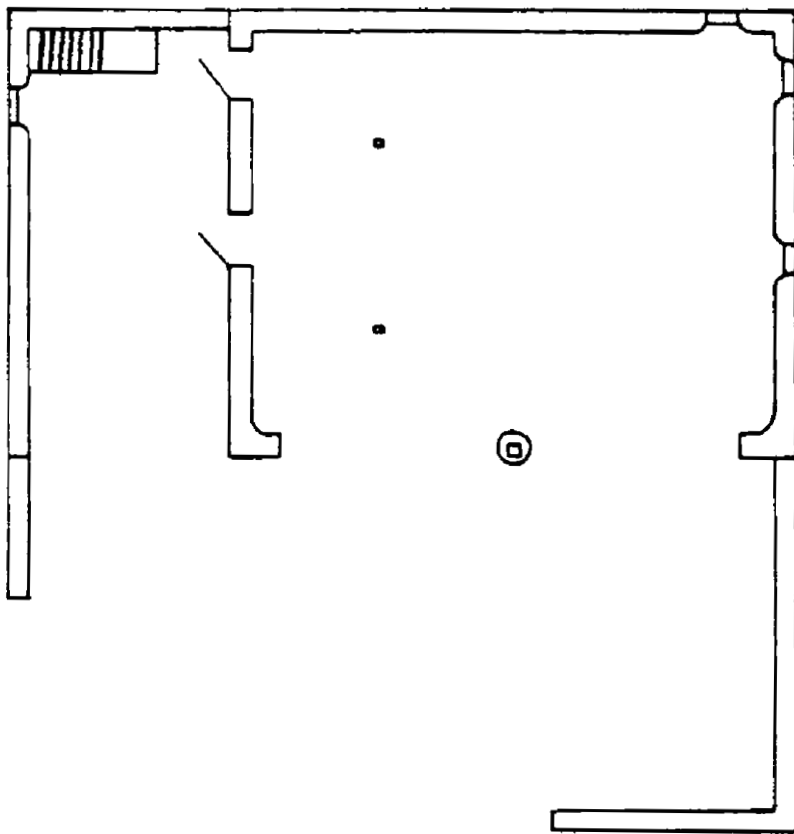
W. M. Peters Bank Barn, Old Paper Mill Rd.  
a) Upper Level with Gable End Addition. b) Lower Level.

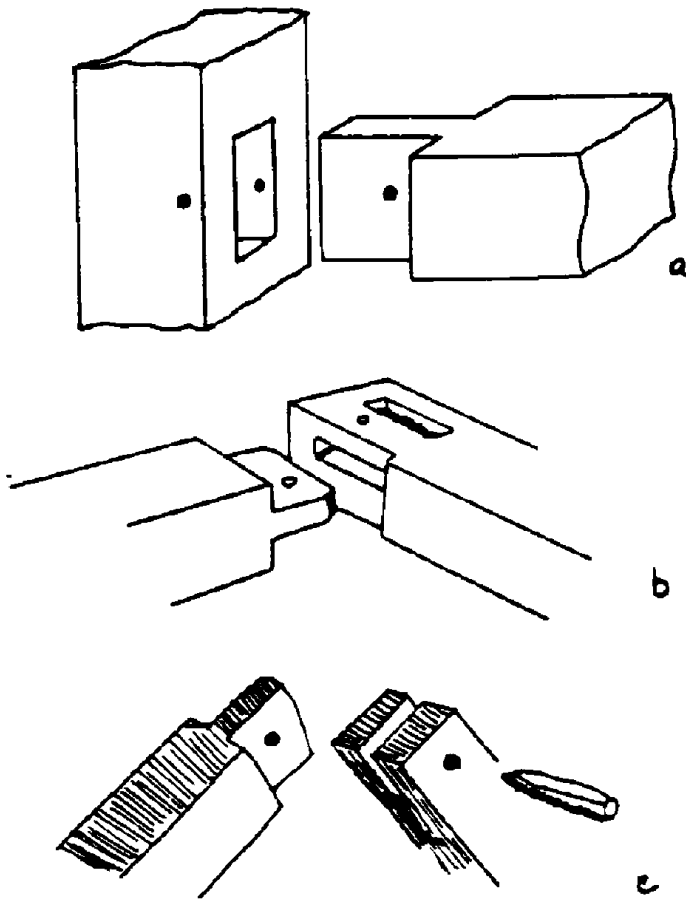
- a) Mortise & Tenon Joint.
- b) Sill.
- c) Rafter Apex.

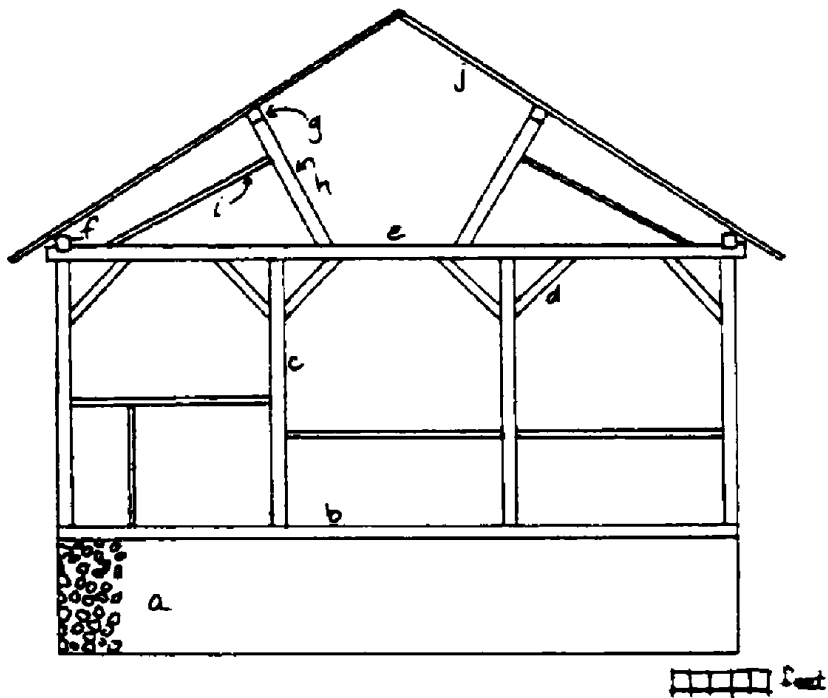
Bent Nomenclature: a) Field stone basement wall.  
 b) Timber Sill. c) Post. d) Up Brace. e) Tie Beam.  
 f) Wall Plate. g) Principal Purlin. h) Purlin Strut.  
 i) Purlin Strut Brace. j) Common Rafter.

Mrs. Outhrie Bank Barn, Limestone Rd. Inner Bent.

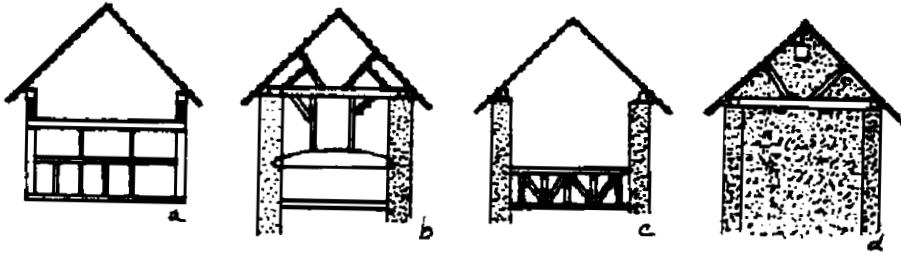
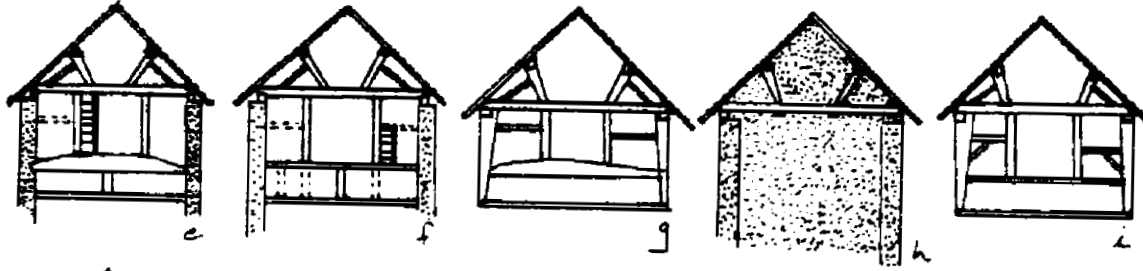
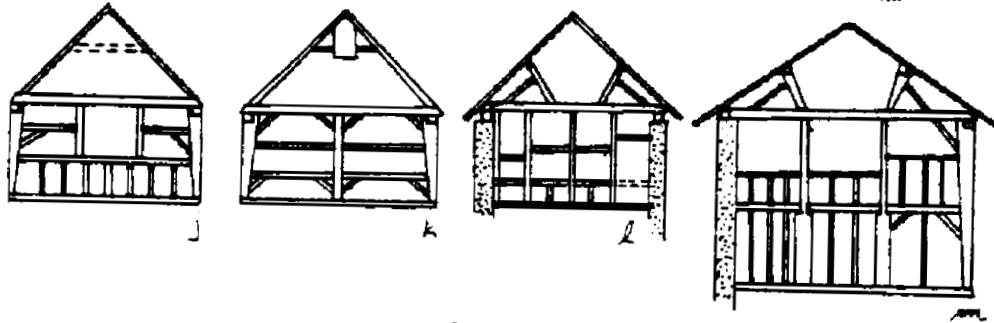
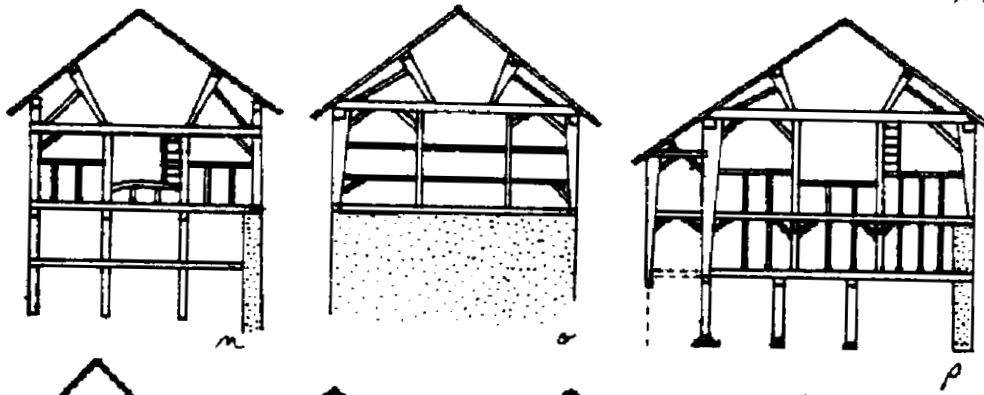
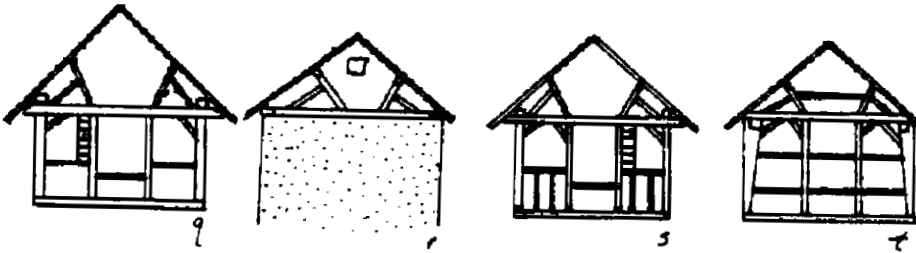
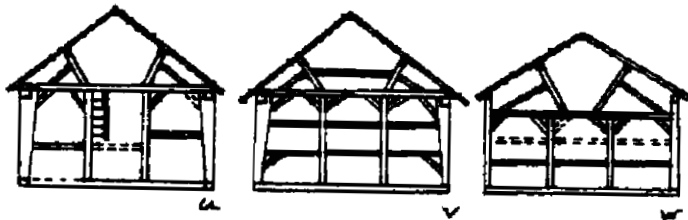
Bent typology. First phase:: Bents with flared posts and purlins.

- (a) A. McIntyre (Simon Hadley) stone barn with frame long wall, Limestone Road; inner bent.
- (b) R. Peters stone barn, Old Paper Mill Road; inner bent with large cambered beam.

Three of the five barns that probably date before 1810 have a very unusual feature which is a large, cambered beam that spans the width of the barn about 8 feet

from the floor and carries two inner posts that connect the cambered beam to the tie beam. It is difficult to determine the function of this timber that looks more closely related to a medieval truss than to American or colonial framing. Approximately four feet behind the beam is another horizontal timber set at a much lower height and has posts and braces for a hay retaining wall. Across the top of the cambered beam down to the secondary beam boards were placed making a diagonal surface in the direction of the hay mow. Apparently, this was to make the job of tossing the loose hay easier since any hay landing on the diagonal surface would slide into the hay mow. Also, beneath this little shed roof was extra storage room for implements or a place to hang tools.

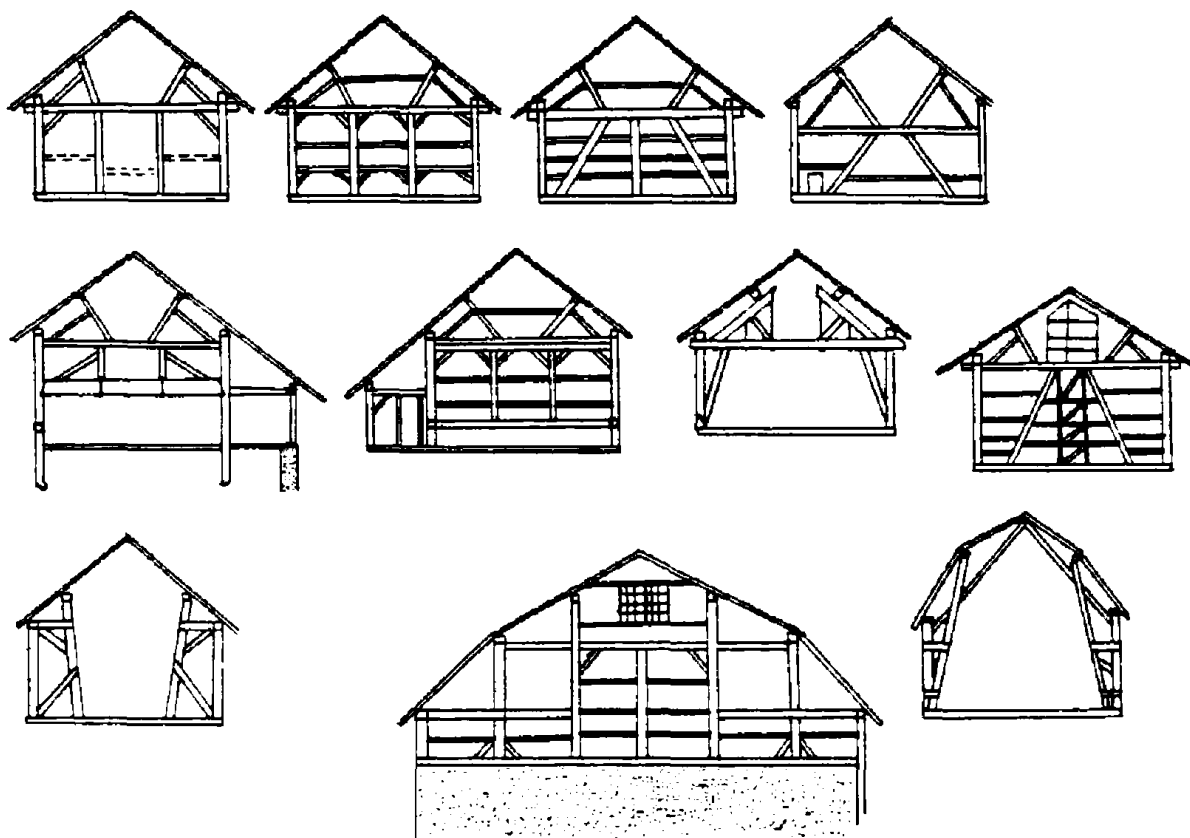
Bent Typology. Second phase:: open mortise posts. (a) W. M. Peters frame barn, Old Paper Mill Road; inner bent. (b) Same barn as a; end bent. Third phase:: diagonal posts. (c) J. Trender frame barn, Old Milltown Road; end bent. (d) J. H. Woodward frame barn, Corner Ketch Hill Road; northeast inner bent. (e) No category. J. Ball frame barn, Polly Drummond Hill Road; north inner bent with swing beam. (f) same barn as e; south end bent, note double end girt. Fourth phase:: bookish bents. (g) Kellig frame barn, Old Paper Mill Road (c.1910); truss bent with tie rods. (h) Dupont frame barn, Union Road (c.1930); northwest end bent. (i) Dupont frame barn, Smiths Mill Road (c.1930); wing inner bent. (j) Alex Jarrel frame barn (rebuilt 1936, G. Klair 1868) Limestone Road; north end bent. (k) J. Thompson Brown frame barn (rebuilt 1936, R. Taylor 1868), Possum Hollow Road; inner bent.

The third phase of bent typology in Mill Creek Hundred is really just a variation of the typical bent form. This is the introduction of diagonal posts into end bents and long walls. Diagonal posts are recommended in at least one source as a method of framing without the

truncated principal rafters (the apex is cut out) that carry the principle purlins and are fastened to the tie beam by four tension bars and two bolts. The rest of the bents are of the typical bent variety, however the long wall features two diagonal braces from post to post.

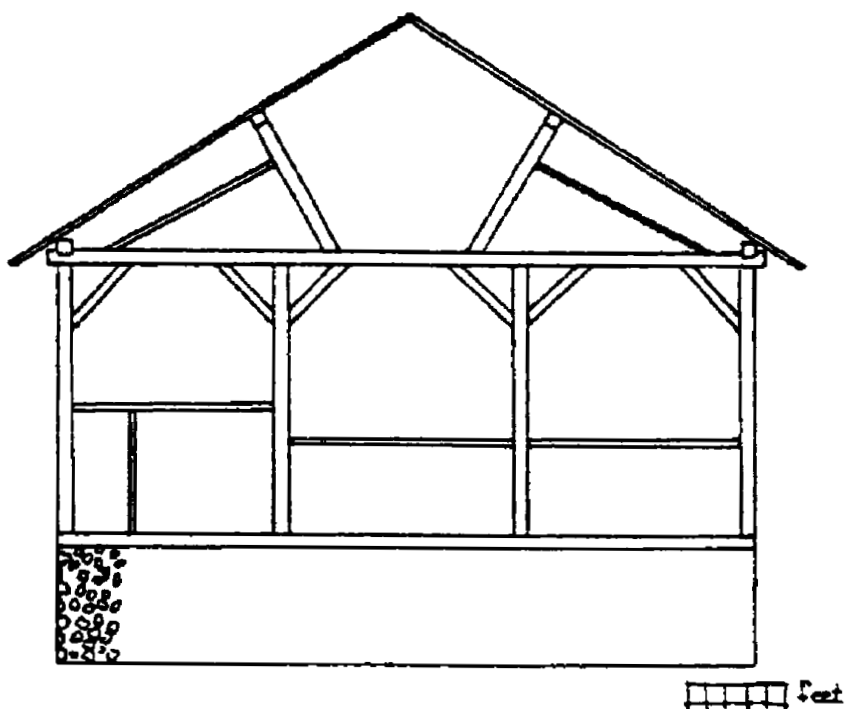
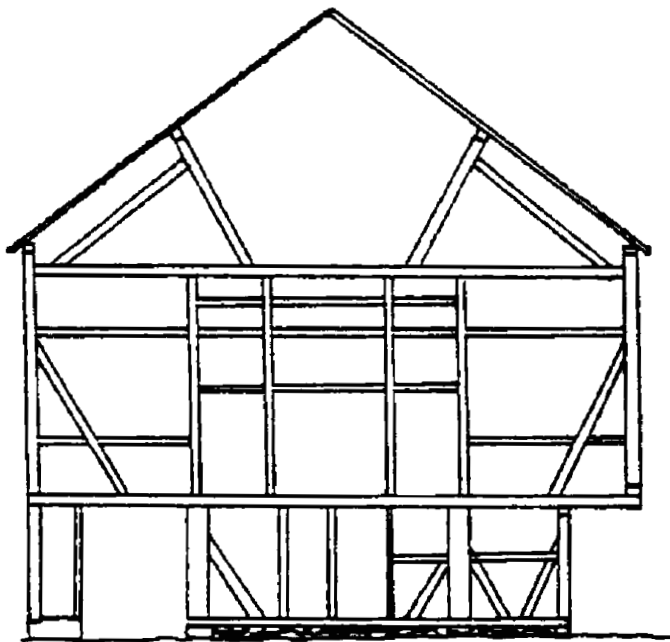
Mill Creek Hundred and Pennsylvania German bents compared.  
 a) Mrs. Outhrie bank barn, Limestone Rd., Mill Creek Hundred. b) Pennsylvania German barn with cantilevered forebay in York Springs, Adams County, Pa. (after Henry Glassie, *Variations...*, p. 228).

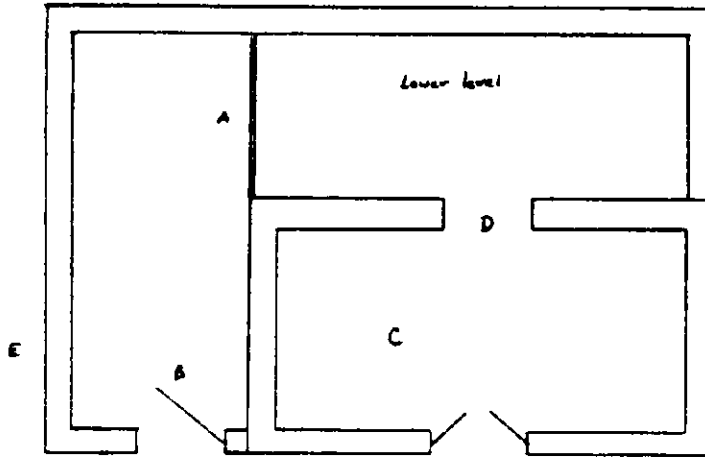
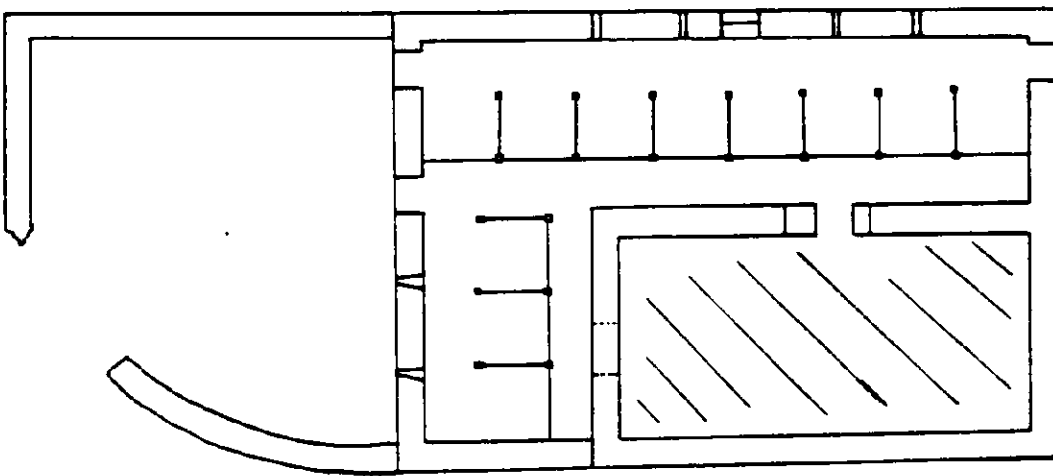
Boothwerk Field Barn Grove Valley Ambleside, Westmorland

Upper level

A Roughly boarded up to retain heat from stables below

B Loose floor boards on timbers provide footing for dropping hay to animals below

C Open Hay Mow

E This wall was constructed as a "dry wall" (i.e. no mortar) to provide ventilation to fresh hay and to facilitate drying

Boothwaite Field Barn; Early to Mid-19th Century

Boothwaite barn is an early to mid-nineteenth century field barn located north of Ambleside on the southeast side of Grove Valley. It is situated on a steep hillside midway between the hill top and the valley, along a dirt lane leading from Low Grove Farmstead to Middle Grove Farmstead, each several hundred yards distant. The barn contains hay, presumably the full two levels, while the shed roof additions contain stalls. A blocked up door on the lower level of the southwest gable and indicates use of the lower level and perhaps a different use of the barn prior to the addition.

The shed roof addition extends the barn 15 feet to the southwest and 15 feet to the northwest making it both wider and longer than the original barn. Along the long wall eight stalls were put in extending the full 50 feet of the wall with an aisle on either side. Perpendicular to this are four more stalls along the gable end. Two doors in the southwest gable end open into a walled cow yard with a gate. There are only two windows for light but several vertical slits for ventilation. Above the gable end addition is a loft floored with loose boards and entered from the upper level through a large door. According to the farmer, this slate wall was built drywall to give ventilation to fresh hay and facilitate drying. The farmer also said that the roof had been replaced at one time. This is supported by the presence of hewn purlins in the addition and a naturally curved knee brace.

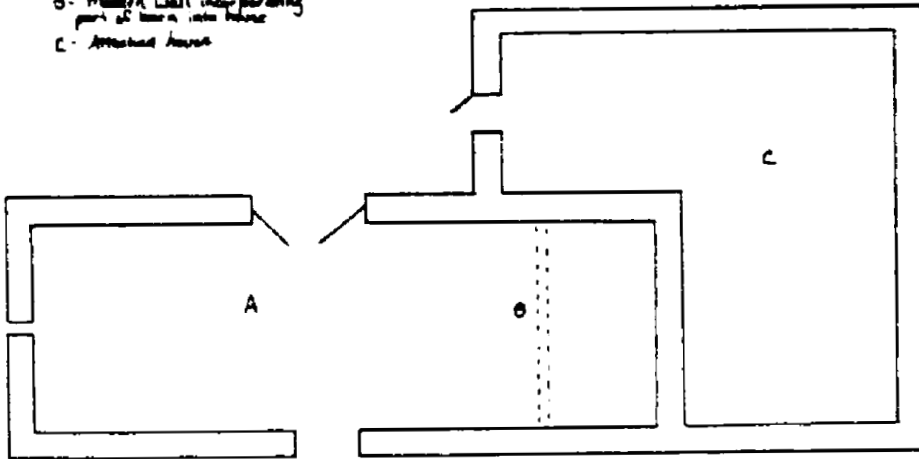
Upper Level

- A - Barn wing perpendicular to slope. Open interior
- B - Modern wall incorporating part of barn into house
- C - Attached house

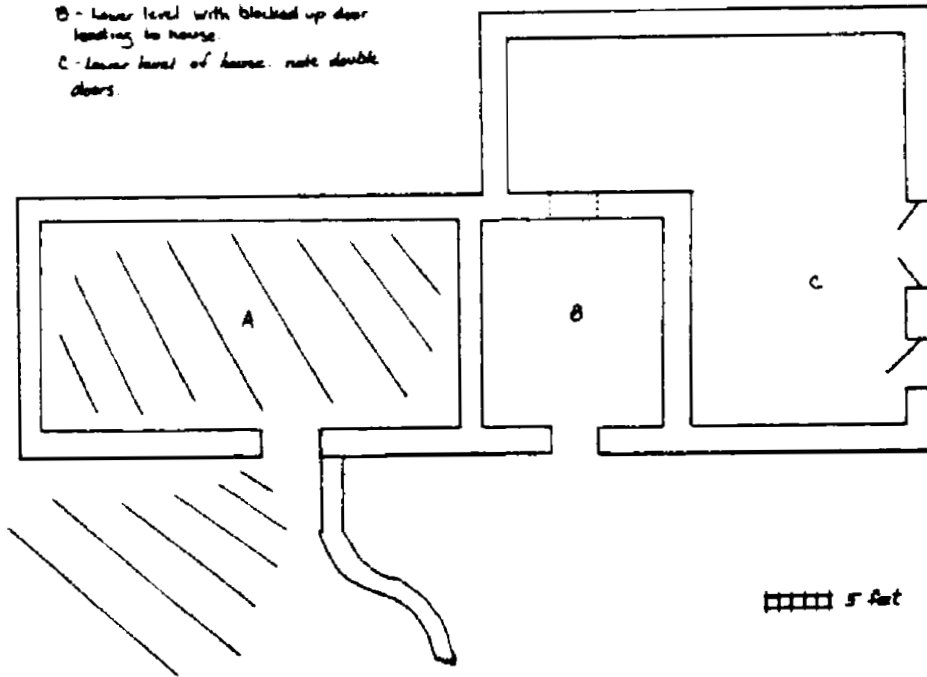
Lower Level

- A - Upper level portion, with door on sloping ground next to retaining wall.
- B - Lower level with blocked up door leading to house.
- C - Lower level of house, note double doors.

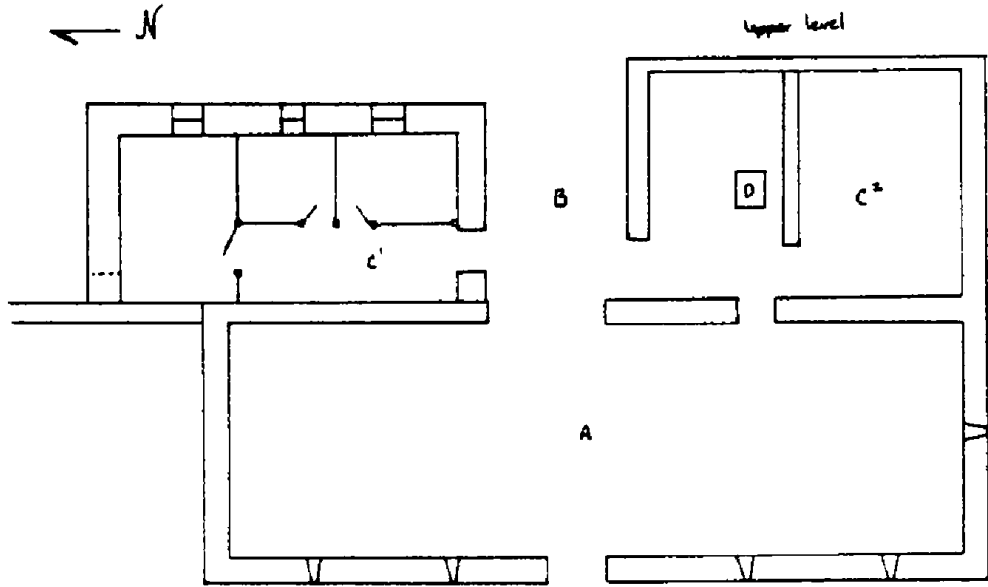
Middle Grove Farm Barn w/ Attached House  
 Grove Valley Ambleside, Wash. state

- A - Barn interior open
- B - Ramp
- C¹ - Outshot containing stables
- C² - Outshot containing storage & workshop
- D - Trap Door for dropping hay below
- E - Lower level stables (interior stabling unmeasured)
- F - Stables beneath outshot C²
- G - Portion of Attached House, north of retaining wall.

Grove, to the south. The farmstead is situated on a relatively flat area before the slope falls steeply again. These connected buildings, like Low Grove, consists of a house with an attached barn with no visible means of inter-communication. The house is a "T" gable with one part contiguous with the barn while the other is perpendicular to it and the barn, the gable ridges forming a "T". The walls of the house are rendered and whitewashed to distinguish it from the barn. Its rounded chimneys and slate roof are characteristic of the area.

The barn is long and narrow, measuring 63 feet by 23 feet. It has a gable roof with slate shingles, and 24 inch thick slate stone walls with sandstone quoins and lintels. There is a slightly inclined ramp to the upper level from the side of the slope descending to the southwest. In contrast, the house sits flat on an excavated site with a retaining wall. The barn upper level is entered from the ramp which is flanked by an outskirt on each side. The double doors are not centered but offset to the north. An open and spacious interior was created by use of the king post truss. The king post is bolted or screwed to the tie beam, dating the roof to sometime in the 19th century when the king post was recognized as a tension member which held the truss together instead of a compression member which held it apart.<sup>50</sup> The upper level is ventilated with tapered, vertical slits, the interior

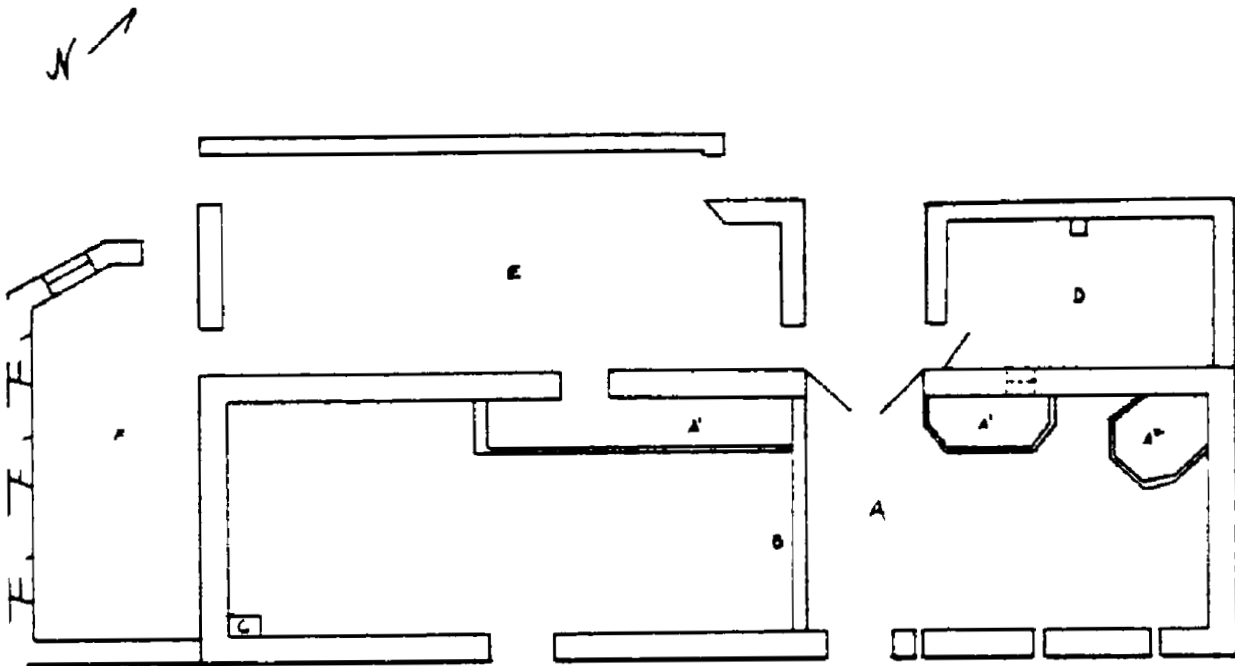
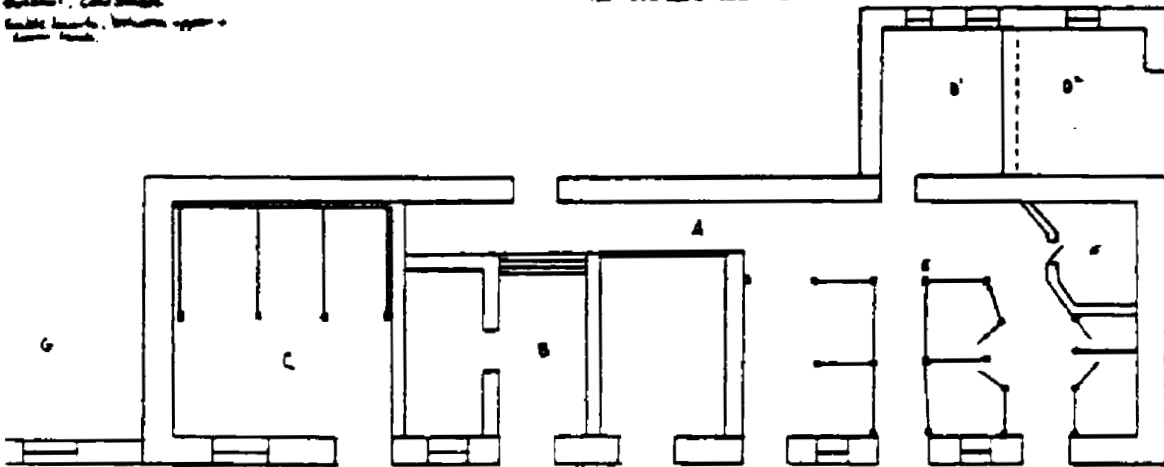
Rayrigg Hall East End Rayrigg Rd. near Lawrence, Co. Kans. (Wisconsin)

- 8 bay here, open interior
- 1 - open to lower level
- 2 - concrete wall on perimeter
- Concrete site
- 3 - 3/4 wall w/ opening at that height containing SW
- 4 - Repaired bay along side of the horse stable
- 5 - Outside, presently stone wall
- 6 - Outside, low stable
- 7 - Stable house, which is upper + lower level

- A - Ramp rising SW to entrance of outside of stable
- B - Bury
- C - Originally horse stable: stalls have elaborate woodwork
- D - Stable stalls for 111 animals
- D' - Present day garage
- E - Shuttered part w/ date 1906
- F - Current site
- G - Stable and lower level floor 3/4 above lower level

The Rayrigg bank barn was the largest barn studied measuring nearly 100 feet by 40 feet, including additions. The original block is more narrow at 81 feet by 24 feet. The barn is entered through large double doors offset to the northeast, up a sharply inclined ramp which is flanked by an outskirt on each side. Opposite the double doors is a domestic size winnowing door. Another domestic size door is offset northwest on the same long wall, perhaps serving a second threshing floor. This barn has very thick slate stone walls compared to other barns surveyed, measuring nearly 30 inches thick. Unlike some of the other barns, there are no sandstone quoins and lintels. The quoins are just very large pieces of slate and the lintels are timber covered with sideways lapping slate shingles to help keep off water. The gable roof with slate shingles is supported by huge triangulated trusses with a halved apex to seat the ridge beam, and incontinuous overlapping purlins. Some of the principal rafters are so curved that they resemble inverted crucks which some may be since they look re-used and crucks are known to have been re-used in this fashion.<sup>55</sup> Two thirds of the interior is 3 feet above the threshing floor because of the raised ceiling of the stables below. This is reflected in the heights of the lower level doors and windows on the south east facade. Large open areas have been cut out of the floor on either side of the double doors for bay

drops. A concrete block silo was added in the north corner. The additions consist of the two outshuts on the northwest facade and a lean-to on the southwest gable end. None appear to be original and are mainly used as extra cow-houses. The outshut north of the ramp is the only two level addition. The upper level is used for feed storage and the lower as a loose box and a garage.

The lower level is divided into several well defined sections by stone partition walls. The northeast end appears to have retained most of the original configuration of transverse slate slab stalling on one side and loose box stalls for calves on the other. These stalls are mainly defined by supporting posts. One of these, a shouldered post, has the date 1790 carved into it. Three doors facing the farmyard open into an aisle to service the stalls and lead into a longitudinal aisle along the northwest longwall which descends as a ramp from the southwest outskirt. The rest of the building is divided into three chambers, one of which has been altered to be a dairy. The horse stable is a completely separate section with elaborate wood work consisting of arched stalls with a central pendant and heavy vertical board siding. There is a ladder in the south corner and a trap door in the ceiling to drop in hay from above, similar to Middle Grove

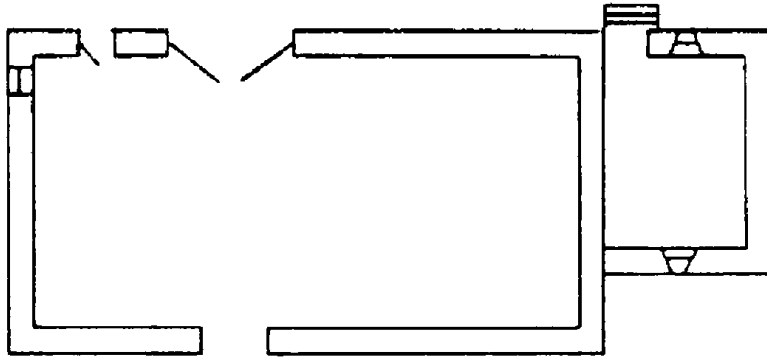
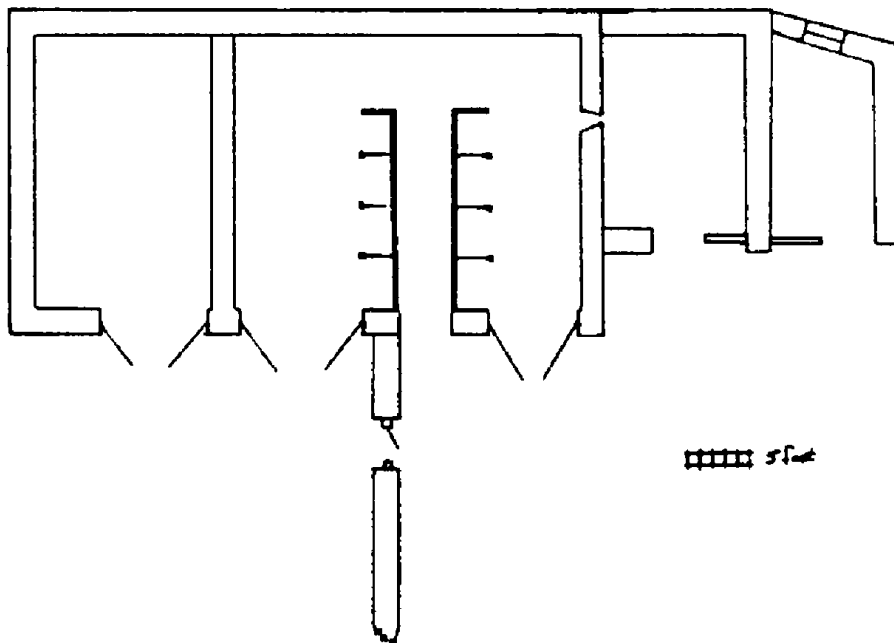
Middlerigg Bank Barn  
a) Upper Level  
b) Lower Level

The lower level is divided into two sections by a stone partition wall and has only two entries, one door centered in the southeast gable end, and one on the north side of the long wall. The cow house section has a central longitudinal aisle in line with the gable end door and a door in the partition wall. The stalls are lined up longitudinally with an aisle along the northeast long wall. These stalls look original and are made of slate

slabs with weight bearing timber posts. The posts support transverse girders that have longitudinal plank joists between them. The partition wall has two blocked up doors; it is difficult to understand why these doors would be needed if the current arrangement is original. The other section on the northwest gable end contains the silo and some modern pipe stalling. It is likely that this was the horse stable, isolated as it is from the cattle. Light and ventilation is provided by three variously placed windows and three tapered, vertical slits.

This rectangular barn measures 47 feet by 25 and has 24 inch thick walls with sandstone quoins. The wall is unusual compared to others studied because of the projecting through stones giving the walls a ragged and rustic appearance. The slate shingled, gable roof is also peculiar with its "corbie stepped" gable ends.

There is a two level gable addition with a one level lean-to on the southwest gable end. This gable addition has a loose box stall in the lower level and a chamber in the upper level. It's roof structure consists of a ridge beam with four purlins. One of these purlins is extremely rough, being left in the round. The lean-to is another loose box stall apparently for horses. These additions have split door entries with the top being considerably smaller than the bottom. Entry to the upper level of the barn, which was inaccessible, is through double doors offset to the northeast, close to the end of the wall. On the opposite wall, a domestic size winnowing door overlooks the yard.
