# **MID-ATLANTIC HISTORIC BUILDINGS SURVEY**

## **HENRY WHITEMAN HOUSE (CRS # N-261)**

SMITH MILL ROAD, CORNER KETCH VICINITY  
MILL CREEK HUNDRED, NEW CASTLE COUNTY  
DELAWARE

Center for Historic Architecture and Design  
University of Delaware  
Newark, Delaware

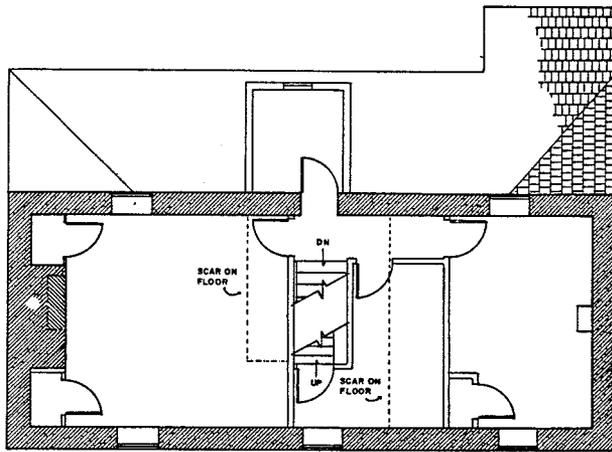
SECOND FLOOR PLAN

▨ PERIOD I  
□ PERIOD II

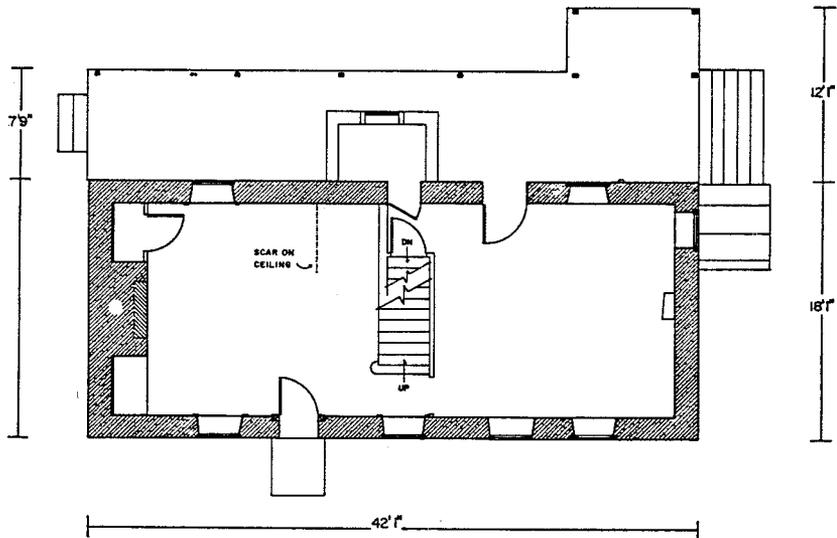
FIRST FLOOR PLAN

▨ PERIOD I  
□ PERIOD II

The paneled threshold at the main entrance on the west elevation opens into a 19<sup>5</sup> x 14<sup>10</sup> foot room. There is a scar in the floor directly inside the entrance – possibly the location of a heater grate. A walled-in fireplace is centered on the north wall, flanked on the west by a cabinet and on the east by a closet. The window on the south side of the entrance lights the straight-run, open-string staircase in the southeast corner that runs along the south wall and leads to the upper story. This stair appears to be a twentieth-century replacement. A scar in the ceiling of this room, running parallel to the current stair, suggests that an earlier partition wall was removed. The original stair may have been located against this wall. This configuration is supported by the location of the door through the rear (east) wall into the bathroom addition. This would have originally been the exterior door at the rear of the stair passage. The two-and-a-half inch plank wood flooring runs east-west in this room and is a twentieth-century addition.
