EAST ELEVATION

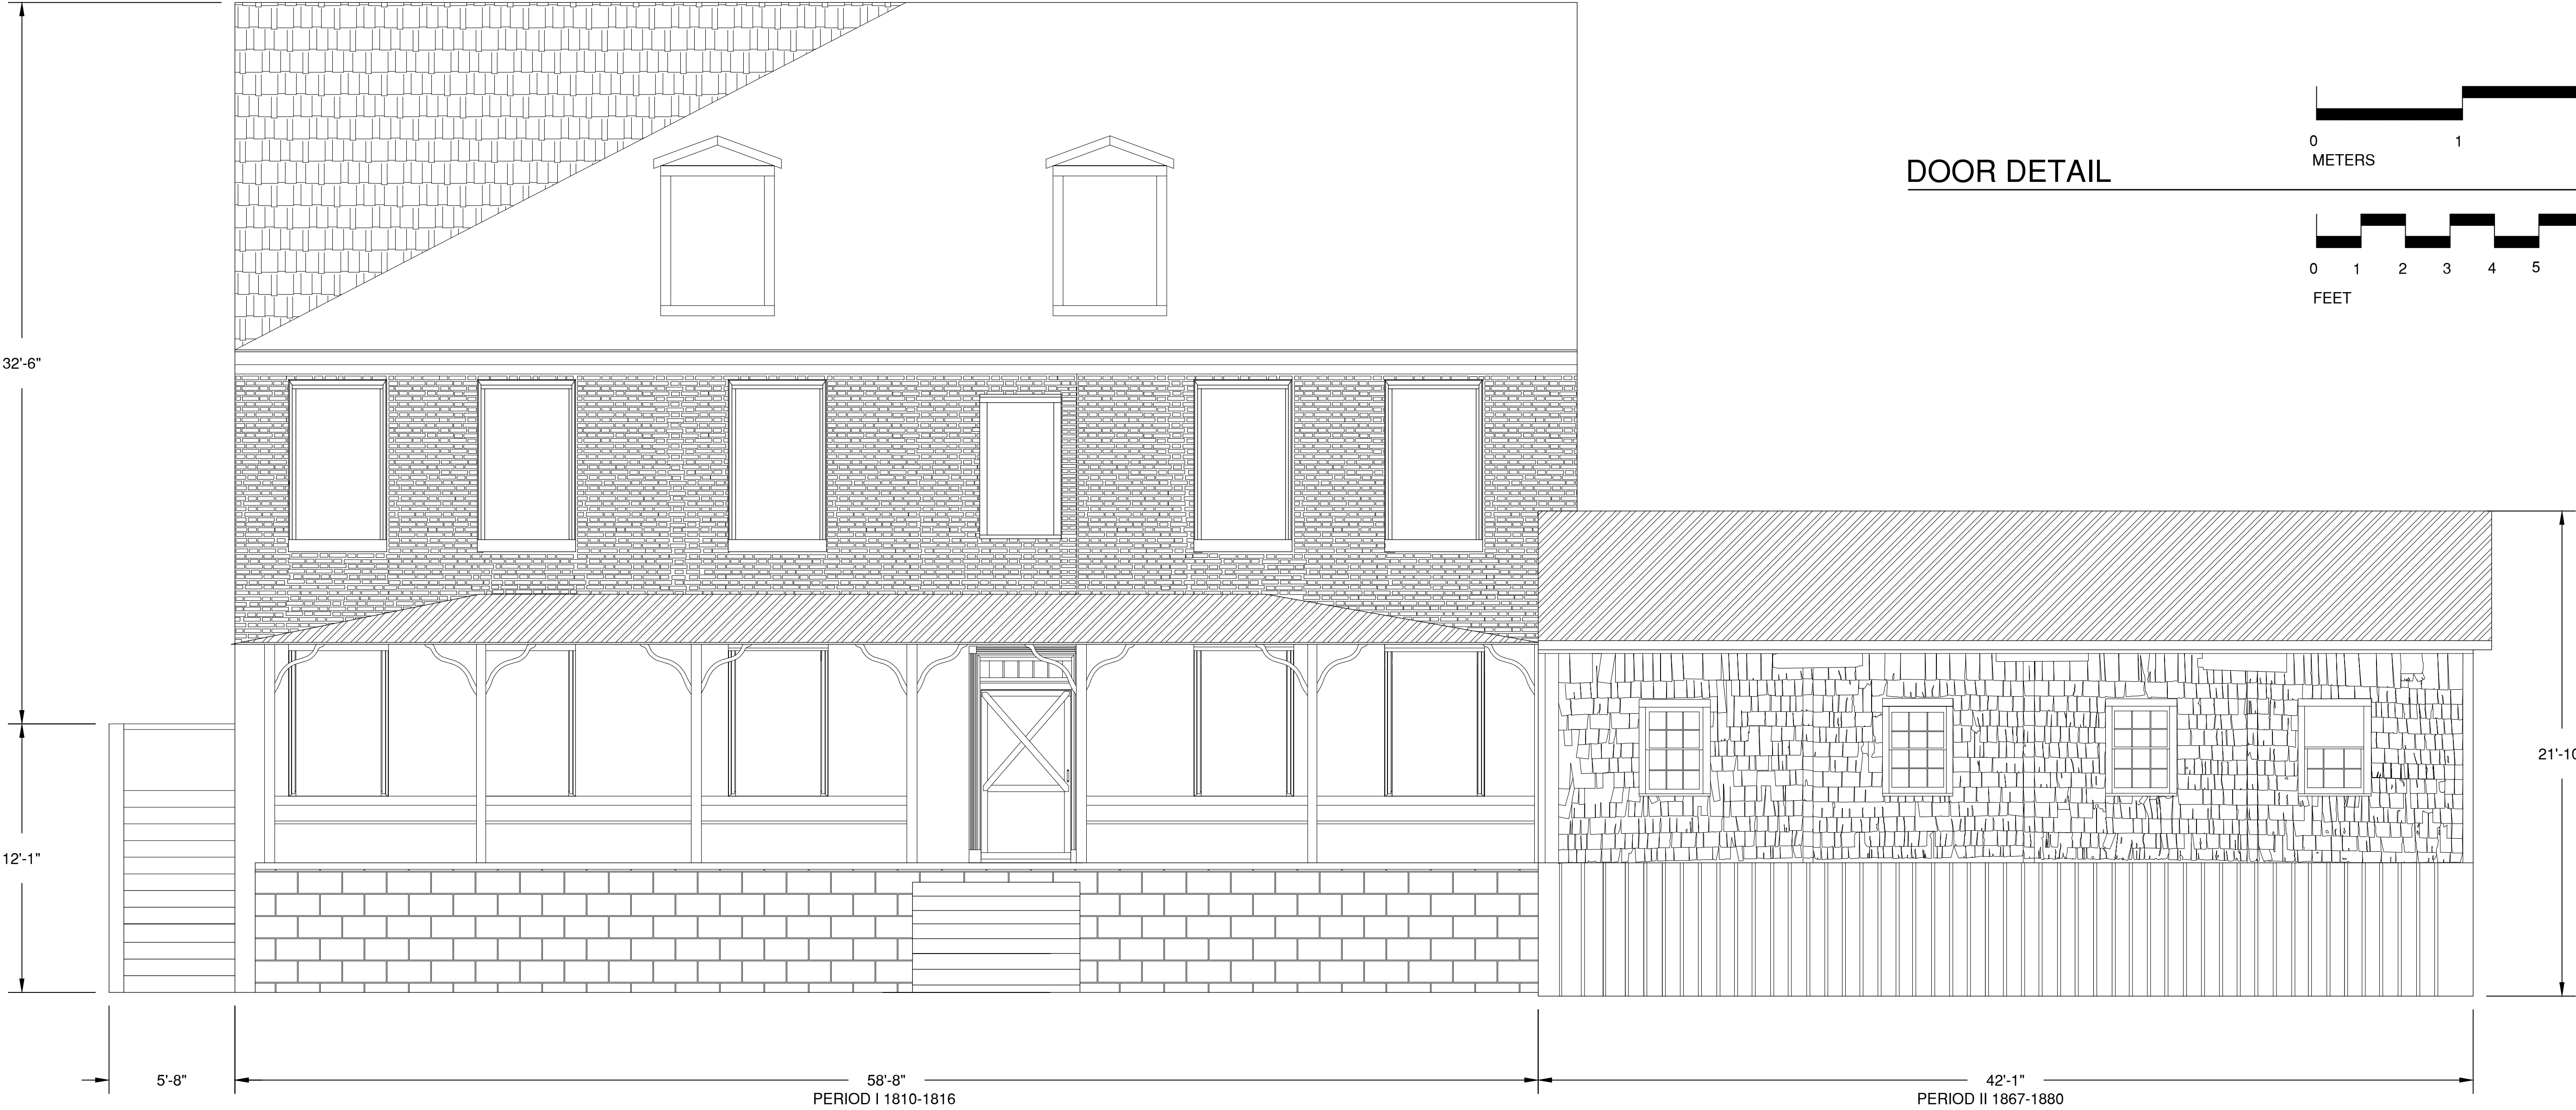
- EXPOSED BRICK CONTINUES ON THE FIRST FLOOR
- ALL WINDOWS IN MAIN BLOCK OF THE HOTEL ARE REPLACEMENT WINDOWS
