**Field Measurements of Non-Point Source Pollutant of Stormwater BMP's in the UD
Experimental Watershed**

March 31, 2004

Kathleen Cormier, Undergraduate Research Assistant
University of Delaware
College of Agriculture and Natural Resources
Food and Resource Economics Department,
Natural Resource Management
Newark, DE 19716

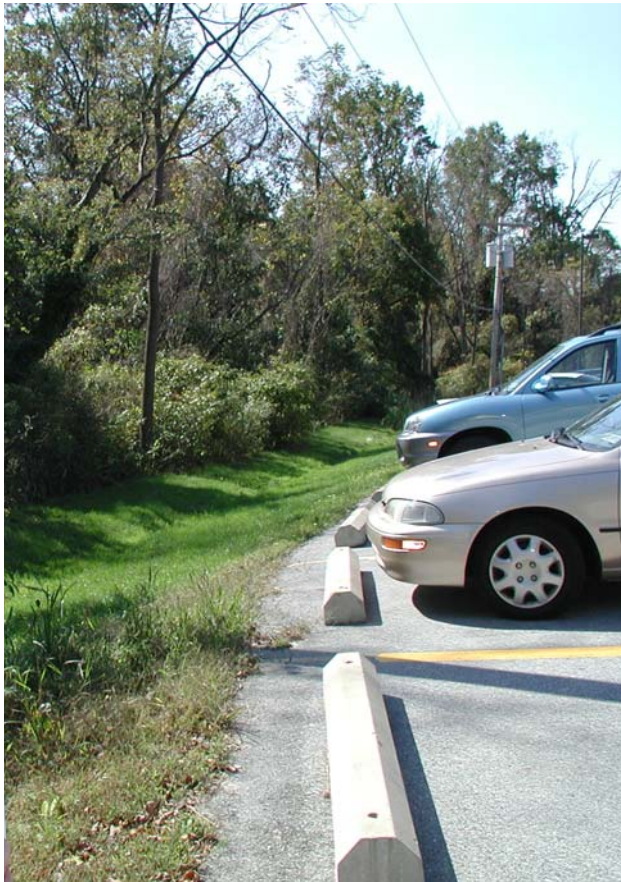
Figure 6: Image of Clayton Hall Stormwater Swale Running along the Alpha Sigma Alpha Parking Lot.

Task 2: Grab samples at inflow and outflow sites. Collect inflowing water flowing in the swale running parallel to Blue Hen Creek and the Alpha Sigma Alpha parking lot. . Researchers modified a plastic graduated cylinder with fishing line to gather outflow water from BMP, collecting water as close to the outflow pipe as possible. Clogging of the outflow pipe presented a problem for sampling.
